Final report

Mine workers injured during pipe installation work

December 2023

Title: Final report: Workers injured during pipe installation work

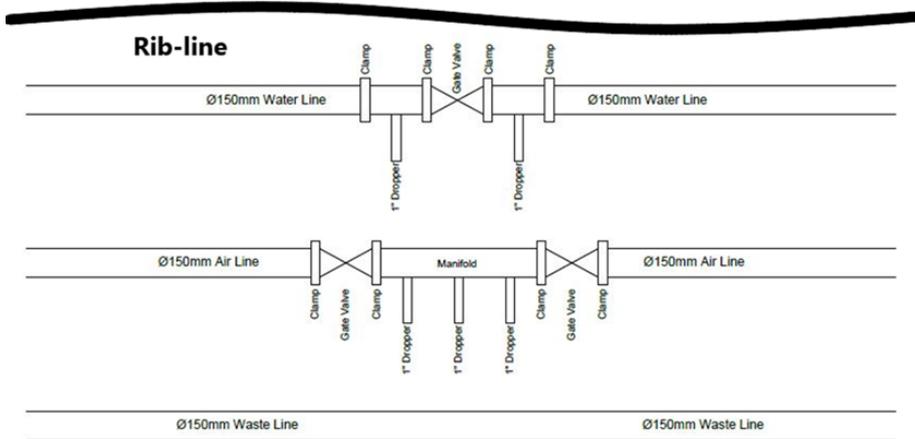
Service pipes at Mandalong were installed in the same configuration throughout the mine. The water pipe was located adjacent to the rib, the air pipe in the centre, followed by the waste pipe.

Figure 1: How the service pipes were installed at Centennial Mandalong Mine

- verify hazards associated with confusing different service pipes are adequately assessed and, if risks cannot be eliminated, they are to be minimised as far as reasonably practicable. This may include clearly demarcating pipes to ensure workers can distinguish different service pipes (e.g. water and air) by:

- colour coding service pipes
 - fixing colour-coded tags or stickers to pipes
 - installing different clamping systems for each energy source
 - installing different pipe diameters.

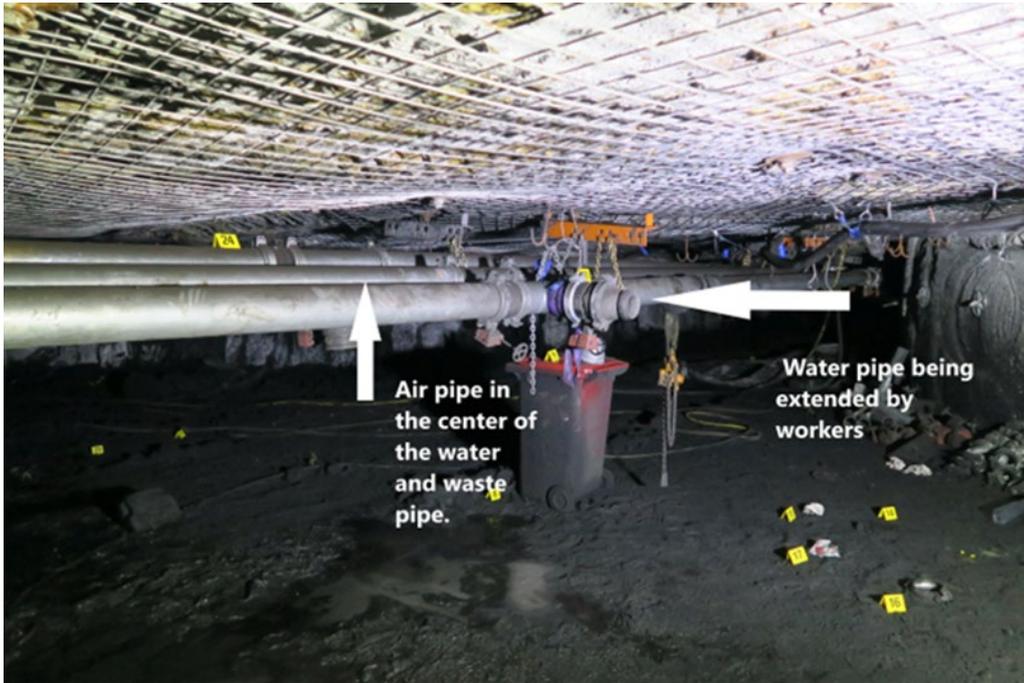
After fitting these parts, one worker walked outbye to re-energise the water pipe while 2 other workers remained near the work area.

Figure 2: Where the workers were located at the time of the incident

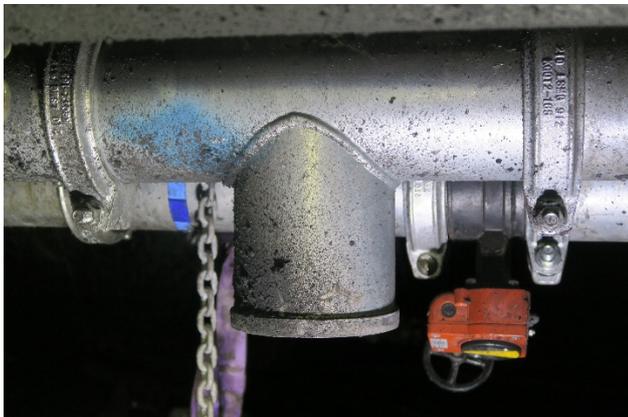
A short time later, an end cap fitted to a T-piece on the airpipe came free and was ejected in the vicinity of 2 remaining workers.

This caused compressed air (750 kPa) to escape and created an instantaneous blackout of the work environment and workers lost their footing. The end cap was later found about 35 metres away.

Figure 3: The T-piece on the airpipe

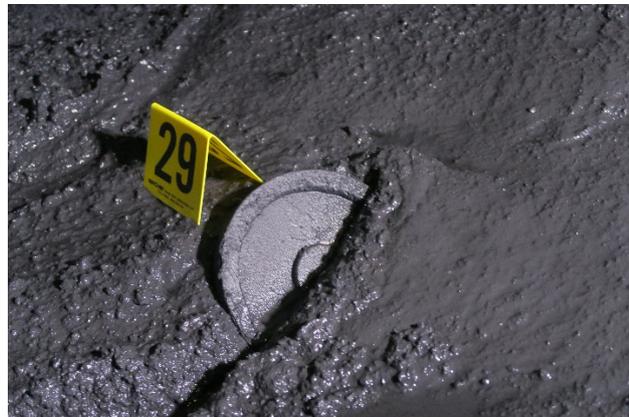
Figure 4: The end cap found 35 metres away

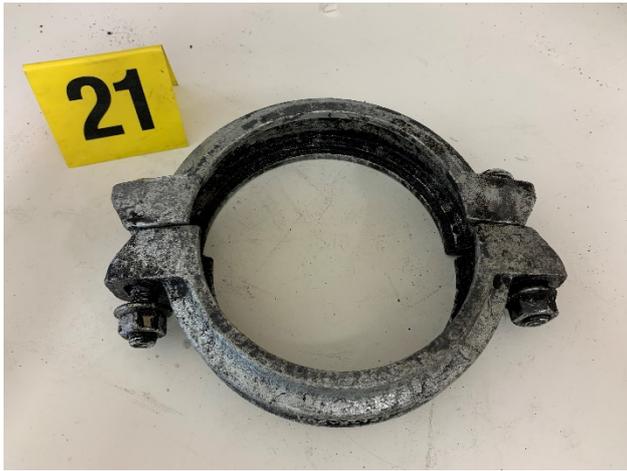
Figure 5: 150mm shouldered galvanised coupling

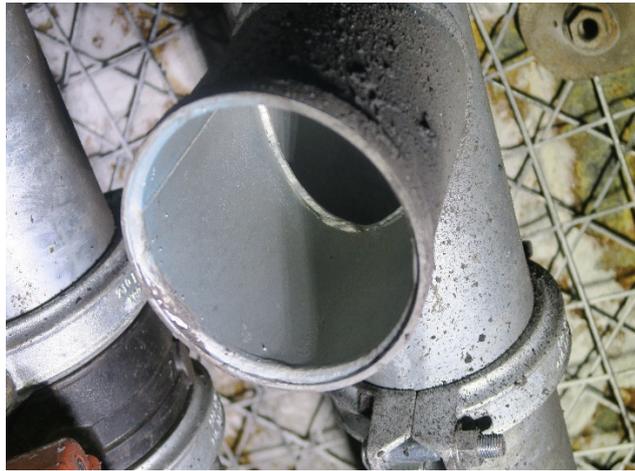
Figure 6: 150mm shouldered galvanised tee
