# Quarterly safety report

July to September 2023

Published by NSW Resources Regulator  
Title: Quarterly safety report – July to September 2023  
First published: November 2023  
Authorised by: Executive Director, NSW Resources Regulator  
CM9 reference: RDOC23/176029

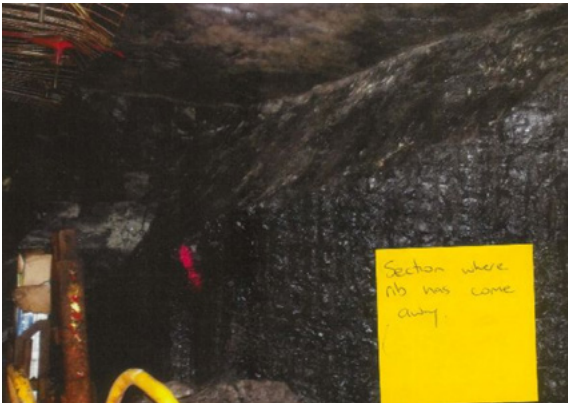
**Summary:** Two workers were on the right-hand platform of a continuous miner. Without warning, a greasy back gave way. The miner driver jumped back but was hit by falling material. The worker was winded and suffered bruising, scrapes and soreness. The worker was cleared of injury after being assessed at hospital.

Picture 1 (left). Section where rib collapsed.

**Comments to industry:** Workers must always be alert to the hazard of unsupported ground and must remain vigilant of their position relative to the risk of unsupported ground failure, which may occur without warning. Operators should review the appropriateness of the equipment they have provided to workers to install the required ground support in a timely manner at all stages of the production cycle. If the appropriate equipment for the prevailing conditions is unavailable, work should not continue.

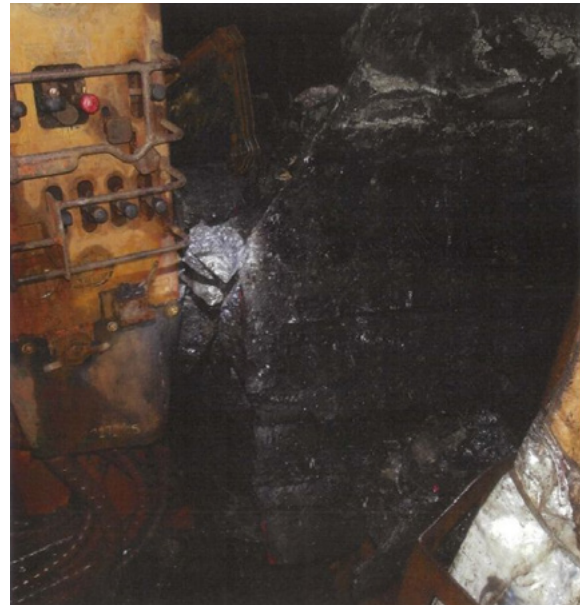
Picture 2 (right). Fallen material.

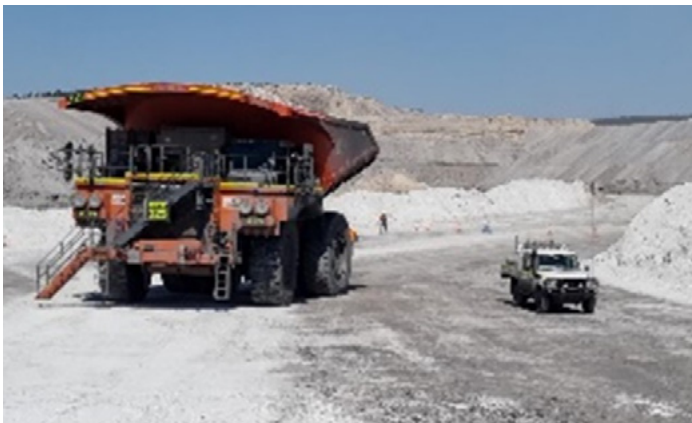
**Summary:** While a light vehicle (LV) was waiting for a dozer to reverse back and park up, a loaded haul truck came around the bend towards the LV and had to take evasive action to avoid a collision. The haul truck stopped approximately 10 m from the LV.

Picture 3. Vehicles involved in near miss.

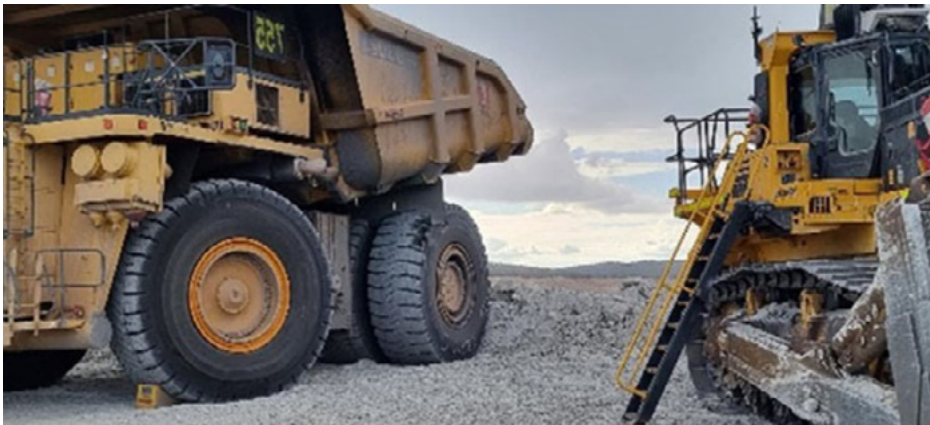
**Summary:** A dozer was pushing off the dump and directing trucks on where to unload. A breakdown in communication occurred, resulting in a truck reversing in behind the dozer as it was reversing across the dump. The ripper box on the dozer hit the tyre on the truck.

Picture 4. Vehicles involved in collision.

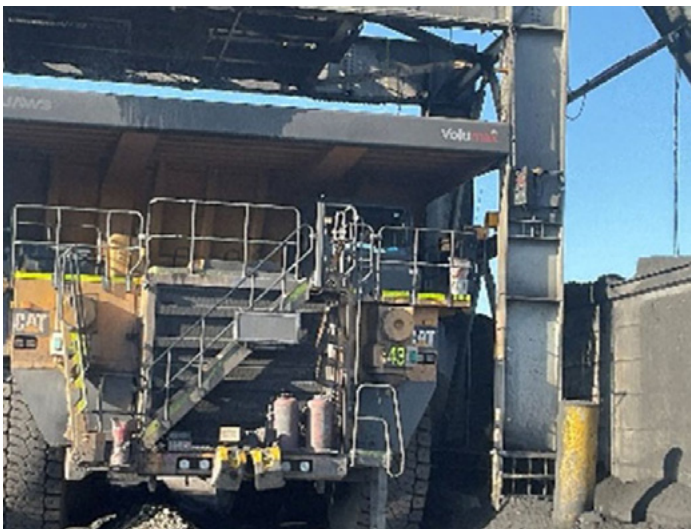
**Summary:** A dump truck was approaching the reject bin to be loaded. As it passed under the bin, the tip of the tray above the operator cabin contacted the left side exit support leg, deforming the tray. This has occurred previously at this mine.

Picture 5. Dump truck hits leg of reject bin.

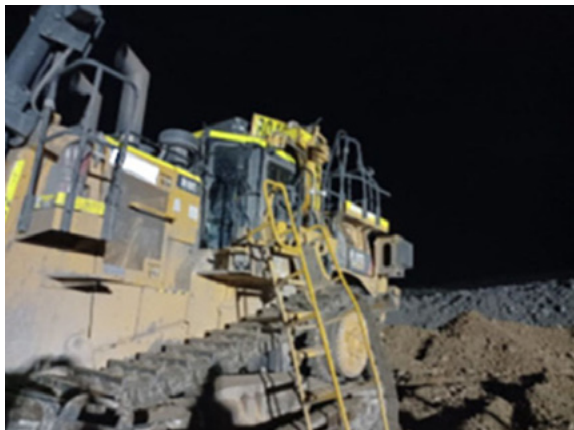
**Summary:** A dump truck collided with a dozer while reversing to the tip head. The dozer was performing clean up along the face. The dozer operator was unaware of the truck on the dump.

Picture 6. Collision between dozer and dump truck.

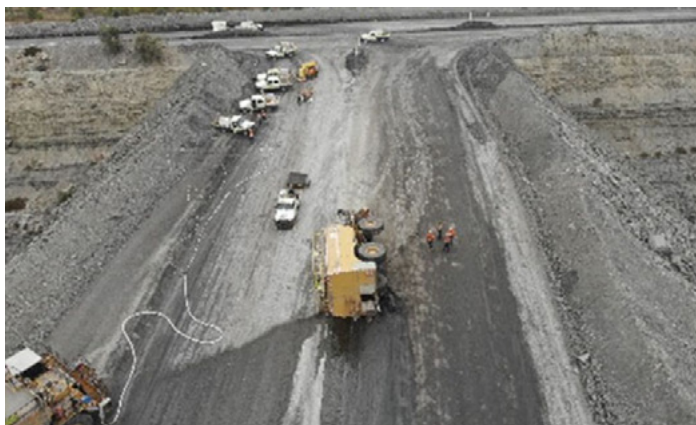
**Summary:** A service truck was travelling along a haul road. After rounding a bend, the truck slid on a wet section of haul road onto a dry section which resulted in the truck rolling onto the driver's side. The operator was able to exit the truck and was uninjured.

Picture 7. Service truck lying on side.

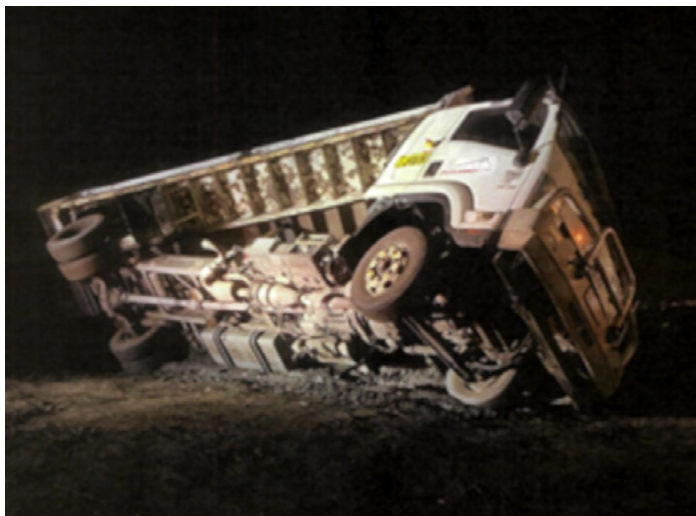
**Summary:** A road-registered 10 tonne tipper truck had a partial, slow 45-degree rollover because of washery spillage material hanging up in the tray. Two people in the truck were able to escape from the cabin onto another vehicle.

Picture 8. Tipper truck rollover.

**Comments to industry:** Mine operators should consider the most appropriate truck type for the material being transported. Workers should monitor for material hang up and should report unsafe conditions to their supervisor.

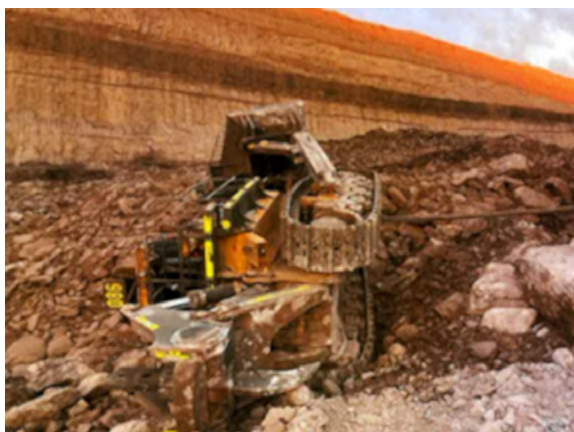
**Summary:** A dozer rolled onto its side while working to push material to an excavator on a double bench. The dozer became destabilised when one of its tracks ran over a large boulder and the machine tipped onto its side. The operator was uninjured and was able to remove himself from the machine.

Picture 9. Rolled dozer.

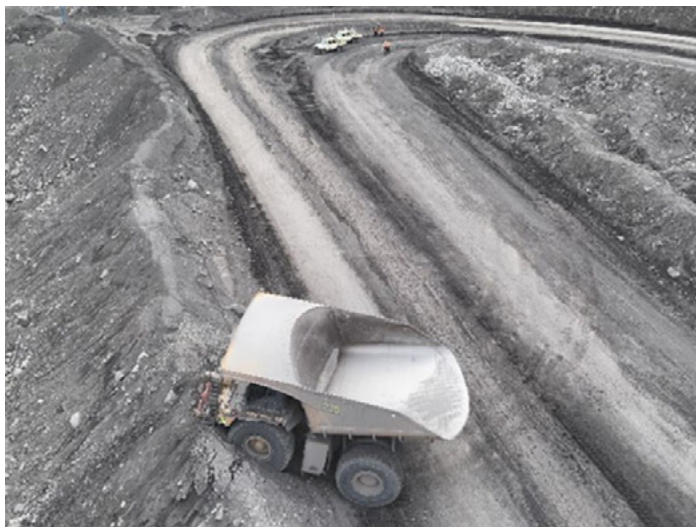
**Summary:** A haul truck leaving a switchback corner lost control when Pos 3 and 4 tyres lost traction on the recently watered road. The truck crossed the centreline of the haul road, contacting and coming to rest on the windrow. The haul truck operator was a trainee under the supervision of an appointed trainer.

Picture 10. Haul truck on windrow.

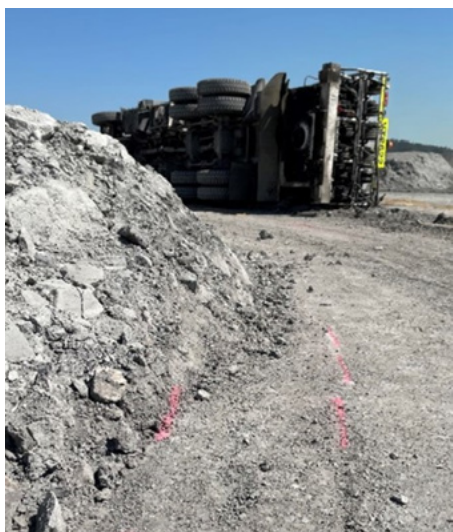
**Summary:** A service cart tipped onto its side when negotiating a bend near a haul road intersection. The truck was turning onto a light vehicle road from an old haul road when the truck drove onto the lower part of the windrow causing it to overturn. The operator self-evacuated. The incident occurred during daylight hours. The road was dry and flat, and visibility was clear.

Picture 11. Service cart tipped on side.

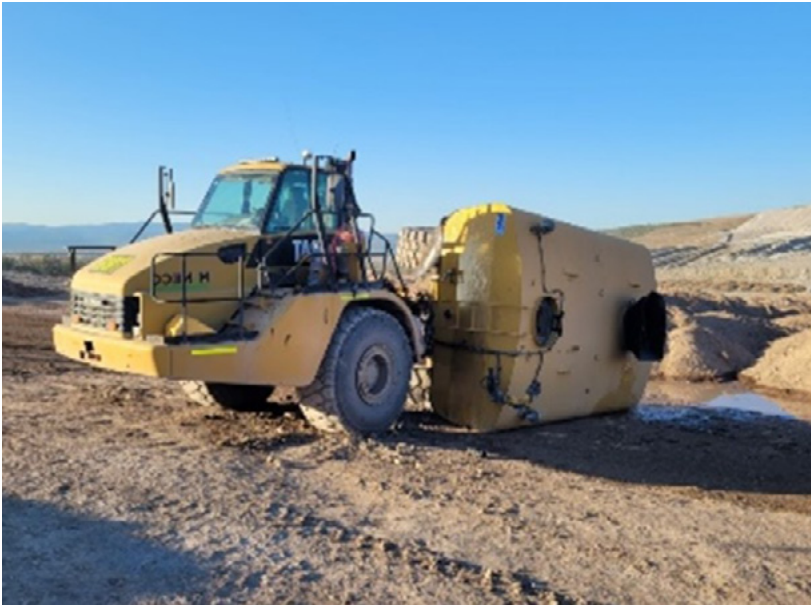
**Summary:** The body of an articulated water cart truck overturned while negotiating a corner after it was filled up.

Picture 12. Overturned body of articulated water cart truck.

**Comments to industry:** The stability of articulated vehicles is a known risk that needs to be managed at mine sites. When developing control measures to deal with the risks associated with articulated trucks, plant characteristics, including stopping distances, manoeuvrability and operating speeds of both the loaded and unloaded vehicle, and the mine's road design must be considered. Movement of fluid in tanks mounted on mobile plant can significantly influence the centre of gravity and overall stability of the vehicle. Consideration should be given to tank shape, baffling and compartmentalisation to control fluid surge. Operators of articulated trucks need to remain situationally aware and drive to the conditions.

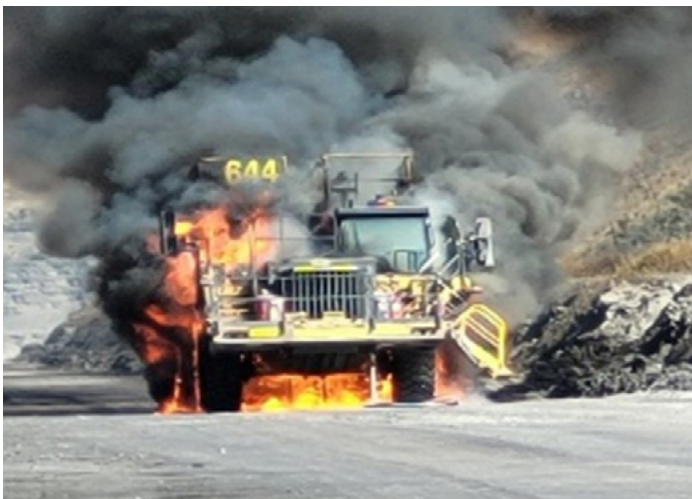
**Summary:** A broken-down service truck caught fire while the truck was being towed. Most of the onboard fluids were drained from the service truck before it was towed. Once the fire was identified, the tow vehicle was disconnected but efforts to extinguish the fire failed.

Picture 13. Fire on service truck while being towed.

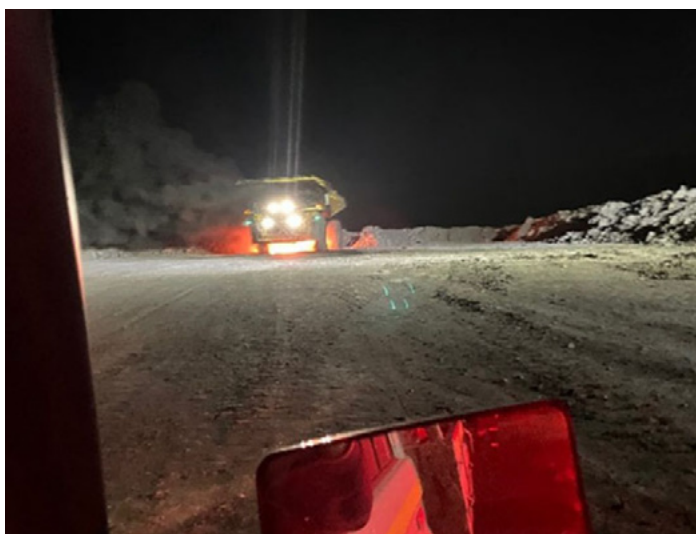
**Summary:** A haul truck was at the dump and had started to lift the tray. A nearby dozer operator noticed flames and called the truck operator instructing him to lower the tray. The dozer operator called emergency over the radio and told the truck operator to hit the fire suppression and exit the truck. The truck operator noticed flames outside the drivers' side door. The operator pulled the plastic tie on the fire suppression and attempted to activate it but was unsuccessful. The operator exited the cab through the passenger door, descended the primary egress, and waited with the dozer operator. The haul truck was engulfed in flames following the failure of the fire suppression system to operate. The operator was uninjured.

Picture 14. Fire on haul truck.

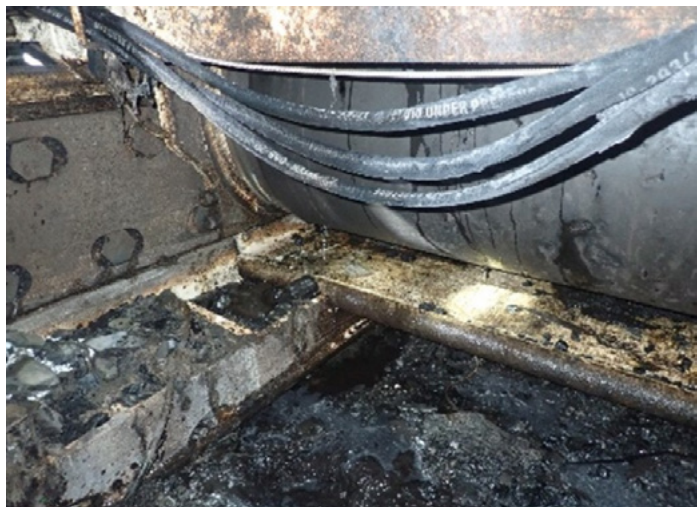
**Summary:** Longwall operators smelt burning and found a 30 cm flame on the side of the conveyor boot-end pulley. The belt was stopped, and water was applied to the pulley. The flame reignited once the water was taken off. Water was reapplied, the flame extinguished, and the water left running on the pulley with a spotter in attendance. The heat source of the fire was identified as a bearing failure. The temperature probes installed were discovered to be 290 mm long compared with a specified length of 450 mm contributing to the lack of warning of failure.

Picture 15. Damage from fire on conveyor pulley.

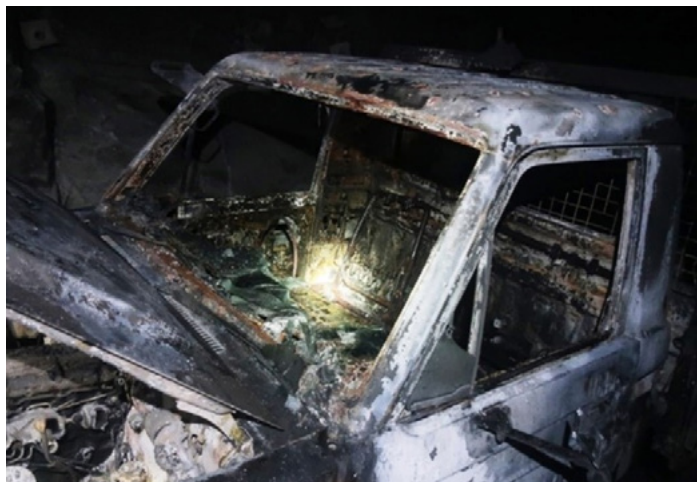
**Summary:** A light vehicle was being driven to a drill rig when it stopped about 80 metres from the drill site. A worker proceeded to the drill rig and commenced work. The worker heard a bang and turned to see the vehicle on fire. The worker used an extinguisher and found the fire suppression system had already activated. This did not extinguish the fire. The worker retreated and raised the alarm. All workers then proceeded to refuge chambers. The mine's emergency rescue team responded to the fire.

Picture 16. Damage to light vehicle from fire.

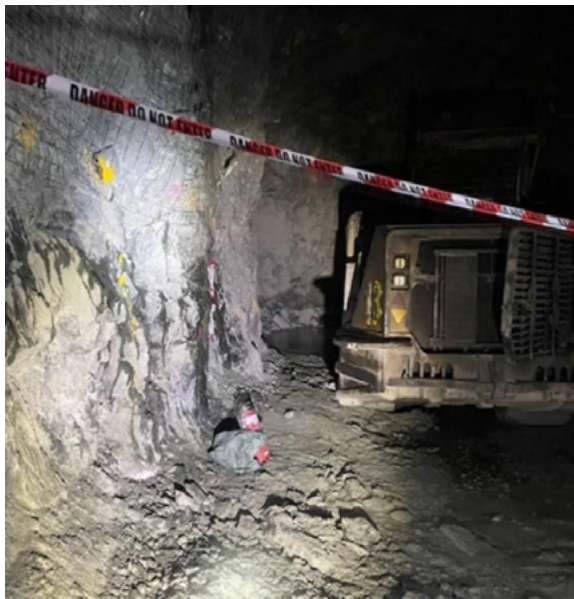
**Summary:** A worker was cleaning up in a decline and noticed a red glow at the back of a loader. The worker activated the fire suppression system, which extinguished the fire. A fire extinguisher was also used to ensure the fire was extinguished. An initial inspection determined that an oil cooler hose failed and sprayed oil onto the fan and the turbo. This was supported by the spray of oil on the ground and wall.

Picture 17. Scene of loader fire.

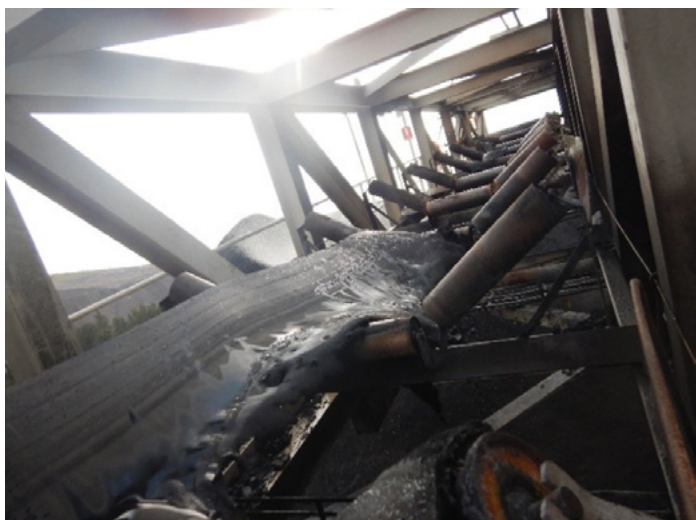
**Summary:** A fire occurred on the boom conveyor of a stacker. The control room slewed the stacker away from the stockpile to assist firefighting. The fire was extinguished by site personnel using onsite fire hoses. The belt was shut down for about 2 hours before ignition.

Picture 18. Fire damage to boom conveyor.

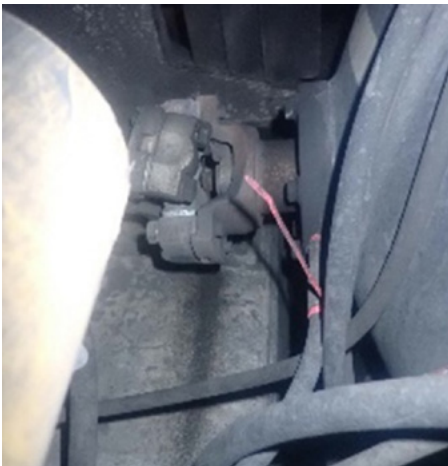
**Summary:** A load haul dump (LHD) with an empty roof support trailer was travelling outbye when the operator smelled smoke and saw flames under the engine, within the engine bay. The investigation identified a failed universal joint.

Picture 19. Damage from engine bay fire on LHD.

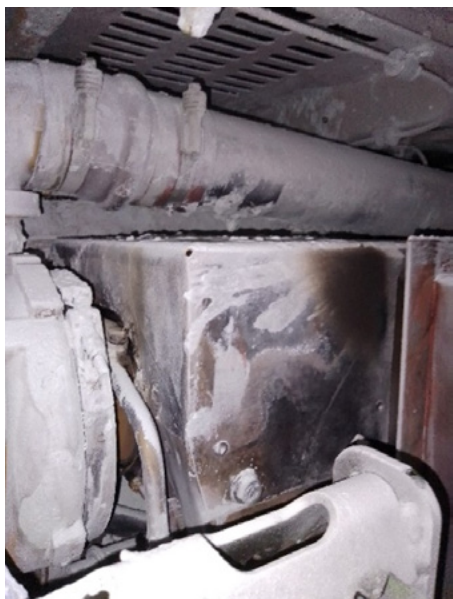
**Summary:** While operating a water cart underground in a metalliferous mine, the operator noticed smoke and flames from the engine bay. The operator exited the cabin and extinguished the fire with a hand-held extinguisher. The fire reignited and the operator and others continued to fight the fire. Emergency protocols were initiated and workers went to refuge chambers.

Picture 20. Damage from water cart engine bay fire.

**Comments to industry:** The failure of oil and fuel lines near exhausts and turbochargers are well-known causes of fire. Fuel sources and ignition points should be separated or have other controls in place to prevent fires. AS5062:2022 Fire prevention and protection for mobile and transportable equipment was published in November 2022, mine operators should review this update to the Standard.
