# Weekly incident summary

## Week ending 24 November 2023

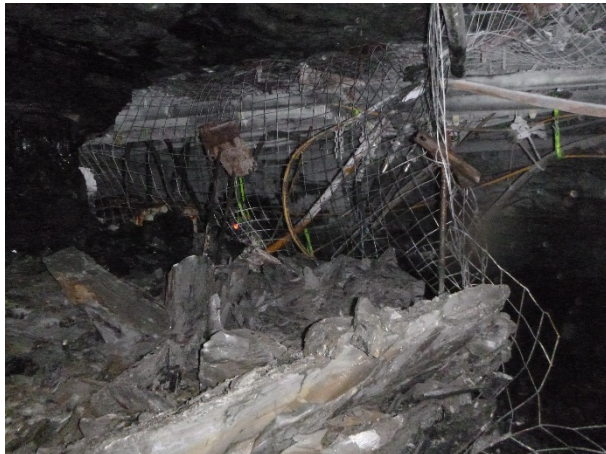
Incident type	Summary	Comments to industry
<p>Dangerous incident IncNot0045860 Underground coal mine Ground or strata failure</p>

<p>A load haul dump (LHD) was cleaning out a cut through to access a seal for repairs. Two workers were inspecting the cut through when they noticed a change in rib conditions. The workers moved to the opposite side of the roadway. Soon after, the rib slumped.</p>

<p>Workers must remain aware of strata conditions.</p> <p>When cleaning up, workers need to be aware of the risk of destabilising the rib support.</p>
