Weekly incident summary

Week ending 12 January 2024

Document control	
CM9 reference	DOC24/2902
Mine safety reference	ISR24-02
Date published	19 January 2024
Authorised by	Director Technical Operations Mine Safety Office of the Chief Inspector

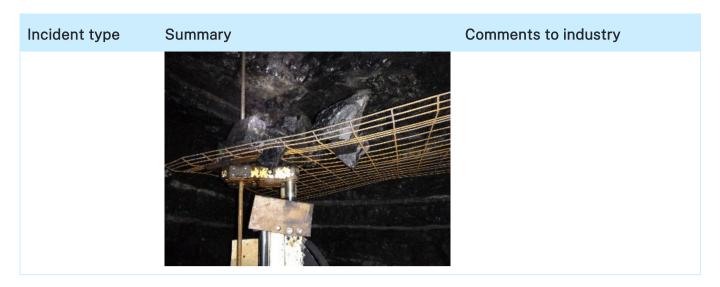
Incident type	Summary	Comments to industry
Dangerous incident IncNot0046138 Underground coal mine Ground or strata failure	An operator on a bolting platform was hit on the left shoulder when a drill steel dislodged a piece of roof coal that was about 2 m x 1 m x 0.6 m. The coal made contact with the temporary roof support, slid down the mesh and hit the centre console bolting rig controls before a second piece of coal that was 250 mm x 400 mm x 100 mm hit the operator - standing about a metre from where the coal was dislodged.	Mine operators must provide safe systems of work. The work methods and controls used must consider the risk of falling material, the positions of workers, and the use of mechanical aids. Whenever there is a possibility that objects can fall, appropriate no-go zones should be established to protect workers. No-go zones should be clearly delineated and communicated to all workers in the vicinity. When establishing a no-go zone, as a control for falling objects, bouncing or ricocheting must be considered.
