Safety Alert

Date: February 2024

Wheel rim ejected during tyre inflation.

Safety Alert SA24-01

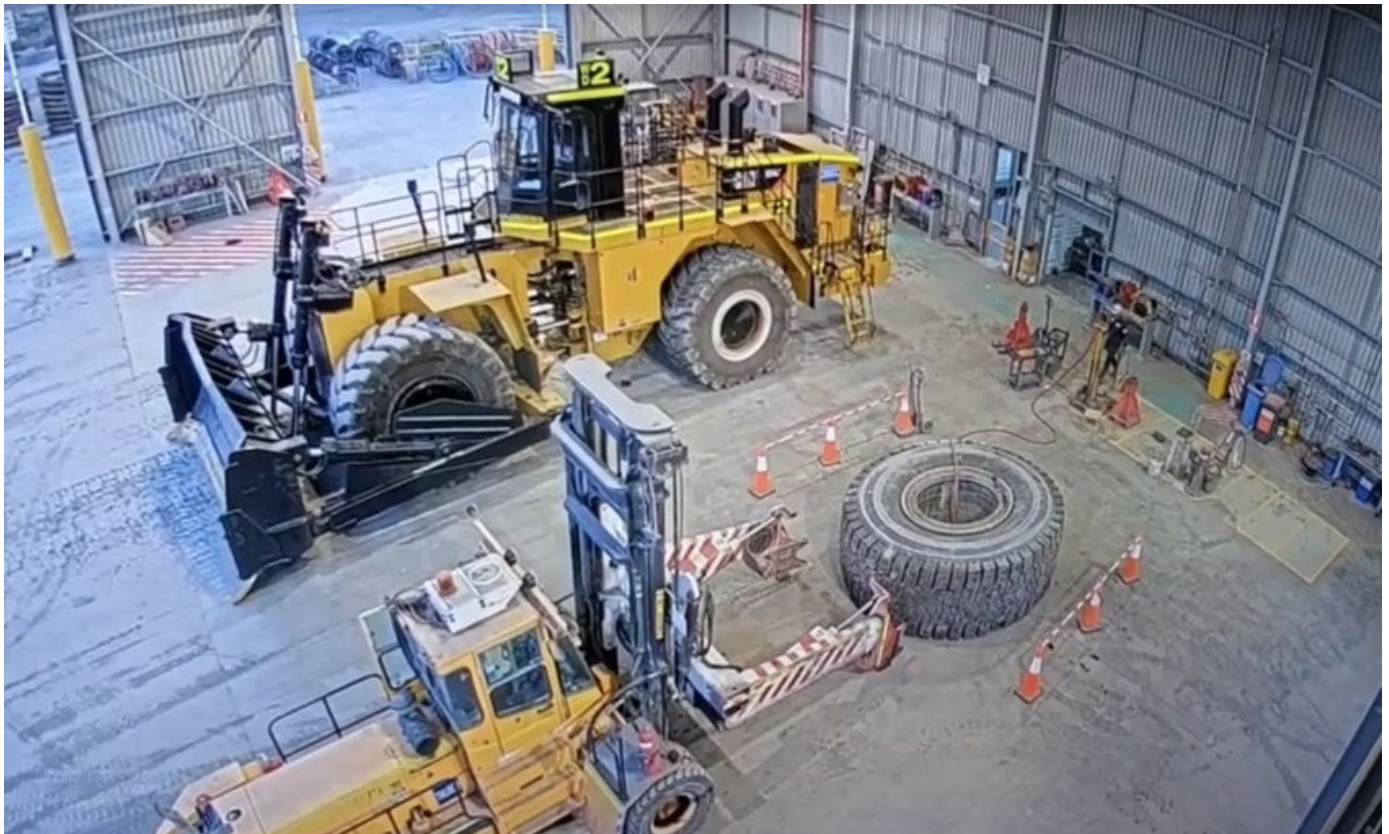
Figure 1: The mine workshop before the rim was ejected

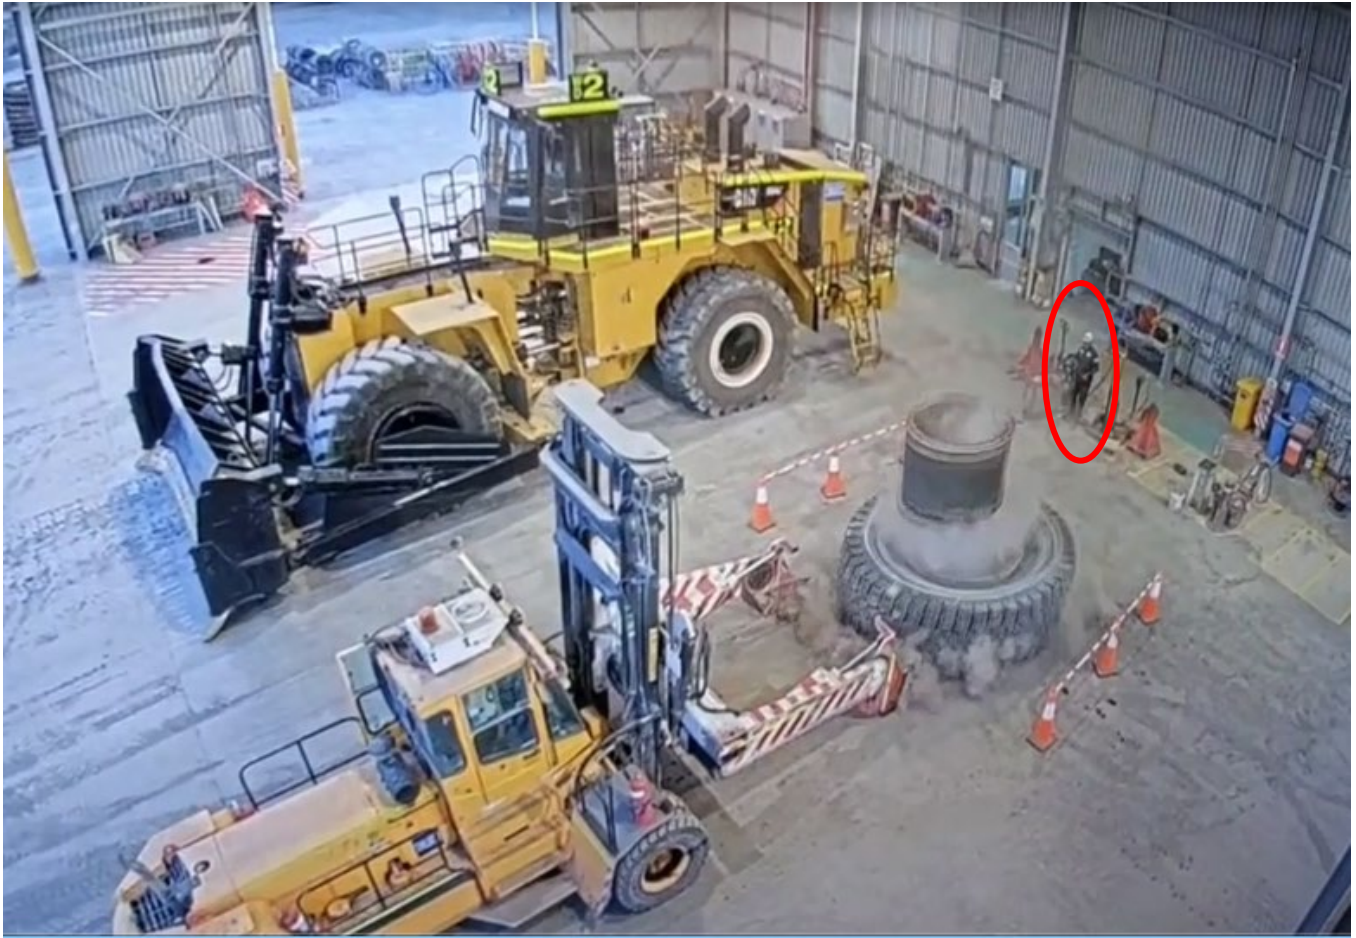
Figure 2: The rim ejected with the tyre technician circled on the right

The rim ejection incident occurred in the tyre bay with the technician about 5 metres from the tyre (See photo above). The pressure in the tyre was reported to be just above 10 psi at the time.

Preliminary findings indicate that during the process of replacing the o-ring, the tyre was rotated twice through 180 degrees. Each time it was dropped about 300 mm to the floor, due to the rotational limitations of the tyre handler. The impact with the floor appears to have dislodged the components and lock ring. This appears to have allowed the rim to dislodge and be ejected during inflation.

- No-go zones during inflation and handling
- Control of line-of-fire risks through retention of rim components using engineering controls
- Detailed, stepped inflation processes including dimensional and fitment checks
- Capability of the tyre handler for all intended tyre and wheel assembly handling processes
- Original equipment manufacturer (OEM) recommendations on discard criteria for lock rings
- OEM component compatibility guidance
