# Weekly incident summary

## Week ending 16 February 2024

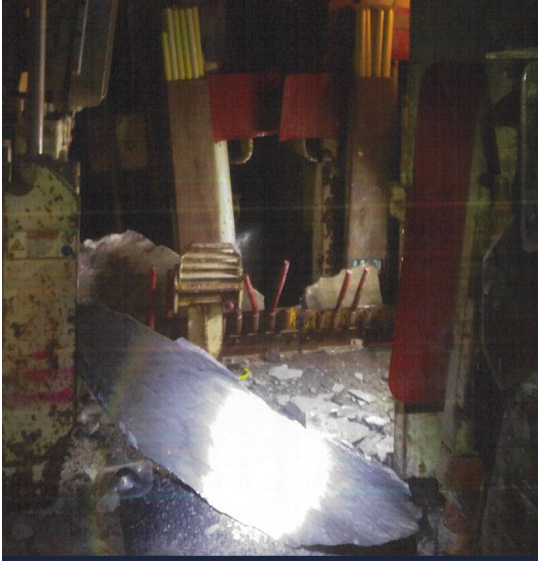
| Incident type | Summary | Comments to industry |
|--|---|---|
| <p data-bbox="124 813 264 882">Dangerous incident</p> <p data-bbox="124 902 328 934">IncNot0046359</p> <p data-bbox="124 956 352 1025">Underground coal mine</p> <p data-bbox="124 1048 312 1108">Ground or strata failure</p> | <p data-bbox="394 813 839 882">A significant roof fall occurred in an underground coal mine.</p> <p data-bbox="394 902 944 972">The fallen material was about 1.8 m high and the full width of the panel.</p> <p data-bbox="394 994 944 1099">It occurred 60 m into a runout in the herringbone panel. No workers were present at the time.</p> | <p data-bbox="1013 813 1414 1032">Mine operators are required to have a principal hazard management plan for ground or strata failure and to ensure that the plan is implemented as designed.</p> <p data-bbox="1013 1055 1394 1346">A system should be in place to update the incoming shift supervisor of trigger action response plans (TARP) risk changes, active TARPs and geotechnical hazards so that relevant information can be relayed to all workers.</p> <p data-bbox="1013 1368 1334 1473">Refer to the NSW code of practice: <u><a href="#">Strata control in underground coal mines.</a></u></p> |
