# Weekly incident summary

## Week ending 2 February 2024

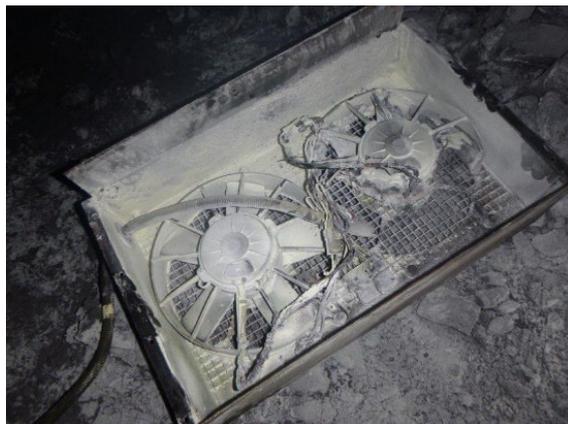
Incident type	Summary	Comments to industry
Dangerous incident IncNot0046232 Underground metals mine Fire or explosion	An air conditioner condenser unit at the rear of an operator's cabin on a long-hole drill rig caught fire while it was underground.  A fitter was inspecting a fault on the unit and observed fire and smoke. The fire was extinguished immediately by the fitter and the driller.	Mine operators should ensure that risk control measures to prevent the occurrence of fires, and the escalation and response to underground fires, are implemented and remain effective. Inspection regimes, housekeeping standards and emergency response procedures should be routinely examined to ensure minimum standards are met or exceeded.  Mine operators should ensure stringent monitoring and quality control of maintenance and repair activities.

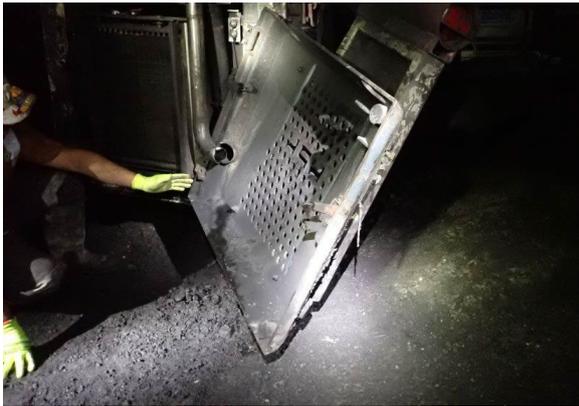
Incident type	Summary	Comments to industry
<p data-bbox="113 232 264 304">Dangerous incident</p> <p data-bbox="113 322 325 353">IncNot0046267</p> <p data-bbox="113 376 352 448">Underground coal mine</p>	<p data-bbox="389 232 970 488">While in the process of repairing a rear door of a bobcat, a fitter had his hand in the pinch point while trying to line up and fit a new bolt to the bottom hinge. The load shifted and the bottom of the door swung out crushing and severing his left-hand index finger against a thin piece of metal.</p> <p data-bbox="389 510 932 654">The bottom bolts had sheared off the hinge and a fitter was attempting to repair it. His offside was holding the weight of the door when the load shifted.</p>

<p data-bbox="1011 232 1469 488">Identifying potential pinch points and associated hazards should be undertaken before commencing any task, and controls to prevent workers from putting any part of their body in the pinch point should be implemented.</p> <p data-bbox="1011 510 1458 618">Procedures for tasks such as fitting of doors should include the risks associated with pinch points.</p>

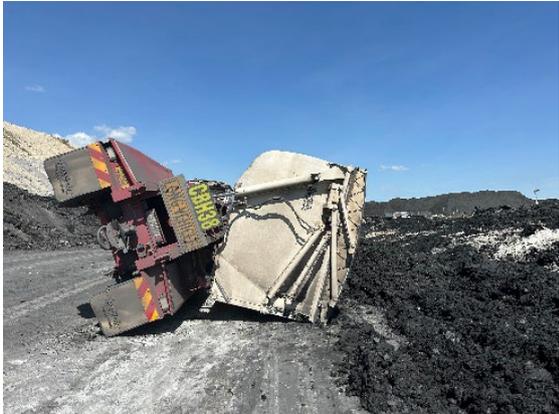
<p data-bbox="113 1111 264 1182">Dangerous incident</p> <p data-bbox="113 1200 320 1232">IncNot0046231</p> <p data-bbox="113 1254 301 1326">Open cut coal mine</p>	<p data-bbox="389 1111 954 1218">The rear trailer of a road registered B-double side-tipper truck rolled over while unloading rejects on the ROM pad.</p> <p data-bbox="389 1240 963 1312">The load was a mixture of belt press filter and coarse rejects with about 21 tonne in trailer.</p>

<p data-bbox="1011 1111 1458 1218">Mine operators should consider the most appropriate truck type for the material being transported.</p> <p data-bbox="1011 1240 1458 1424">The stability of articulated vehicles is a known risk that needs to be managed at mines and was the subject of a compliance priority program in 2018.</p> <p data-bbox="1011 1447 1406 1509">Refer to the following outcome report for more information:</p> <p data-bbox="1011 1532 1458 1603"><u><a href="#">Articulated truck rollovers and falls from mobile plant</a></u></p>
