Weekly incident summary

Week ending 23 February 2024

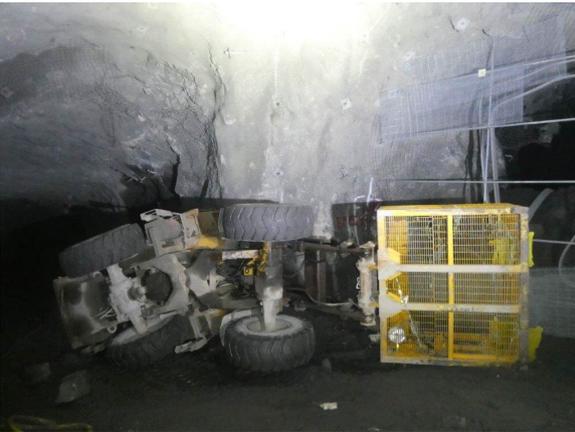
Incident type	Summary	Comments to industry
		<ul style="list-style-type: none"> hired equipment is maintained in accordance with a suitable maintenance strategy considering the original equipment manufacturer's recommendations and relevant Australian Standards. For elevated work platforms (EWPs) this should include AS 1418.10 and AS 2550.10.
<p>Dangerous incident</p> <p>IncNot0046399</p> <p>Underground metals mine</p>	<p>An integrated tool carrier overturned while 2 workers were in the basket installing mesh. The workers in the basket instructed the IT operator to turn the IT so that it was square to the wall. When turning to the left on a cross cut on the ramp (1 in 7) the operator felt the right hand rear of the machine lift and the IT slowly overturned. Both workers in the basket were wearing harnesses and were uninjured.</p>

<p>Mine operators must have controls in place to manage the risk of EWPs overturning during activities.</p> <p>Mine operators must ensure that plant is fit for its intended purpose. This includes the stability of plant in all configurations and tasks it is undertaken.</p> <p>Operators must be trained in the limitations of the plant.</p>
