**NSW
Resources
Regulator**

COMPLIANCE AUDIT PROGRAM

BOGGABRI COAL MINE

Boggabri Coal Pty Ltd

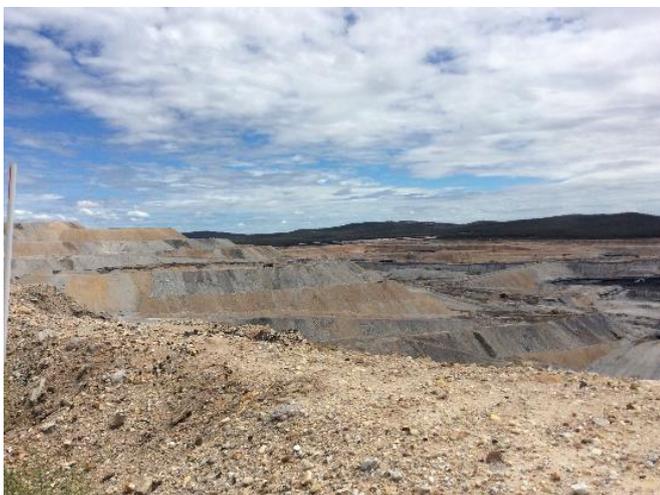
- Sections 2.3.7.3 and 4.2.1.15 - observations made on site and discussions with the short term mine planners confirmed that rejects material is co-disposed as described in the approved MOP (Figure 1). A reject limit plane is imposed, allowing a 5-metre offset from the edge of the dump for any carbonaceous material dumping which must also be above the final water table.
- Section 4.2.1.1 - the maximum out-of-pit dump height of RL395m was factored into the dump design profiles. The mine planners had adopted a dump profile consistent with the final design landform from the MOP.

Figure 1 Reject materials co-disposed with overburden

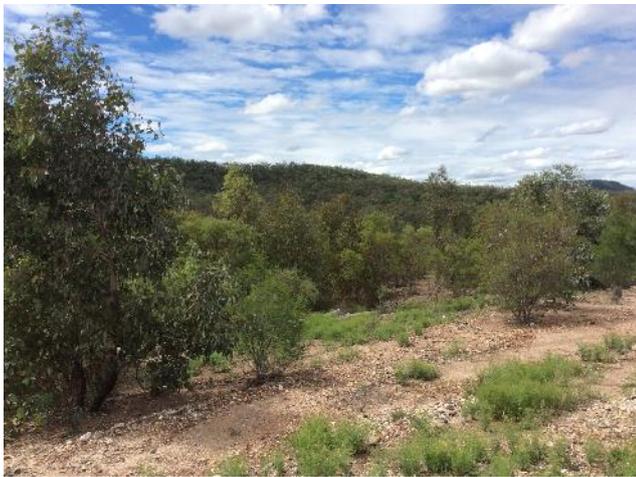
Severe drought has been a factor in the Gunnedah area for the last two years and monitoring was showing an increased rate of mortality within the rehabilitation. Mitigation measures used by Boggabri Coal included delaying planting of target species in the 2019 southern rehabilitation area and the watering of plantings already in the ground. The 2017 and 2018 rehabilitation areas were inspected during the audit (refer to Figure 2, Figure 3, Figure 4, and Figure 5). Generally, the rehabilitation has been reasonably successful with good growth.

Figure 2 2017 rehabilitation

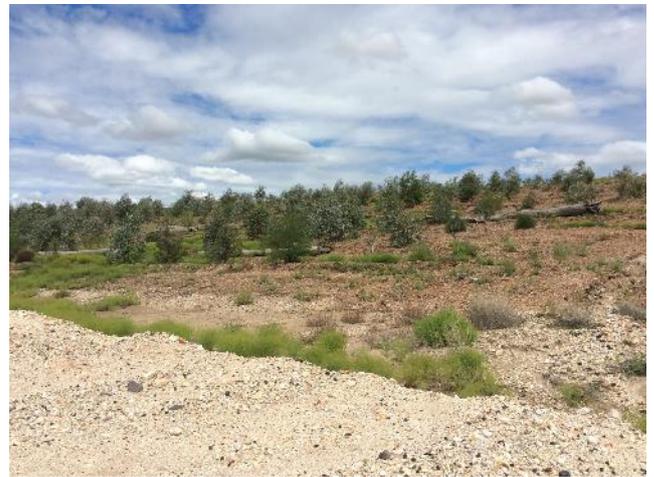
Figure 4 2018 rehabilitation

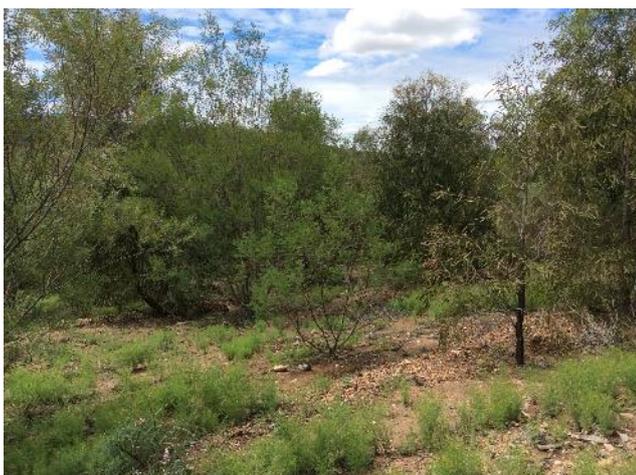
Figure 3 2017 rehabilitation

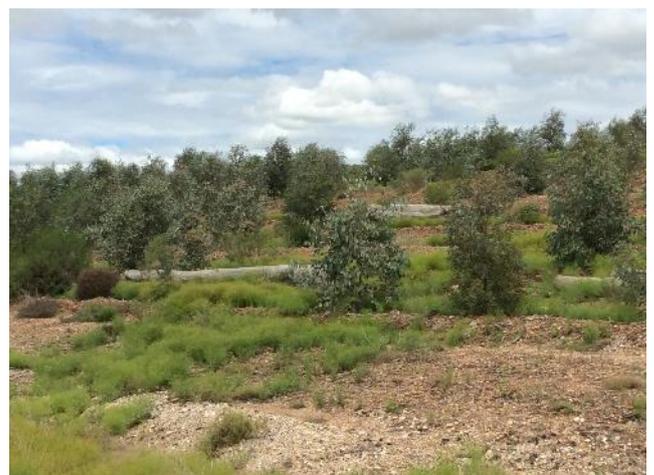
Figure 5 2018 rehabilitation

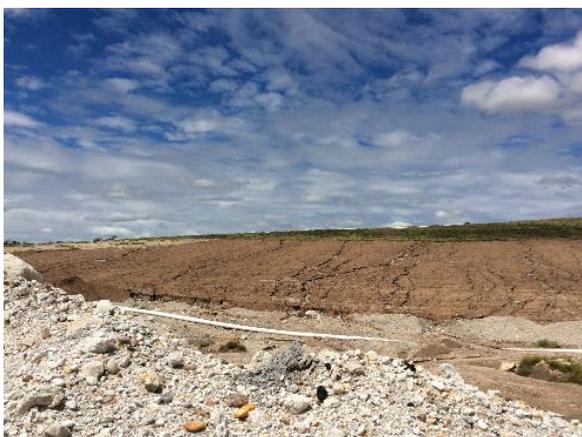
One of the short-term objectives was to progressively reshape and stabilise disturbed areas and areas were observed during the site inspection where progressive reshaping had taken place. It was observed during the site inspection that there was an area in the southern rehabilitation area that had experienced significant erosion, indicating that the landform may not have been stable and/or structural erosion control measures may not have been adequate to achieve the stated objective (refer to Figure 6 and Figure 7).

Figure 6 Landform on 2019 southern rehabilitation area

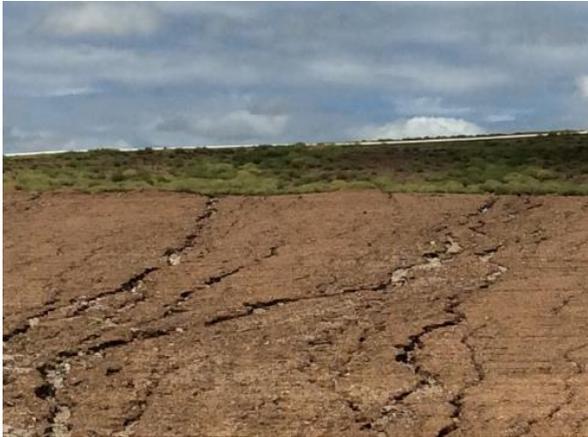
Erosion was first observed by Boggabri Coal staff prior to March 2019. The eroded area was repaired at the time and a consultant was engaged to design remediation actions to improve the stability of the dump batters (report dated March 2019). At the time of the audit, Boggabri Coal was working on construction of containment structures on the top of the embankment to stop water cascading over the embankment.

Significant rainfall in January and February 2020 resulted in erosion of the previously remediated batters. This second erosion event had not been repaired at the time of the audit (March 2020). Boggabri Coal advised that the erosion observed on the batters would be repaired once the construction work on the containment structures was completed. It is acknowledged that Boggabri had commenced actions to address the erosion issue. The erosion issue is raised as **observation of concern no. 1** and the progress and effectiveness of the construction works will be monitored by the Regulator during future inspections.

Figure 7 Erosion on 2019 southern rehabilitation area

- Erosion of the batter on the southern waste emplacement – text amended to reflect that the original erosion of the batter was repaired prior to March 2019 and a subsequent erosion event in February 2020 was responsible for the erosion observed during the audit site inspection.
- Compliance management systems – text amended to acknowledge that Boggabri Coal has implemented the INX system for compliance management, which was generally well managed, but the audit identified a gap in the identification of compliance requirements.

OBSERVATION OF CONCERN NO.	DESCRIPTION OF ISSUE	RECOMMENDATION
1	It was observed during the site inspection that there was an area in the southern rehabilitation area that had experienced significant erosion, indicating that the landform may not have been stable and/or structural erosion control measures may not have been adequate to achieve the stated objective. It is acknowledged that Boggabri Coal had commenced actions to address the erosion issue.	Boggabri Coal should complete and monitor the erosion control works on the southern rehabilitation area. The progress and effectiveness of the construction works will be monitored by the Regulator during future inspections.

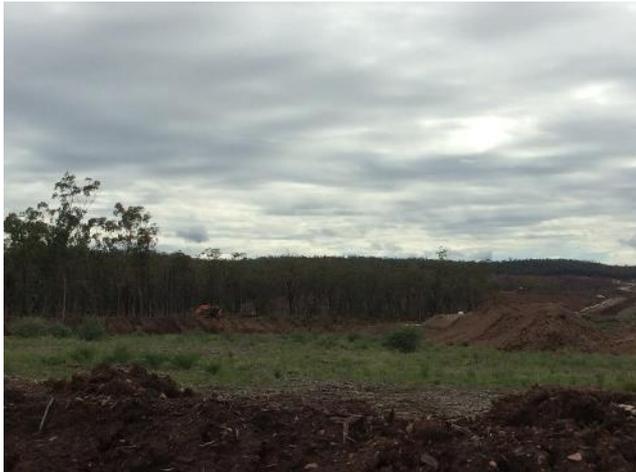
stripping as described in Section 4.2.1.6 of the MOP. Figure 8 and Figure 9 show the clearing operations in progress at the time of the audit.

Figure 9 Northern clearing area - topsoil and gypsum stockpiles

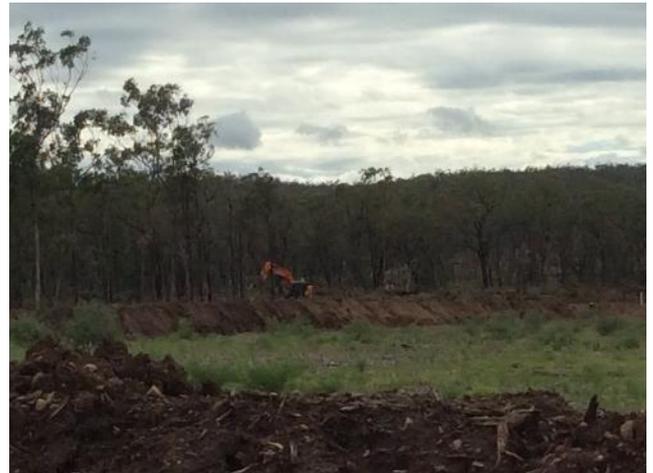
Figure 8 Northern clearing area - ecologists monitoring
