**NSW  
Resources  
Regulator**

COMPLIANCE AUDIT REPORT

# **MOUNT OWEN COMPLEX – TOPSOIL MANAGEMENT**

Mount Owen Pty Ltd

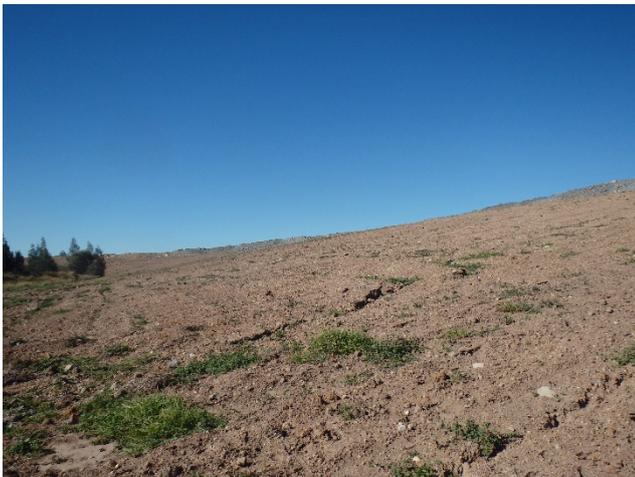
However, some minor rilling was observed (Figure 1). The Glencore Environment and Community Manager advised that while the topsoil had been placed, it had not been ripped at the time of inspection. The minor rilling was the result of some light rain. It is acknowledged that the minor rilling will be addressed once the topsoil is ripped along the contour, however it is of concern that the topsoil had not been ripped and seeded at the time of placement. This was raised as **observation of concern no. 1**.

Figure 1 Topsoil placement at Bayswater North showing minor rilling

Mount Owen generally accepted the audit findings. In relation to the direct placement of topsoil at Bayswater North (Figure 1), Mount Owen advised that the topsoil had been placed but not yet ripped, so the light rilling was a result of some light rain before the inspection and not a result of land preparation. The auditors accept that the topsoil had not yet been ripped and that ripping would address the minor rilling observed. However, it is of concern that there was a delay between placing topsoil and the ripping and seeding of the area. Therefore, the observation of concern remains.

The topsoil inspected at Bayswater north in this photo had been placed, but not yet ripped. So the minor rilling was a result of light rain, sometime before the inspection, and not from land preparation. If you require, we can verify this methodology via the rehabilitation contract in place as well as Lidar.

<b>OBSERVATION OF CONCERN NO.</b>	<b>DESCRIPTION OF ISSUE</b>	<b>RECOMMENDATION</b>
<b>1</b>	Section 5.2.4 of the GLD Land Clearing and Topsoil Stripping Procedure states that topsoil is to be spread across the slope to eliminate the chance of topsoil being lost in rain conditions. However, topsoil appeared to have been ripped perpendicular to the contour and as a result some minor rilling had developed.	Remediate rilling and review topsoil resspreading procedures.

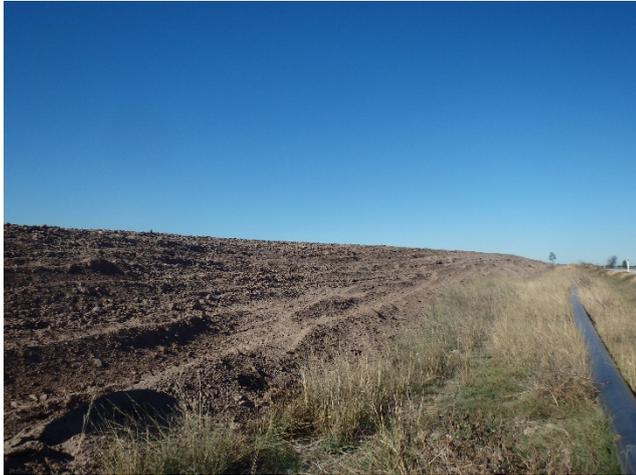
Figure 2 Stockpile 11 showing height less than three metres

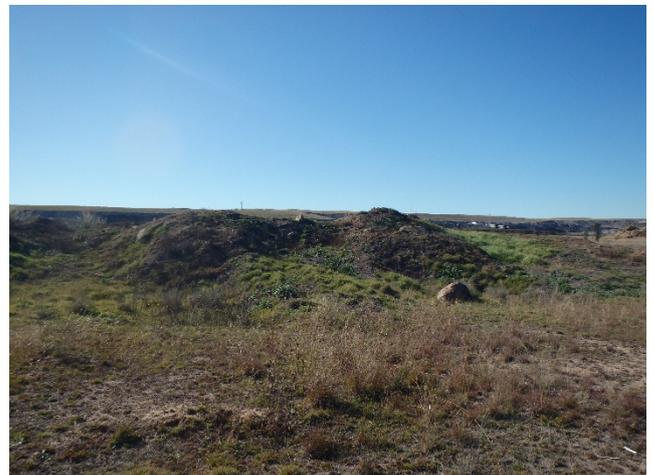
Figure 4 Stockpile 9, paddock dumped and weed infested

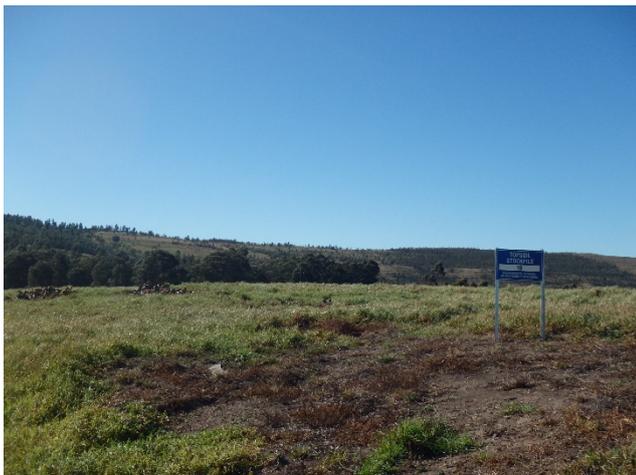
REQUIREMENT	OBSERVATION
Topsoil will be stockpiled away from mining traffic and watercourses	The topsoil stockpiles inspected during the audit were all located away from mining traffic and watercourses.
Identification of stockpile sites will be identified as part of the pre-task risk assessment and ground disturbance permit	The GDP for the strip 19 area was noted to include a map showing the location of the topsoil stockpiles. It was noted that a maximum height of two metres was also specified in the GDP.
Where possible, stockpiles are to be generally less than three metres in height.	Generally, the topsoil stockpiles inspected during the audit were less than three metres in height, with many being less than two metres (Figure 2).
The stockpiles are to be set out in windrows to maximise surface exposure and biological activity	Some of the stockpiles inspected had been set out in windrows (e.g. Glendell stockpile 11 and stockpile 1). Other large stockpiles had generally been shaped into low mounds, particularly where the stockpiles were to be left in place for long periods (e.g. Glendell stockpile 19) (Figure 3).

Figure 3 Stockpile 19 mounded formation

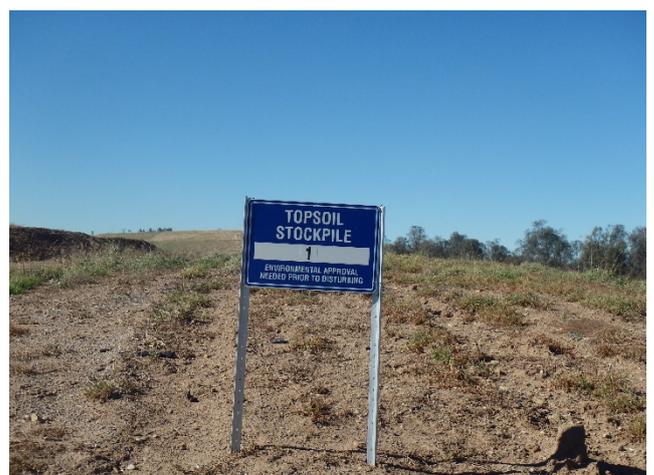
Figure 5 Typical topsoil stockpile signage

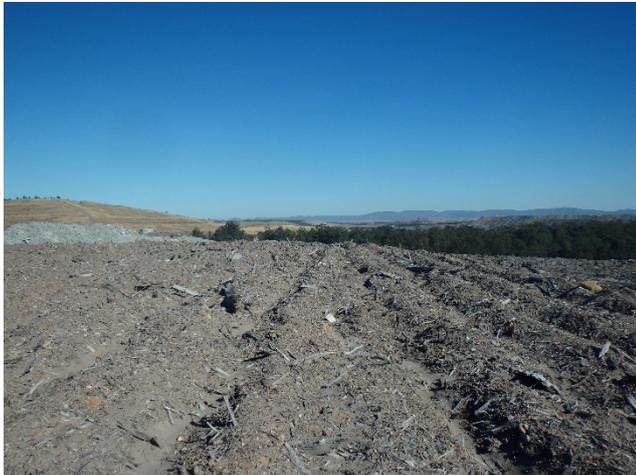
Figure 6 Loosely placed topsoil and mulch in stockpile 14

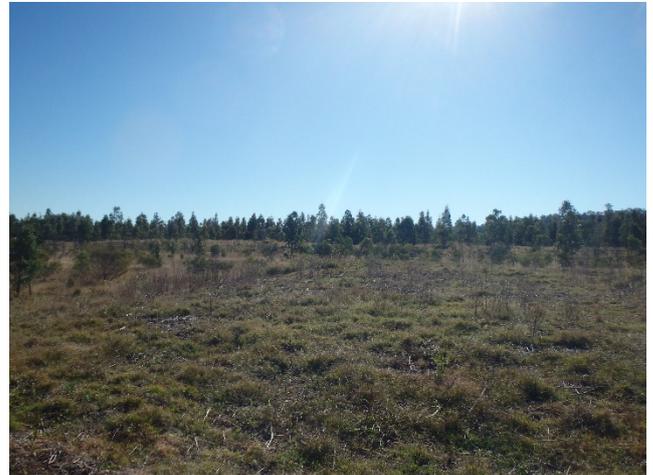
<p>Loosely place stockpiles to a maximum depth of three metres. The optimum depth is one metre and effort shall be made to minimise the stockpile depth.</p>	<p>The stockpiles inspected were all below three metres in height and mostly below two metres in height. Recently established piles were observed to be loosely placed (e.g. stockpile 14 – Figure 6), but the older stockpiles were more compacted.</p>
<p>Where the stockpile is to be in place for longer than three months, rip and sow with a suitable non-invasive cover crop.</p>	<p>The two older stockpiles inspected (stockpiles 2 and 5) were observed to have reasonable vegetation established (Figure 7).</p>

Figure 7 Vegetation establishment on stockpile 2

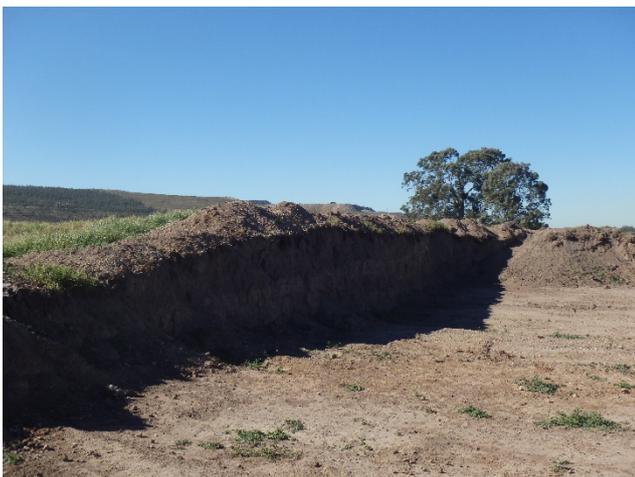
Tables 21 and 25 of the approved MOP identify requirements for topsoil to be tested to assess the suitability for post mining land uses. It was observed that topsoil was in the process of being recovered from Glendell stockpile 19 (Figure 8). However, the Glendell environmental manager could not provide evidence that testing of topsoil had been undertaken before respreading and confirmed that a testing program has not been implemented for the Glendell operations. This is raised as **non-compliance no. 2**.

*Figure 8 Topsoil recovery from stockpile 19*
