COMPLIANCE AUDIT REPORT

MOUNT PLEASANT OPERATION

MACH Energy Australia Pty Ltd

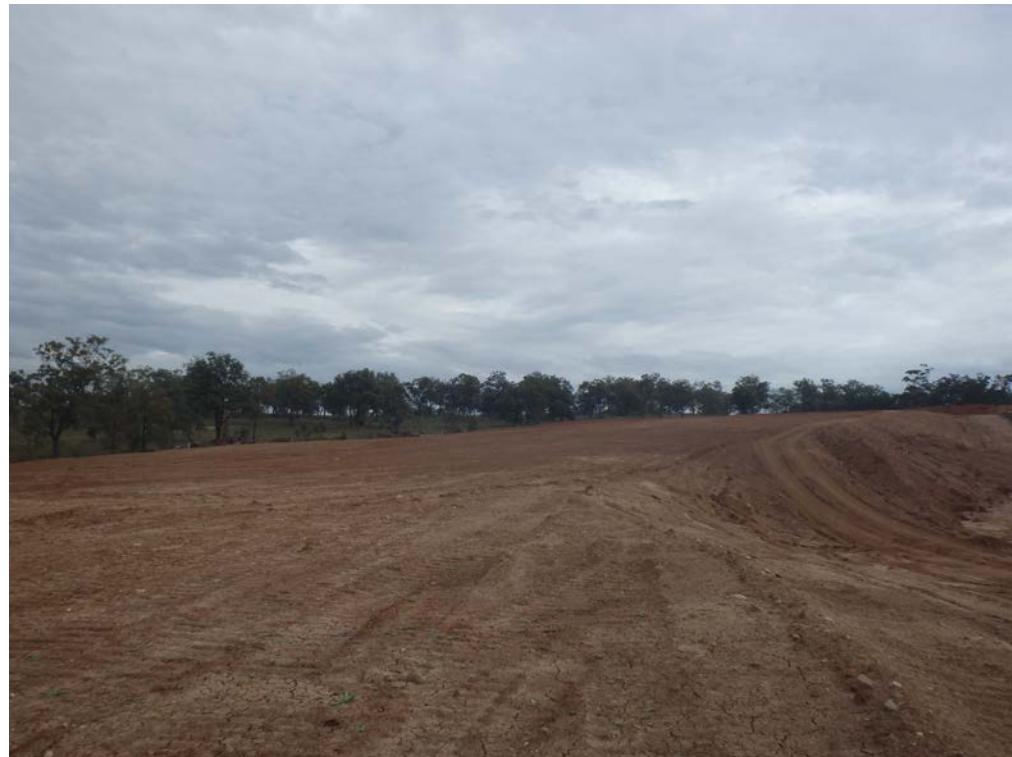
The audit team also noted that there were several areas of significant erosion across the site and MACH staff indicated that soils were known to be dispersive. However, erosion was not included in the risk assessment in the MOP, other than for a major storm event (which was also ‘Unlikely’). A topsoil stockpile (Pit D topsoil stockpile) was observed to have been recently shaped but not vegetated (Figure 1). The stockpile had quite a long slope length but there were no erosion controls observed on the site. Given the potentially dispersive nature of the soils, the erosion risk was not adequately considered, and consequently, adequate controls were not identified and implemented. This has the potential to result in a loss or degradation of the topsoil in the stockpile.

Figure 1 Pit D topsoil stockpile showing no erosion controls on the slope

The observations made by the audit team on site do not give confidence that the titleholder has a good understanding of the risks to successful rehabilitation outcomes. This was raised as **observation of concern no. 1**.

OBSERVATION OF CONCERN NO.	DESCRIPTION OF ISSUE	RECOMMENDATION
1	<p>It was noted that a basic risk assessment was provided in the MOP and this risk assessment was reviewed each time the MOP was amended. Some concerns with this basic risk assessment were identified by the auditor. The observations made by the audit team on site did not give confidence that the titleholder has a good understanding of the risks to successful rehabilitation outcomes.</p>	Review the risk assessment in the MOP to ensure it addresses the key risks to successful rehabilitation outcomes.
2	<p>An area of about four hectares of rehabilitation on the eastern side of the overburden emplacement was inspected during the audit. Evidence of extensive erosion and weeds was observed throughout this rehabilitation area (Figure 2 and Figure 3). A further area was shaped and partially laid with topsoil, but it was observed that this area was not consistent with the extent detailed in the MOP Plan 3.</p>	Undertake remedial actions on the rehabilitation areas of the overburden emplacement.

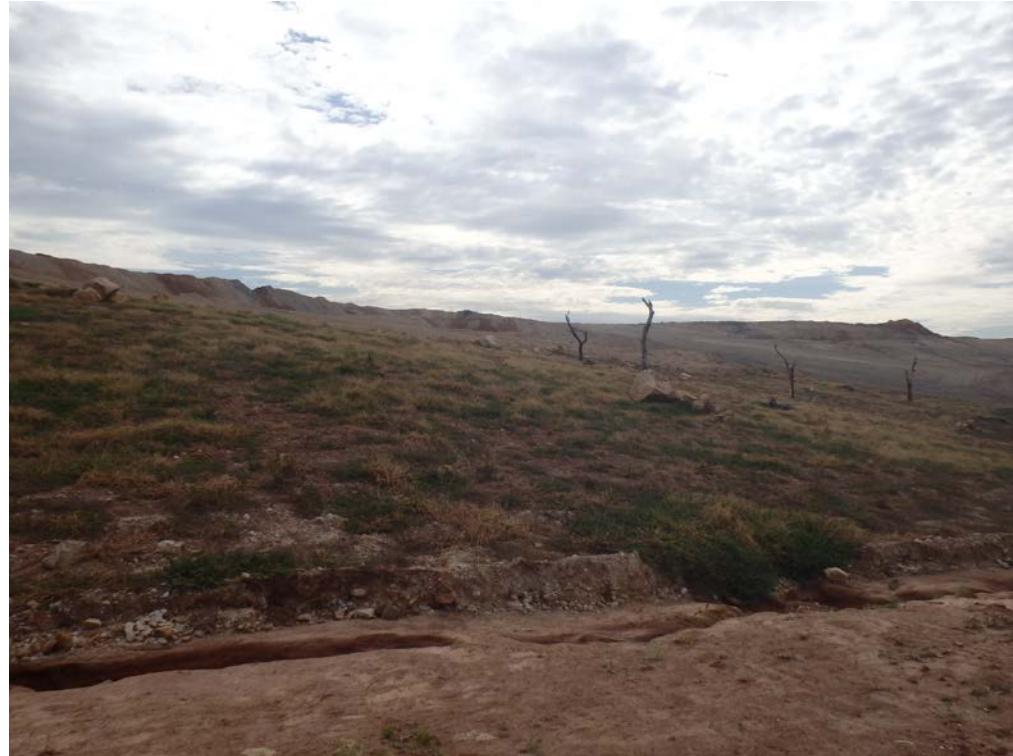
An area of about four hectares of rehabilitation on the eastern side of the overburden emplacement was inspected during the audit. Evidence of extensive erosion and weeds was observed throughout this rehabilitation area (Figure 2 and Figure 3). A further area was shaped and partially topsoiled, but it was observed that this area was not consistent with the extent detailed in the MOP Plan 3. This was raised as **observation of concern no. 2**.

Figure 2 Rehabilitation of the eastern side of the overburden emplacement showing weed infestation

mine rehabilitation success over the full life-of-mine cycle.	
2 - Erosion and Weed Management An area of approximately four hectares of rehabilitation on the eastern side of the overburden emplacement was inspected during the audit. Evidence of extensive erosion and weeds was observed throughout this rehabilitation area (Figure 2 and Figure 3). A further area has been shaped and partially topsoiled but it was observed that this area was not consistent with the extent detailed in the MOP Plan	<p>MACH Energy Australia has commissioned an experienced Land Management and Rural Services provider to undertake weed mapping and spraying activities on a regular basis. Weed management on the mining leases has been undertaken throughout the life of the mine.</p> <p>As part of the MOD3 works, the overburden emplacement toe extended further east to enable macro and micro relief of the final landform. On approval of MOD3, extensive works were undertaken on the design of the macro and micro relief of these areas, which was completed in the first half of 2019. These areas are now currently being shaped to design, with topsoiling and rehabilitation to follow as soon as practicable after.</p>	<p>An erosion and sediment control audit was undertaken in Q1 2019. The outcomes of this audit include remediation of areas of erosion throughout the mine. Scoping works were conducted in Q2, with works to commence in Q3 2019.</p> <p>Weed mapping is due to be undertaken in July 2019, with the next weed eradication program to follow shortly afterwards.</p>

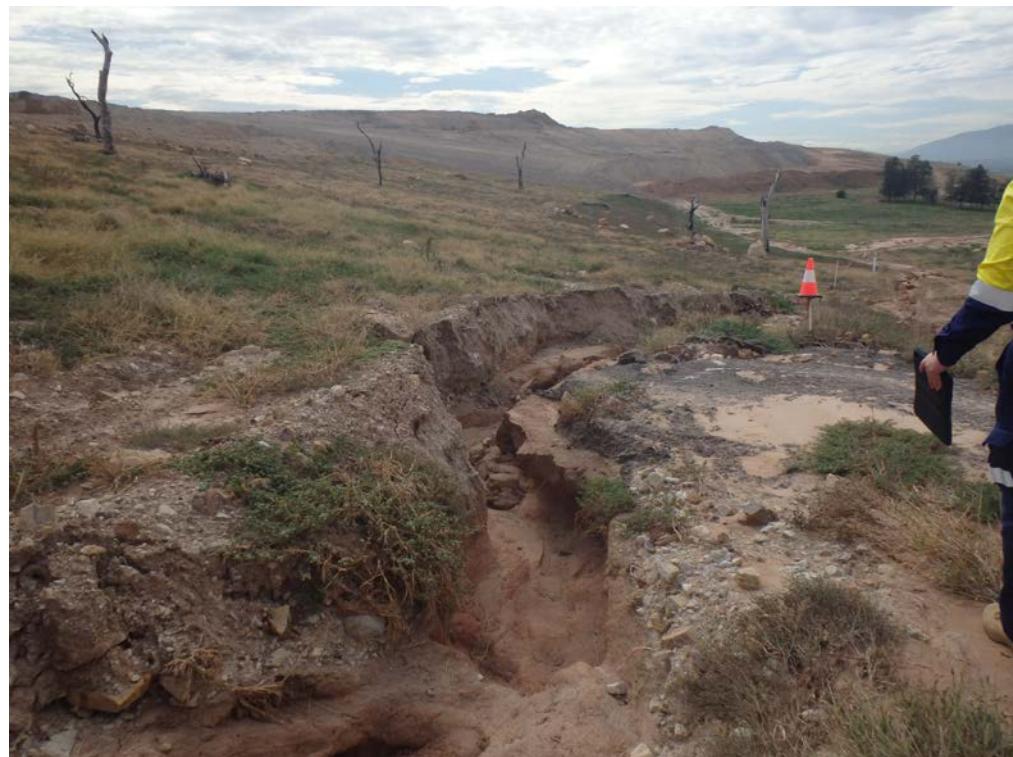
Figure 3 Significant erosion in the overburden emplacement rehabilitation area

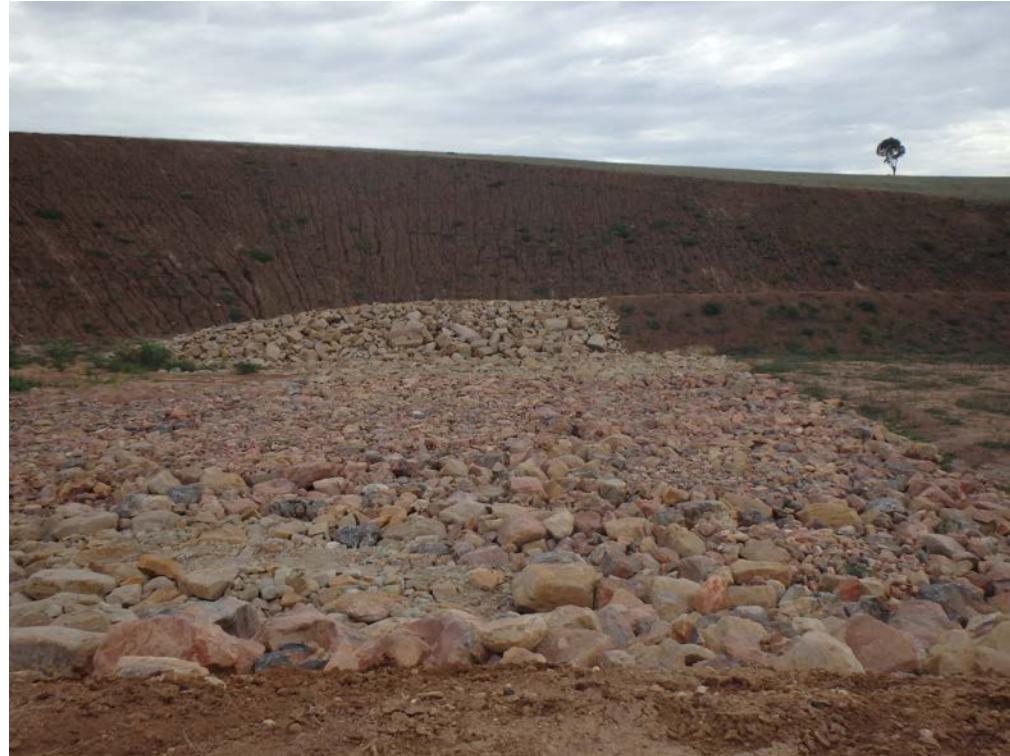
Temporary rehabilitation was undertaken on construction batters around the Mount Pleasant site as outlined in the MOP. It was observed that significant erosion and weed infestation occurred on some of these areas, and revegetation failures occurred on other areas that were not addressed (Figure 4). This was raised as **observation of concern no. 3**.

Figure 4 Revegetation failure and erosion on construction batters at the tailings dam

3	<p>Temporary rehabilitation has been undertaken on construction batters around the Mount Pleasant site as outlined in the MOP. It was observed that significant erosion and weed infestation has occurred on some of these areas, and revegetation failures had occurred on other areas that had not been addressed (Figure 4).</p>	Undertake remedial actions on areas of erosion and weed infestation where temporary rehabilitation occurred on construction batters.

3- Erosion and Weed Management Temporary rehabilitation has been undertaken on construction batters around the Mount Pleasant site as outlined in the MOP. It was observed that significant erosion and weed infestation has occurred on some of these areas, and revegetation failures had occurred on other areas which had not been addressed	<p>MACH Energy Australia has commissioned an experienced Land Management and Rural Services provider to undertake weed mapping and spraying activities on a regular basis. Weed mapping is due to be undertaken in July 2019, with the next weed eradication program to follow shortly afterwards. Weed management on the mining leases has been undertaken throughout the life of the mine.</p> <p>Rehabilitation within the construction areas of the mine is completed as works are finalised. In</p>	As above.
