**NSW  
Resources  
Regulator**

COMPLIANCE AUDIT REPORT

# **WAMBO MINE – TOPSOIL MANAGEMENT**

Wambo Coal Pty Ltd

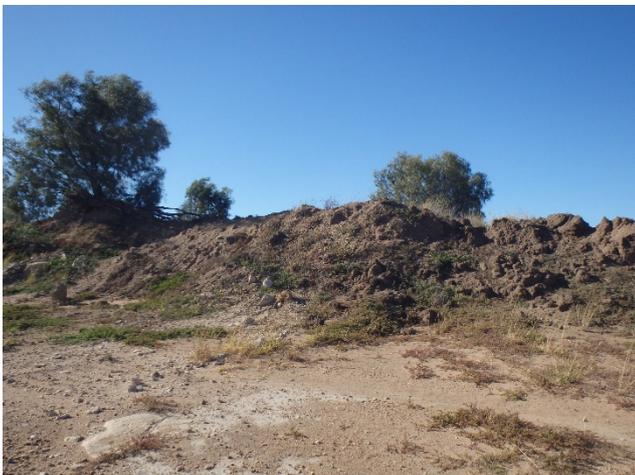
- It was observed that topsoil from stockpiles 1A and 6 had been borrowed from but not completely removed. The excavated face had not been reshaped to ensure water shedding and stockpile stability and had not been re-sown with a protective cover crop (Figure 1 and Figure 2). These issues are raised as **non-compliance no. 1**.
- Stockpile 7 was close to the Homestead Pit and was observed to have quite steep batters that were eroding (Figure 3). The height of this stockpile was uncertain but could be as high as 10 metres on the northern side. During the audit site inspection, the light vehicle was driven up onto the stockpile (Figure 4). These issues are raised as **non-compliance no. 2**.

*Figure 1 Stockpile 6, not shaped, sparse vegetation, weed infestation*

NON-COMPLIANCE NO.	DESCRIPTION OF ISSUE	RECOMMENDATION
1	It was observed that topsoil from stockpiles 1A and 6 had been borrowed from but not completely removed. The excavated face had not been reshaped to ensure water shedding and stockpile stability and had not been re-sown with a protective cover crop as required by the stockpile maintenance requirements outlined in Section 3.3.6 of the approved MOP.	Excavated faces on stockpiles should be reshaped and resown in accordance with the requirements of the approved MOP.
2	Stockpile 7 was observed to have quite steep batters that were eroding. The height of this stockpile was uncertain but could be as high as 10 metres on the northern side, greater than the three metre height specified in the MOP. During the audit site inspection, the light vehicle was driven up onto the stockpile, even though the MOP specifies that every effort will be made to avoid trafficking over topsoil.	Review the erosion on the batters at stockpile 7 and educate personnel to avoiding trafficking over topsoil.

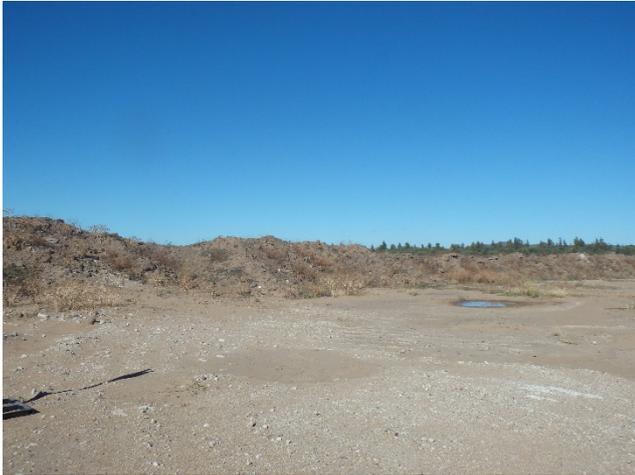
Figure 2 Stockpile 1A, sparse vegetation, not well shaped, weed infestation

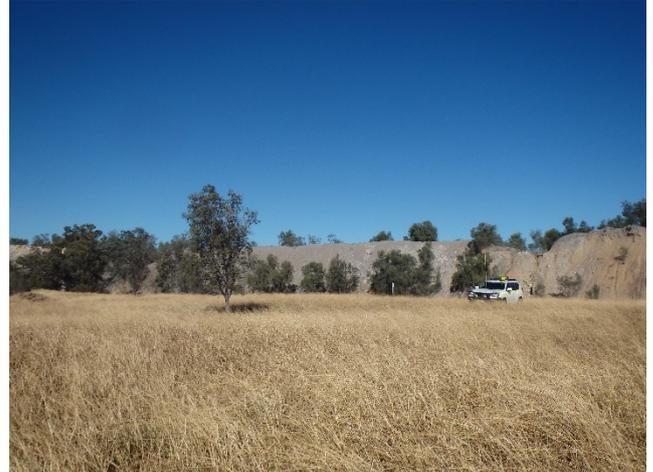
Figure 4 Stockpile 7 with light vehicle parked on top

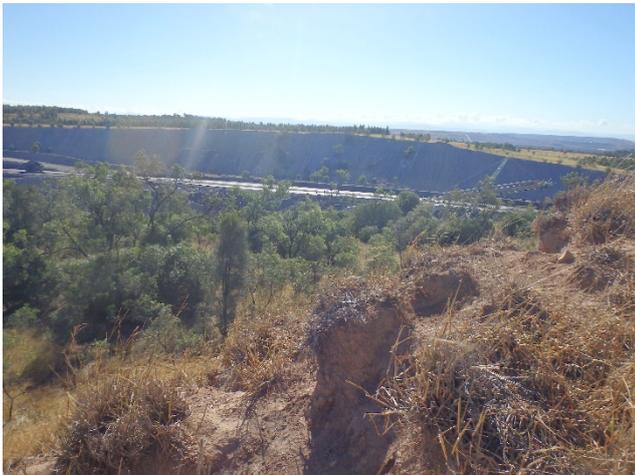
Figure 3 Stockpile 7 showing steep eroding batters

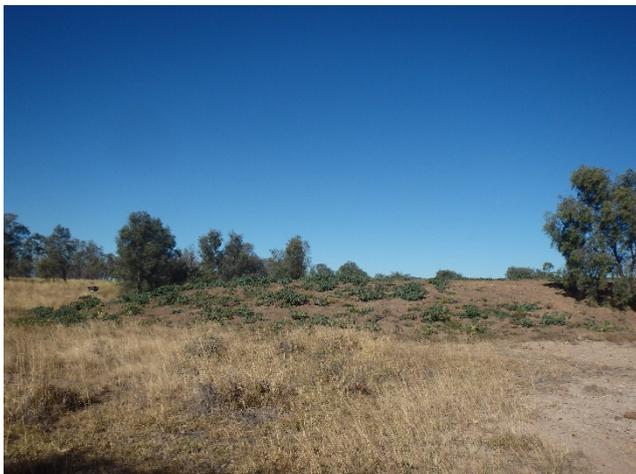
For example, stockpile 5 was originally paddock dumped but has now been shaped and signposted in accordance with the requirements of the MOP. However, significant infestations of thorn apple and fireweed were observed (Figure 5), indicating that further work is required. It was also noted that establishment of a cover crop on this stockpile appeared to have failed (Figure 6) and no evidence of monitoring of vegetation establishment as specified in the approved MOP was provided. These issues are raised as **non-compliance no. 3**.

Figure 5 Weed infestations on stockpile 5

NON-COMPLIANCE NO.	DESCRIPTION OF ISSUE	RECOMMENDATION
3	<p>Stockpile 5 was originally paddock dumped but has been shaped and signposted in accordance with the requirements of the MOP. However, significant infestations of thorn apple and fireweed were observed, indicating that further work is required. It was also noted that establishment of a cover crop on this stockpile appeared to have failed and no evidence of monitoring of vegetation establishment as specified in Section 3.3.6 of the approved MOP was provided.</p>	<p>Implement weed management, establish a cover crop and monitor vegetation establishment as described in the approved MOP.</p>
4	<p>Topsoil from stockpile 6 had been respread over a pasture rehabilitation area across the road from the stockpile. This area was inspected during the audit and was found to be significantly weed infested (galena and thorn apple), in a similar manner to the weed infestations observed on the remaining stockpile. This would suggest that the requirements for topsoil placement and treatment specified in the approved MOP were not implemented. These requirements include <i>'an assessment of weed infestations on stockpiles should be undertaken to determine if individual stockpiles require herbicide application and/or 'scalping' of weed species prior to topsoil spreading.'</i></p>	<p>Implement weed management practices as described in the approved MOP.</p>

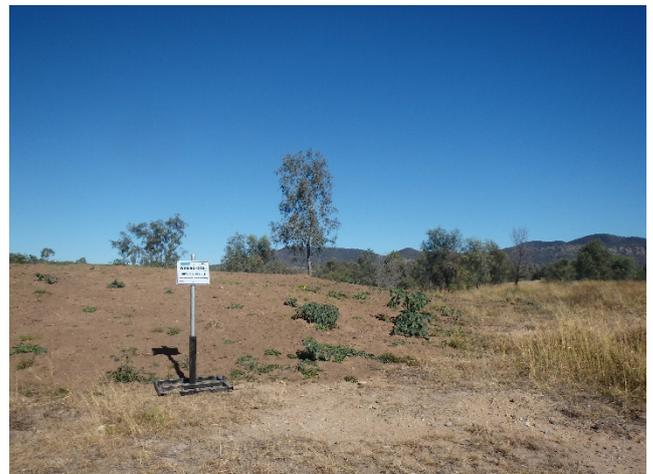
Figure 6 Lack of cover crop establishment on stockpile 5

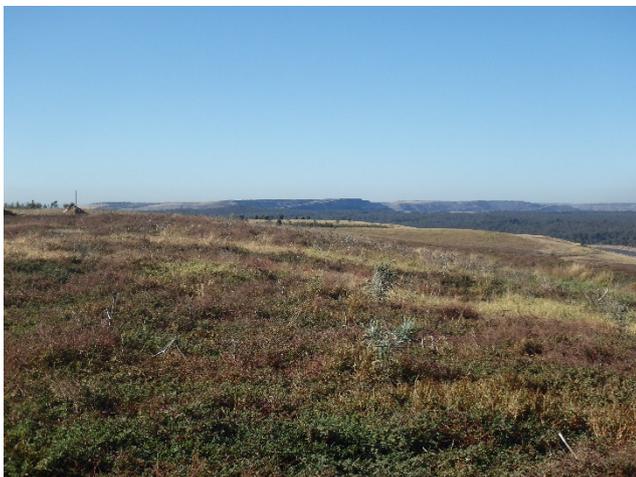
Topsoil from stockpile 6 had been respread over a pasture rehabilitation area across the road from the stockpile. This area was inspected during the audit and was found to be significantly weed infested (galena and thorn apple) (Figure 7), in a similar manner to the weed infestations observed on the remaining stockpile (Figure 8). This would suggest that the requirements for topsoil placement and treatment specified in the approved MOP were not implemented. These requirements include *‘an assessment of weed infestations on stockpiles should be undertaken to determine if individual stockpiles require herbicide application and/or “scalping” of weed species prior to topsoil spreading.’* This is raised as **non-compliance no. 4**.

Figure 7 Weed infestations from respread topsoil on a rehabilitation area

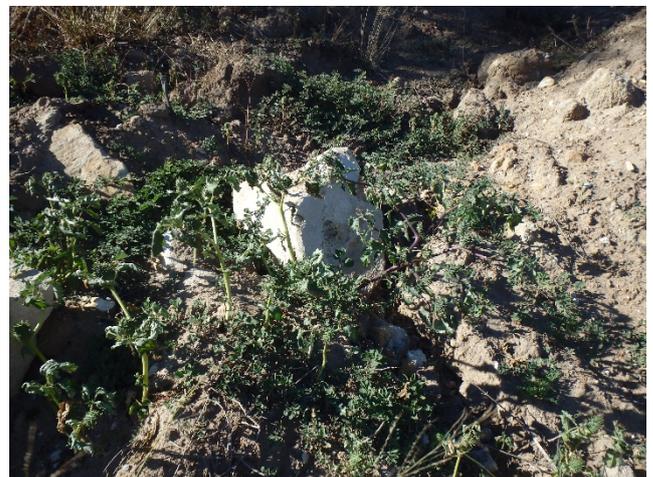
Figure 8 Thornapple weed infestation on stockpile 6, reflected in rehabilitation when respread
