COMPLIANCE AUDIT PROGRAM

# EXCELSIOR QUARRY

Graymont (Excelsior) Pty Ltd

Title: Compliance audit program: Excelsior Quarry, Graymont (Excelsior) Pty Ltd

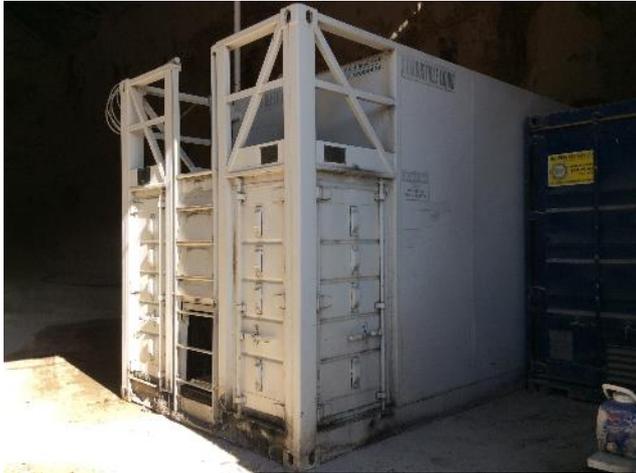
- Water management areas – diesel tank is double bunded and spill kits are kept on site (also noted in Section 3.2.22)– the self-bunded diesel tank and spill kits were observed in the plant area (Figure 1 and Figure 2).

Figure 1 Self-bunded diesel fuel storage tank

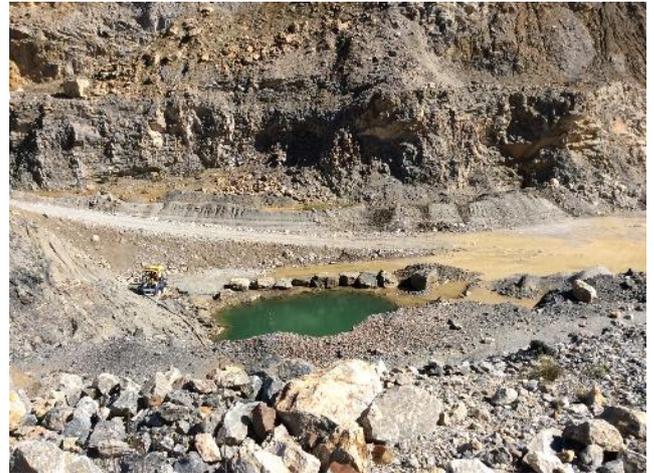
- Accumulated water in the pit is pumped to the wet quarry for use in dust suppression – a pump was observed in operation at open cut pit no. 1 (Figure 3).

Figure 3 Pump operating to pump water from open cut pit 1 to the wet quarry

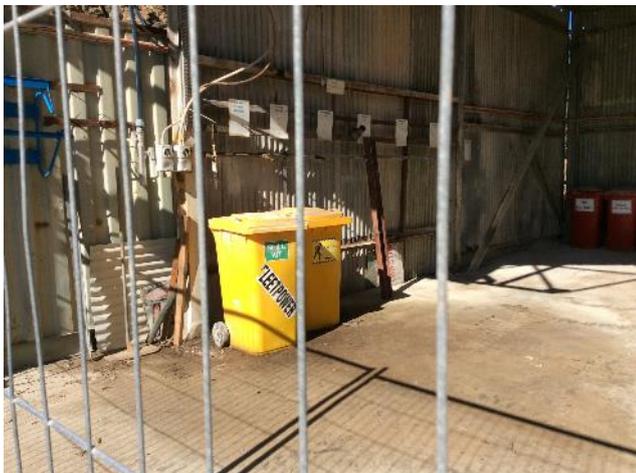
Figure 2 Spill kits in the mobile plant workshop

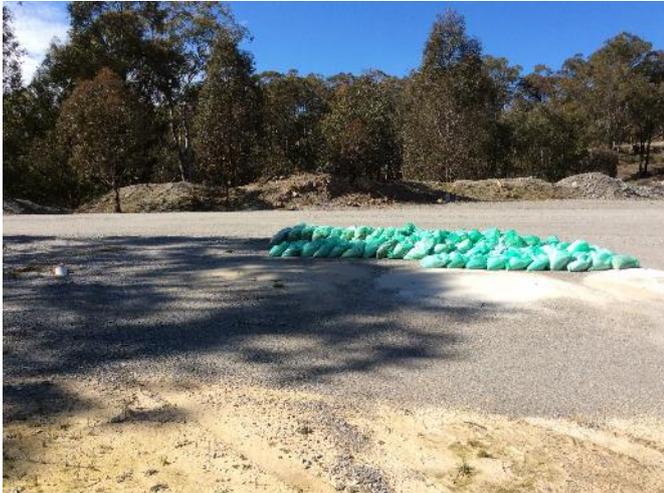
It was observed that a drilling program had been undertaken in April 2020. These sites have not yet been plugged or backfilled, but the drill collars had been capped. Sample bags were still on site at the drill holes inspected (Figure 4). The plastic sample bags will deteriorate over time when exposed to the weather, so it is recommended that Graymont collect the sample bags for storage or disposal. This is raised as suggestion for improvement no. 1.

Figure 4 Capped exploration borehole and sample bags

- the sample bags would be collected for storage or disposal as recommended in suggestion for improvement no. 1
- amendments had been made to the site inspection checklists as recommended in suggestion for improvement no. 2 with this revised checklist also being rolled out to other Graymont sites to improve routine inspections.

SUGGESTIONS FOR IMPROVEMENT	DESCRIPTION OF ISSUE
1	Sample bags were still on site at the drill holes inspected (Figure 4). The plastic sample bags will deteriorate over time when exposed to the weather, so it is recommended that Graymont collect the sample bags for storage or disposal.
2	The checklist for the monthly inspection primarily has a work health and safety focus. Some basic environmental checks were included but the checklist does not address all the commitments of the MOP. As suggestion for improvement no.1, it is suggested that the monthly inspection checklist be reviewed and revised to include a more comprehensive range of environmental checks in accordance with the MOP requirements.

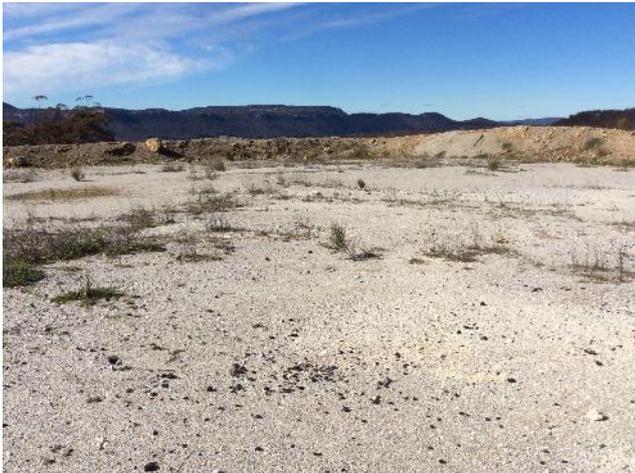
*Figure 5 Capping on the dical storage area*

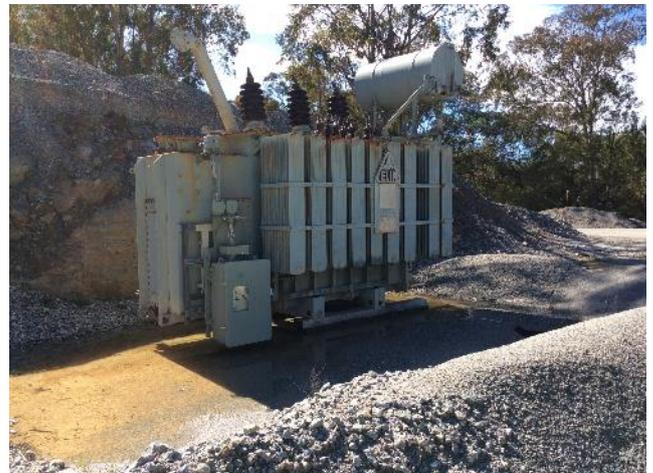
A large electrical transformer was observed in the product stockpile area. This had been banded and Graymont staff advised that the transformer had been drained of oil prior to being decommissioned. There was no evidence of leakage or contamination from the transformer observed during the site inspection (Figure 7).

*Figure 6 Decommissioned transformer in the product storage area*
