Technical Report No. CF7

BELLBIRD COLLIERY

The recovery of the No. 1 Tunnel following an underground fire

J. G. BAILEY

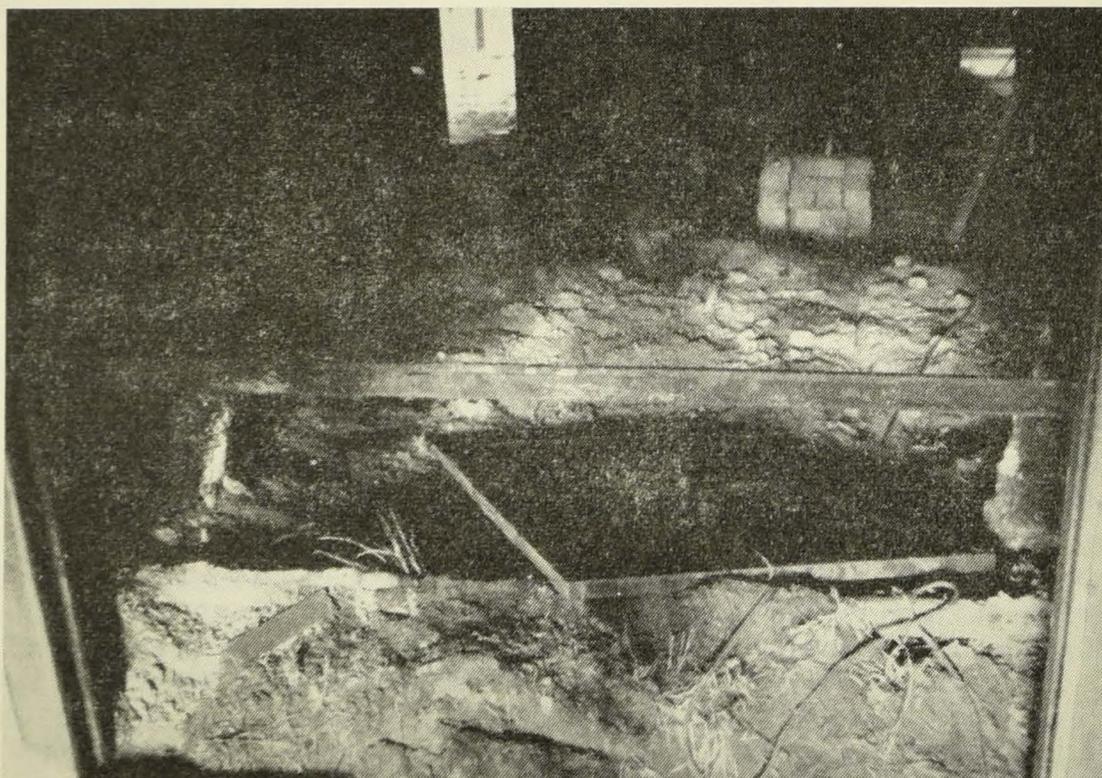
Work then began to complete the seal over the upcast shaft by covering the planks with brattice and applying 6 inches of loam. When this was completed, the fan was stopped. The time was 5 a.m. on 22nd December, 1963.

Seal over upcast shaft. (24th December, 1963.)

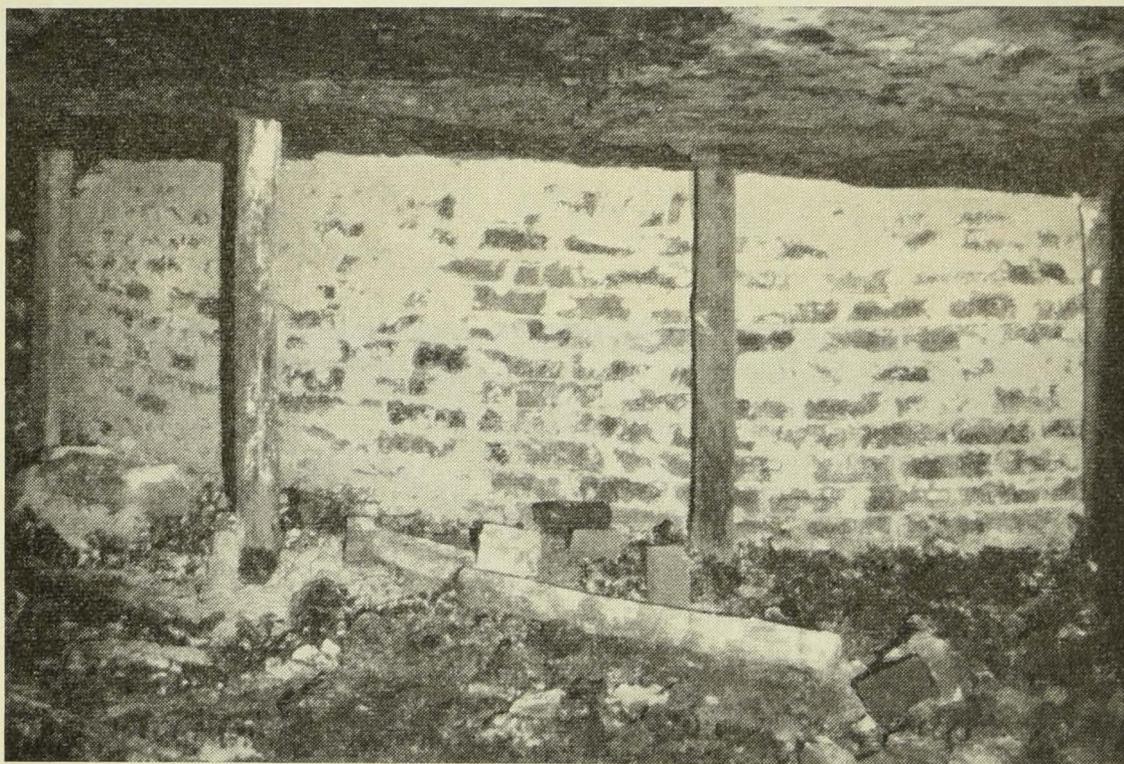
Seal at C. (11th March, 1964)

Seals A, B and C.	Intact.
Seal D	Completely blown down.
Seal E	Overcast completely blown down.
Seal F	Intact and covered with soot.
Seal G	Could not be clearly seen, but appeared to be intact.
Seal H	No trace of original masonite/urethane seal. Outbye brick seal visible. Evidence of second fall of 12 in. to 18 in. coal probably due to second fire.

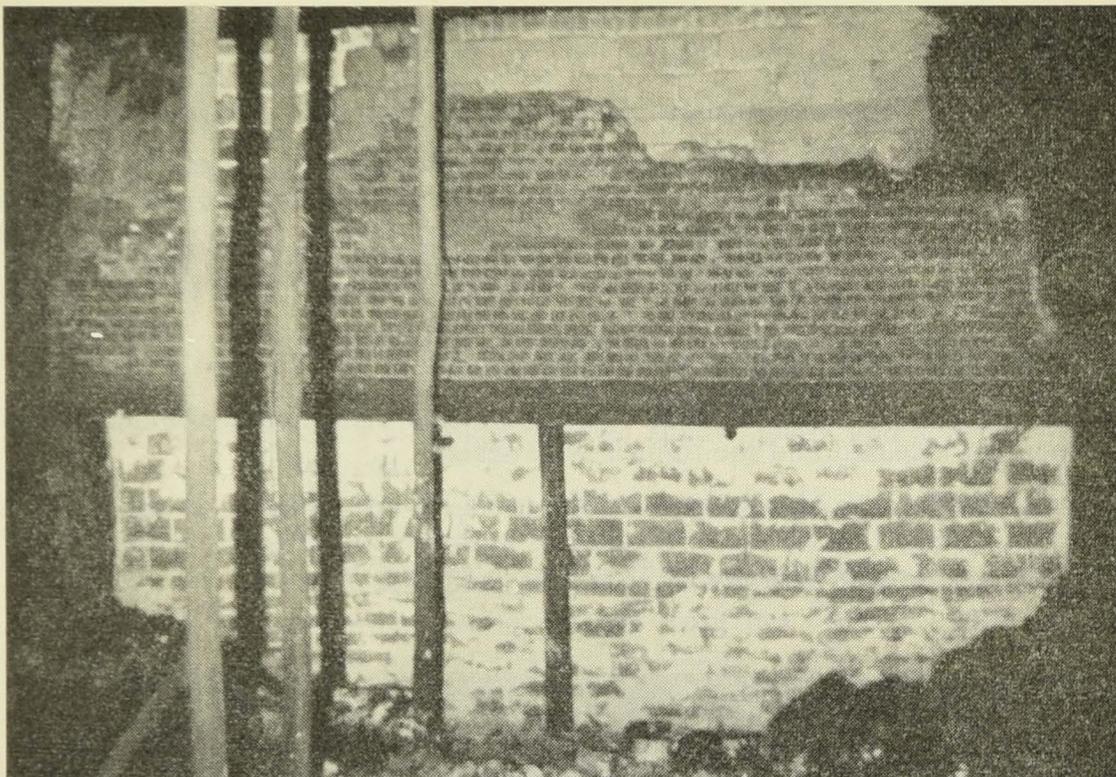
| Seal E | New brick seal under existing overcast. |

Seal at E under overcast. (11th March, 1964)

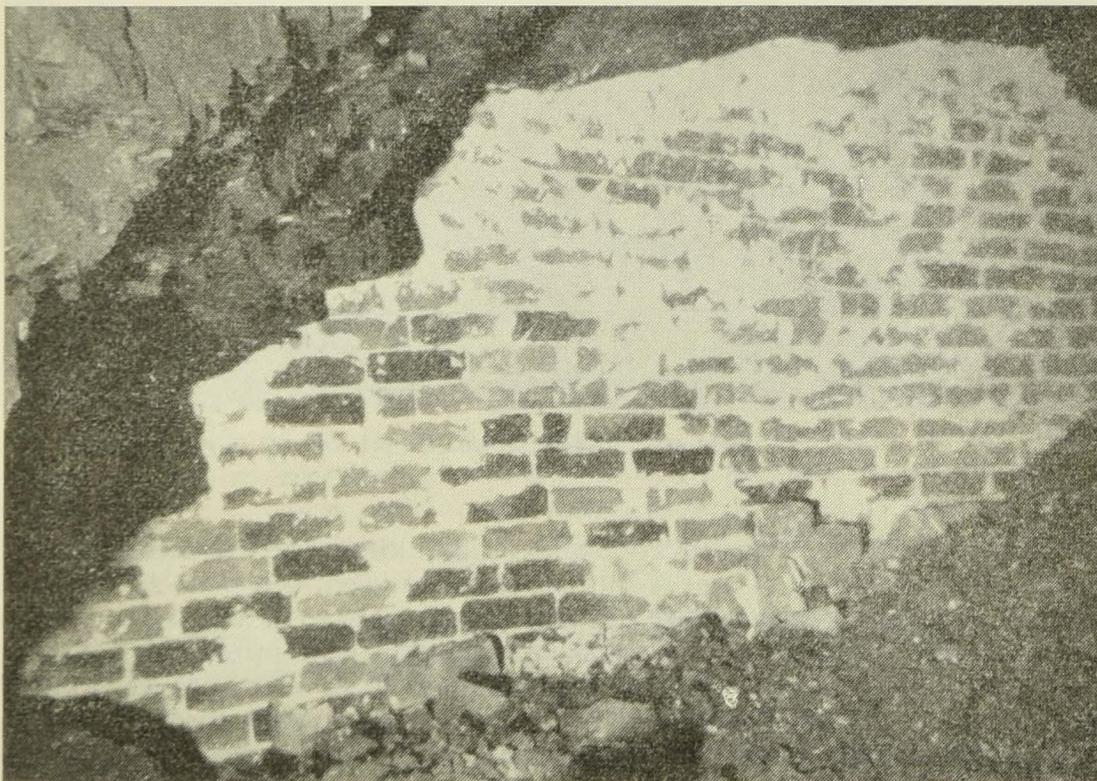
Seal at F. (11th March, 1964)

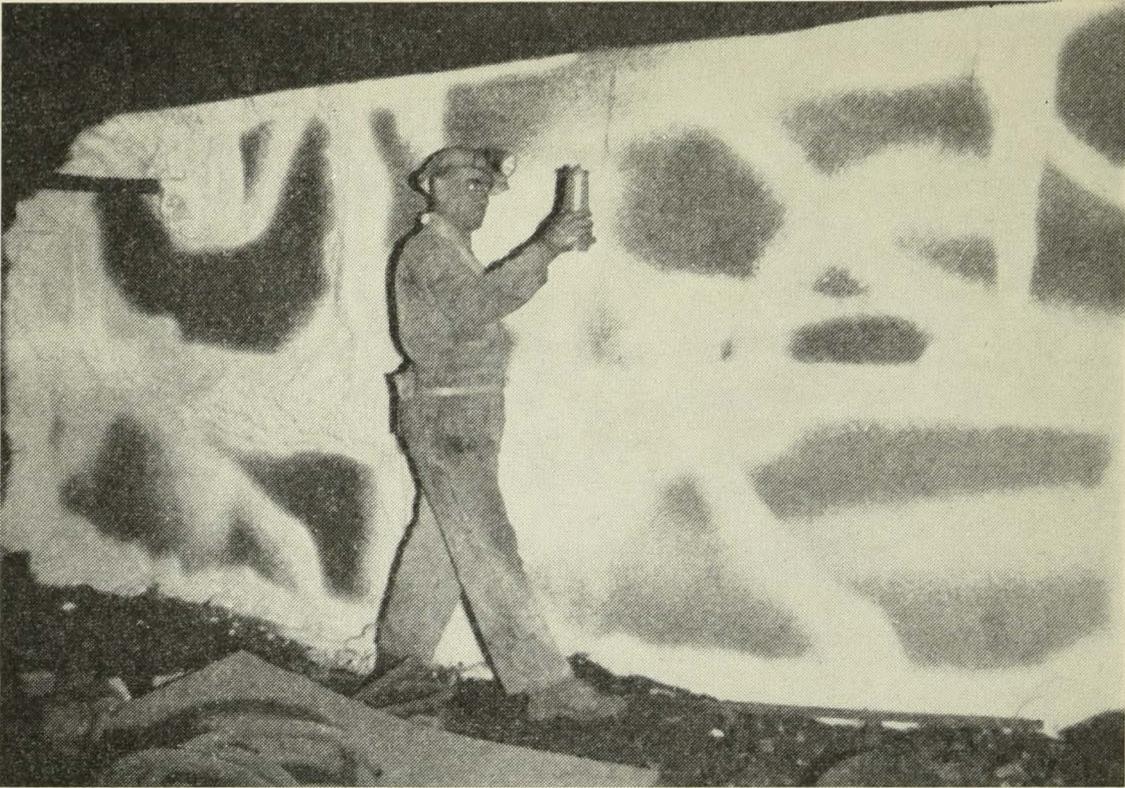
- Seals G, H and I. New seals of masonite and brattice secured to a timber frame and sprayed with urethane rigid foam.
- Seal J Existing brick seal repaired.
- Seal K This seal site was almost inaccessible due to extensive falls of top coal and stone. A stowed pack of stone and fine coal was constructed under a remaining bridge of top coal at this location to relieve the reclamation teams of the arduous task of carrying bricks and mortar to the location.

Seal at G. (11th March, 1964

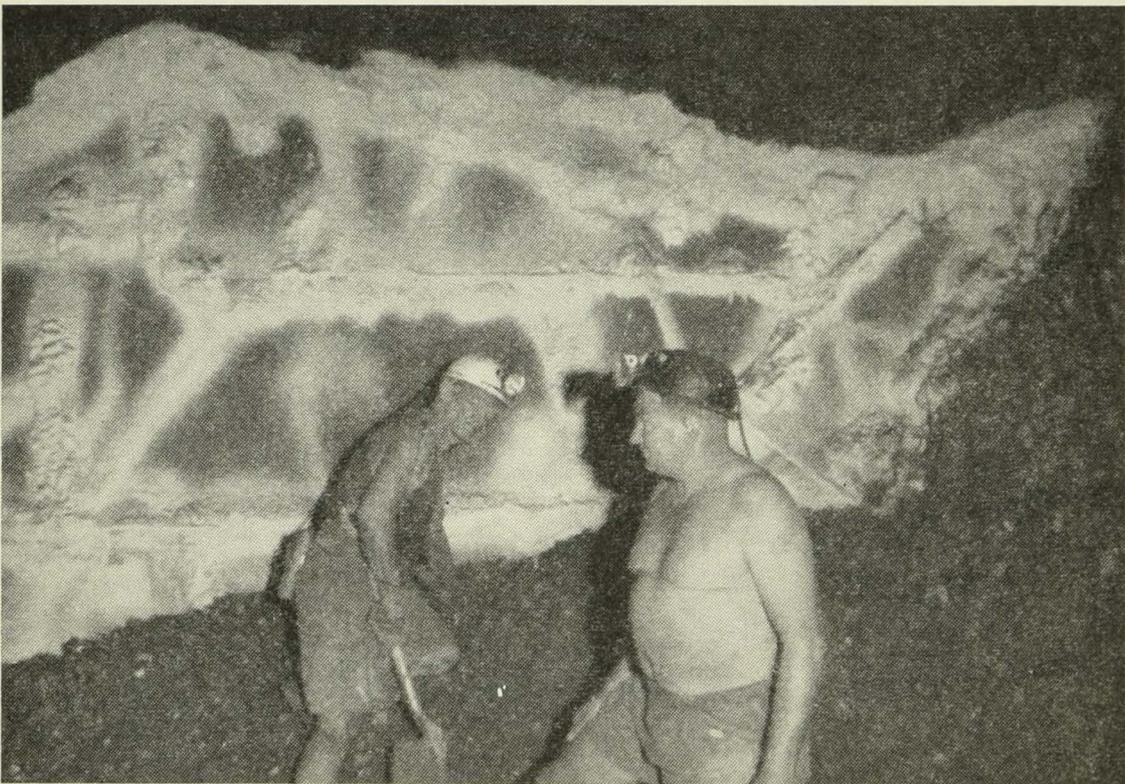
Seal at H. (11th March, 1964)

A large heap of top coal at the intersection outbye of the seals G and H was giving off a small quantity of white smoke. It was impossible to hold a piece of coal from the surface of this heap in the hand. Roof conditions generally, in this area showed signs of deterioration with one major fall up into the stone.

The second outbreak of fire appears to have been a reactivation of the original conflagration. Evidence of heated coal was apparent in the vicinity of the temporary seal H and it is likely that a fire could have developed at this point and consumed the temporary seal. It is also likely that a small fall in the goaf area may have resulted in the breaching of two or more temporary seals. These seals were about 25 feet wide and 18 feet high and prone to such damage. The resultant air circuit would easily reactivate the fire.

All the reclamation personnel began work to erect a 16 in. brick seal outbye of temporary seal H. This involved the transport of bricks and mortar, the removal of 6 ft. of loose coal to expose the seam floor and the laying of the concrete blocks. When work ceased at 5 p.m. that day, about one-quarter of the bricks necessary for the 12 ft. high seal had been set.

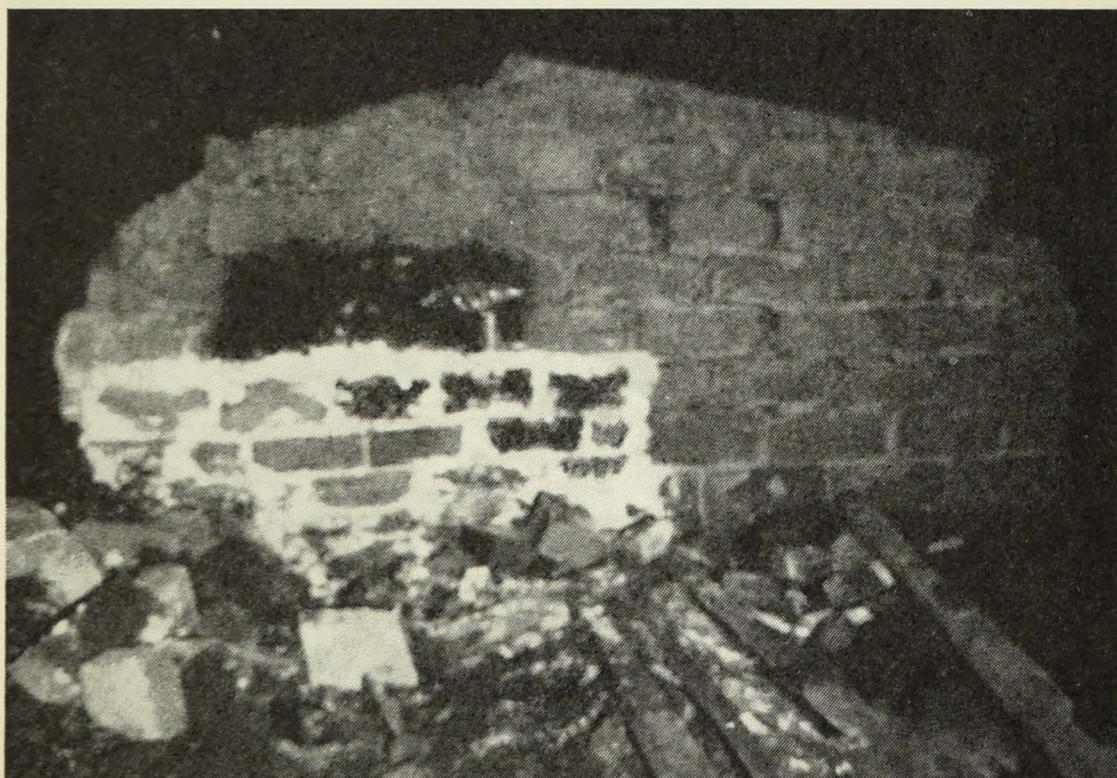
Seal at J. (11th March, 1964)

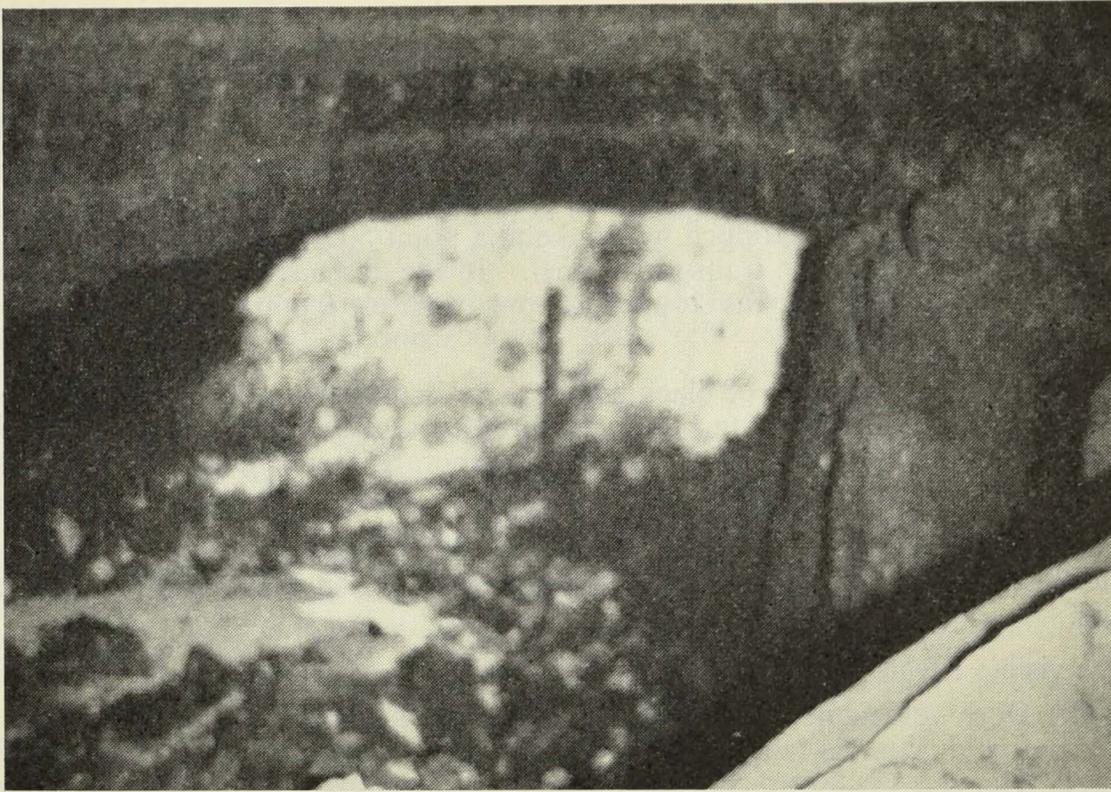
Stowage pack at K. (11th March, 1964)

During the day, the stowed pack at location K was supplemented with additional material and covered with stone dust. This seal was observed to be leaking when completed but was not considered to be excessive. Work also continued with the brick seal at H and when work ceased for the day, was within 2 ft. of the roof. The temporary masonite seal H remained at approximately blood temperature, and during the day a sulphur smell was detected and attributed to the dust in suspension caused by the workmen in this vicinity.

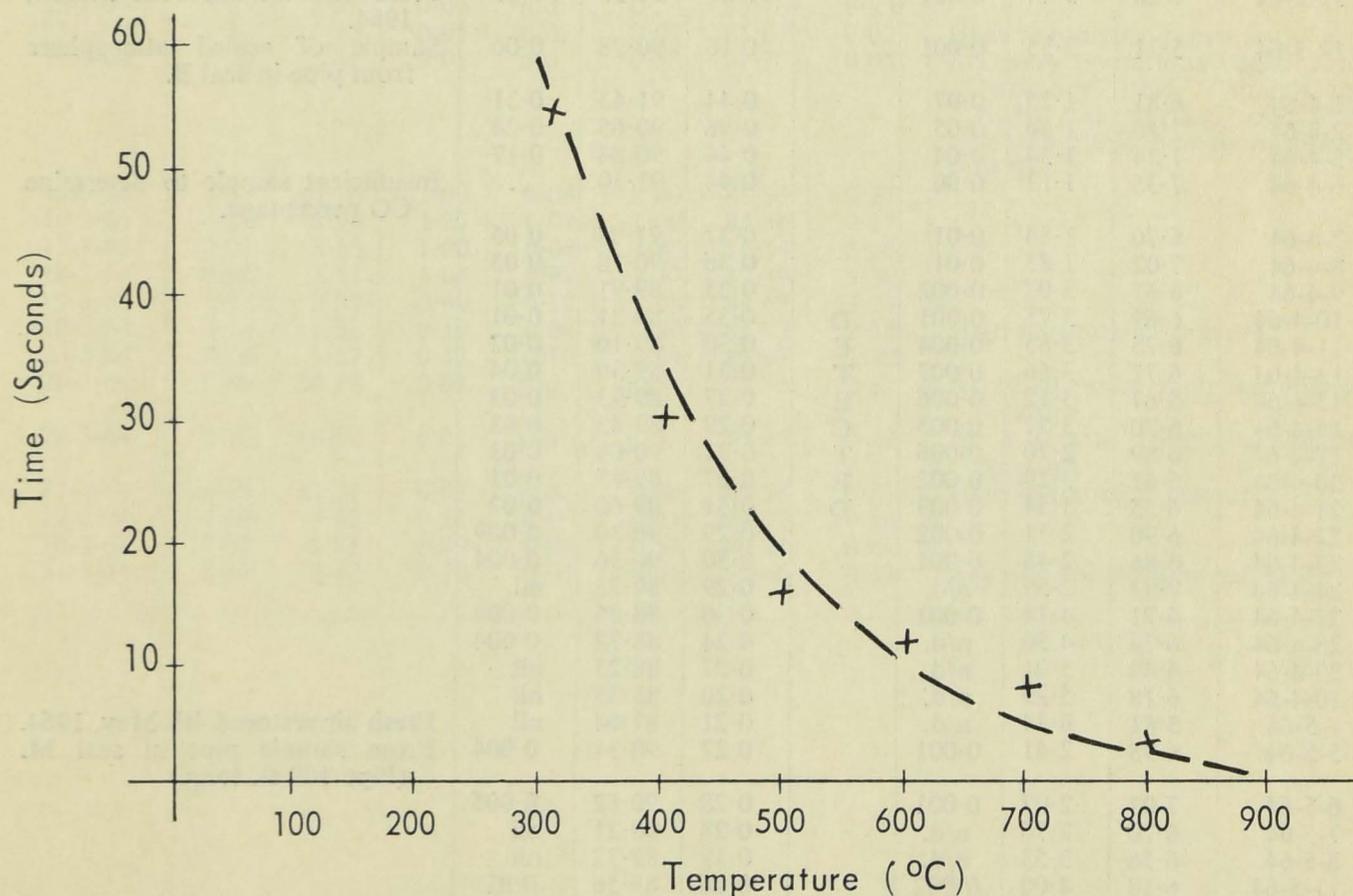
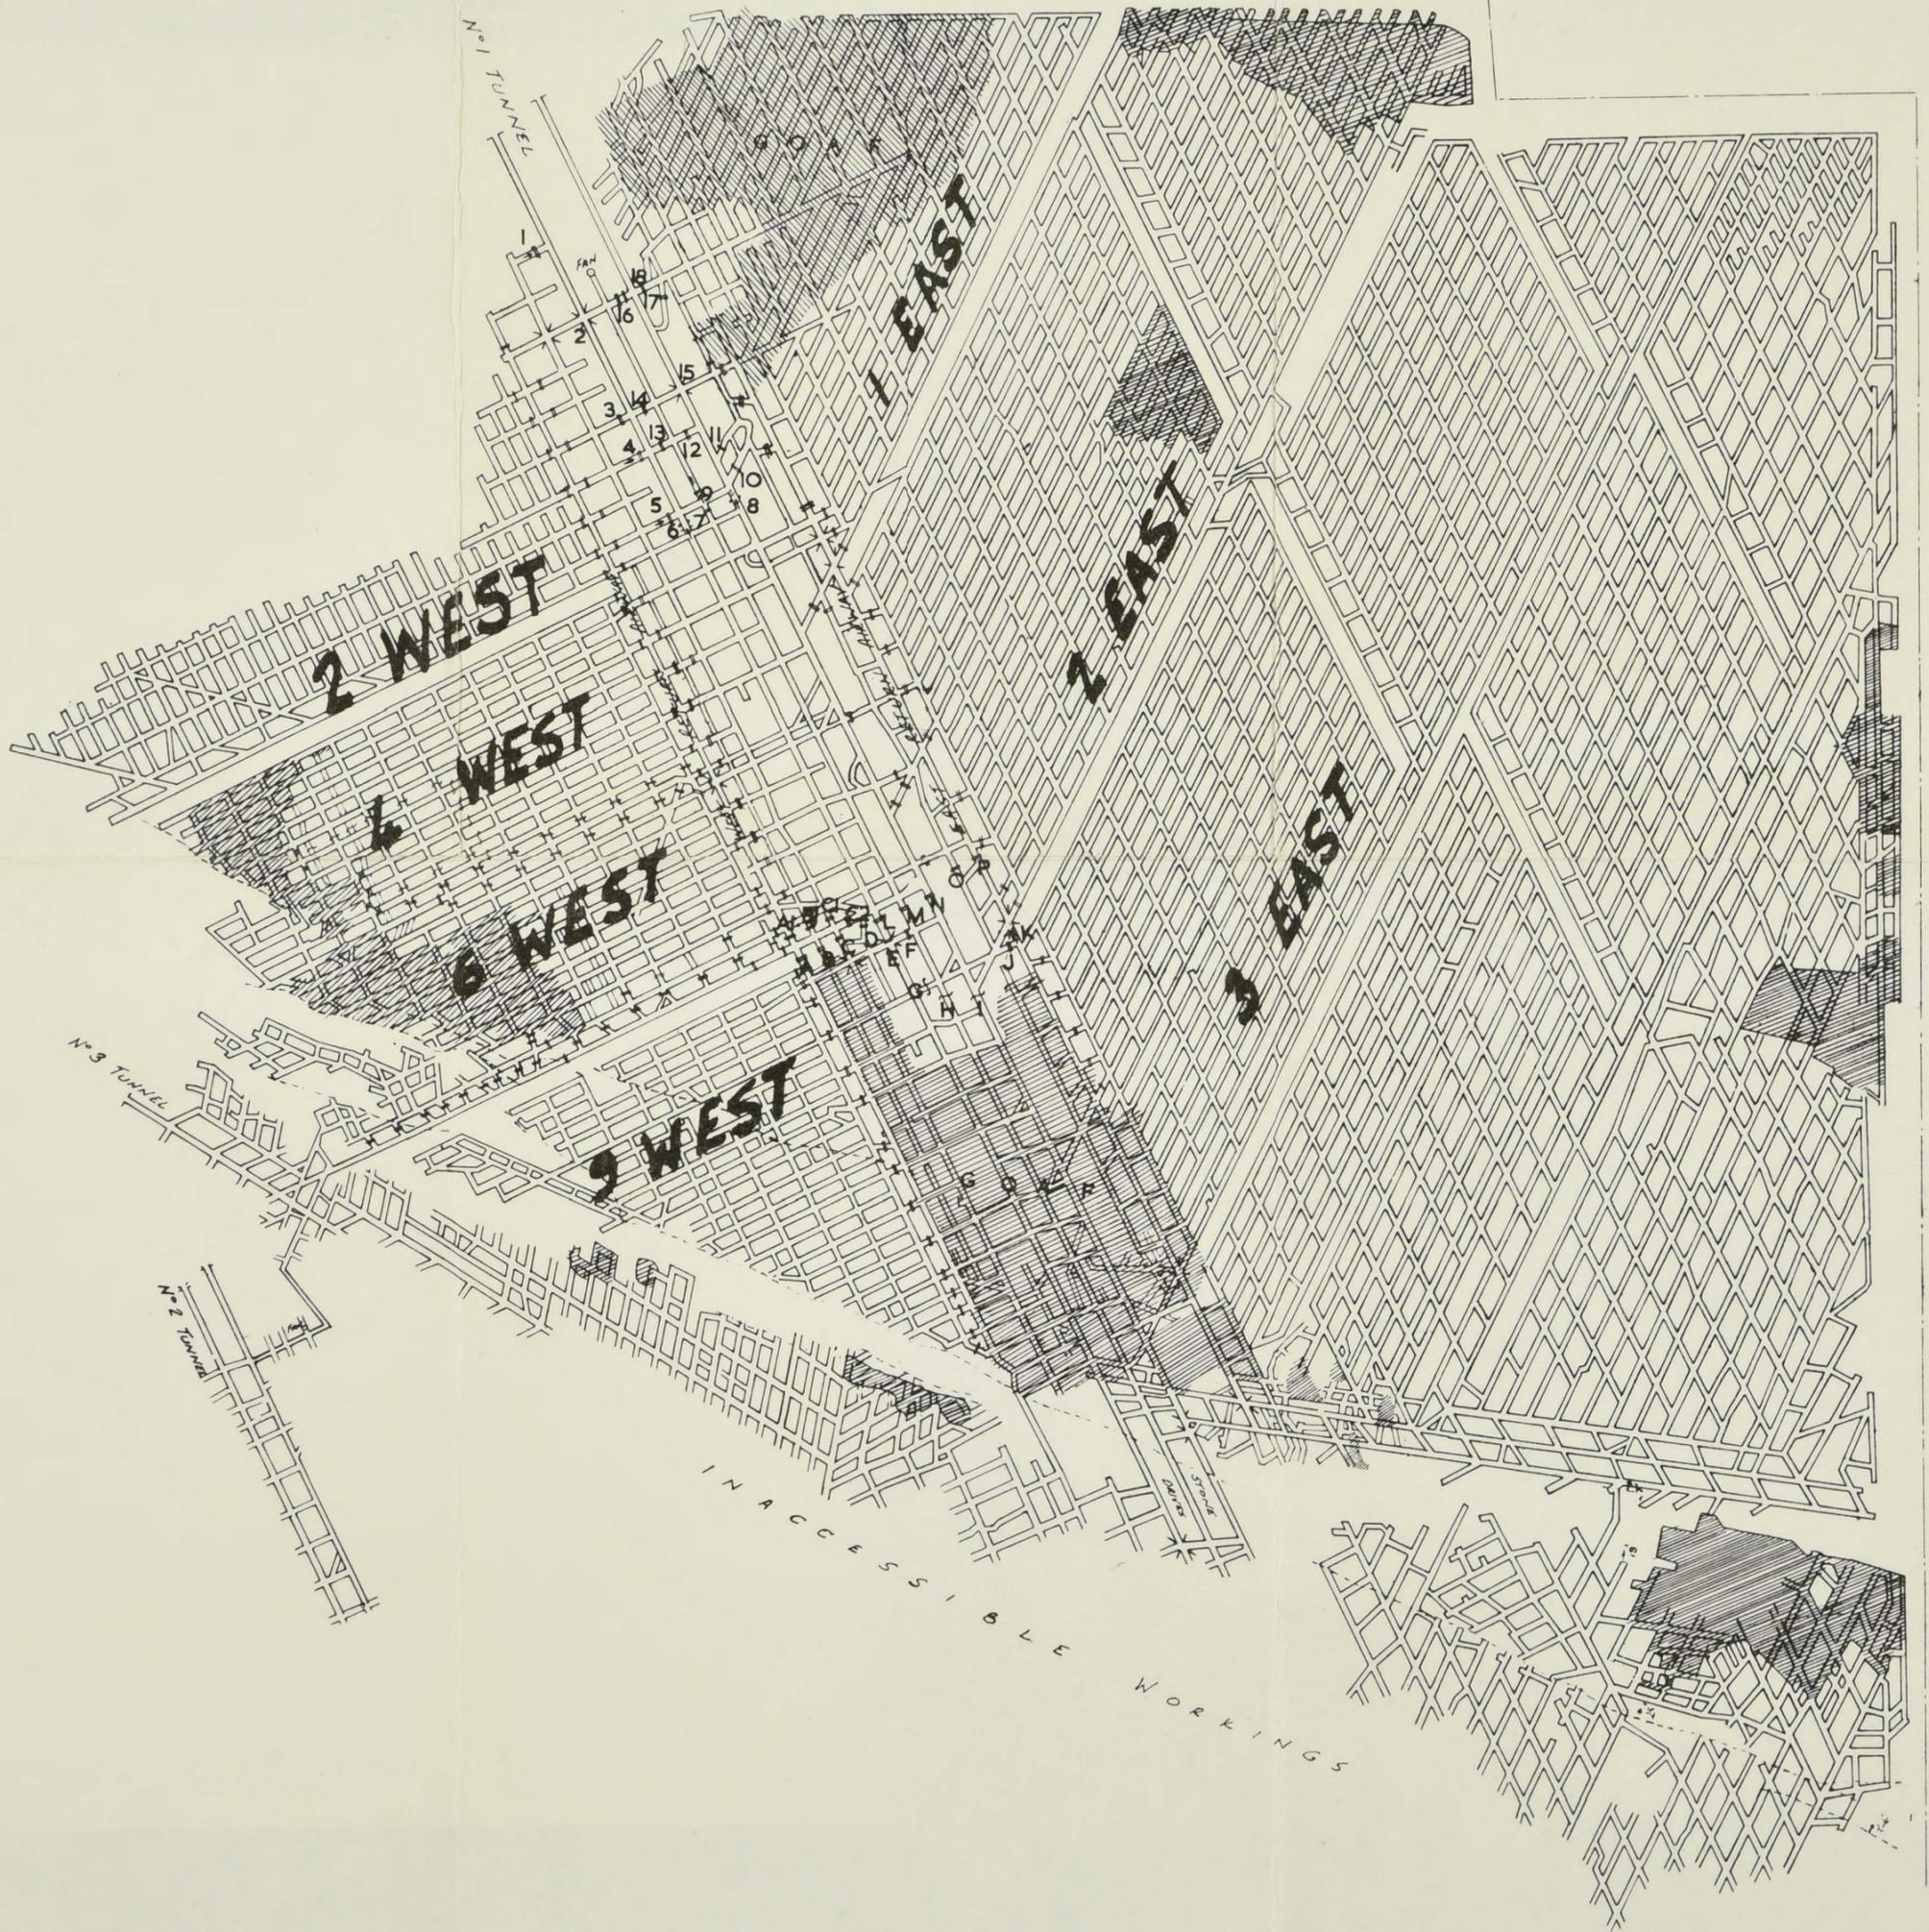
PLAN OF PART OF
BELLBIRD COLLIERY.

An inspection of the tunnel was made on 31st March, 1964 using self-contained breathing apparatus. Damage observed mainly concerned the recently erected brickwork, and was as follows, reference being made to the accompanying plan:—

A subsequent inspection revealed seal No. 9 to be completely blown down and the remaining seals to be intact. The small arrows on the plan indicate the direction of the blast at each seal.

Work began immediately to restore these damaged seals and was completed by the recovery team on 5th April, 1964 organised in the same way as for the previous operation, with the exception that all seals were now in concrete blocks.
