**NSW
Resources
Regulator**

COMPLIANCE AUDIT PROGRAM

JANUARY 2017 TO JUNE 2018 REVIEW

July 2019

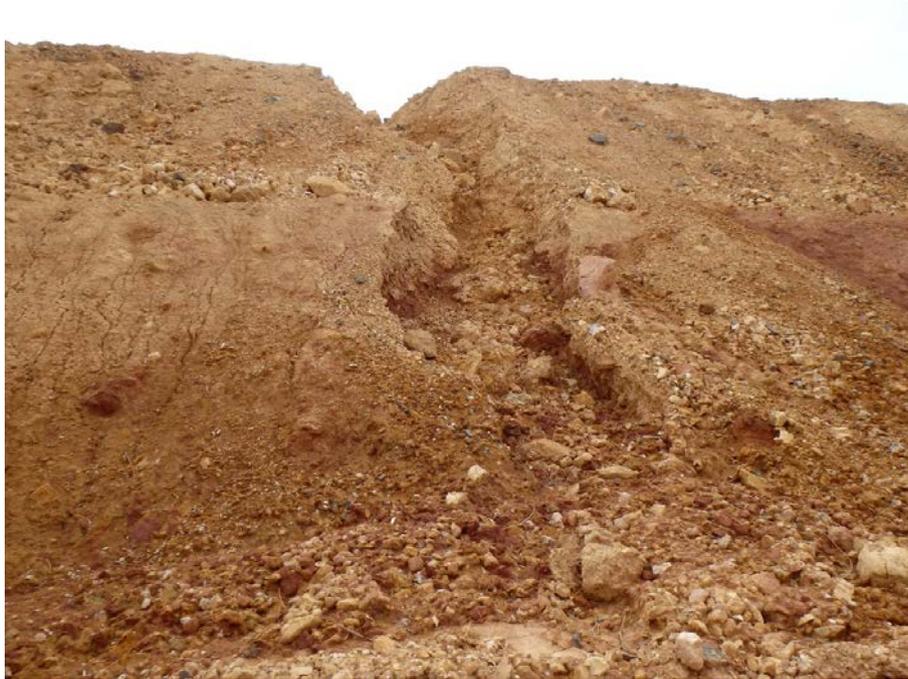
Site inspections of each of the tailings dams did not identify any issues (e.g. erosion of dam walls, excess vegetation, seepage) that had not already been identified by the mine during routine inspections. For example, at one mine, it was observed that there were some large erosion scours on the buttress walls (refer to figure 1). It was noted that these were identified by the dam engineer in the mine's surveillance report dated April 2018. It stated that the erosion scours were not deemed to be detrimental to the

safety of the dam and were recommended to be monitored until remediation, as part of the closure plan.

Figure 1 Large erosion scour on a tailings dam buttress wall

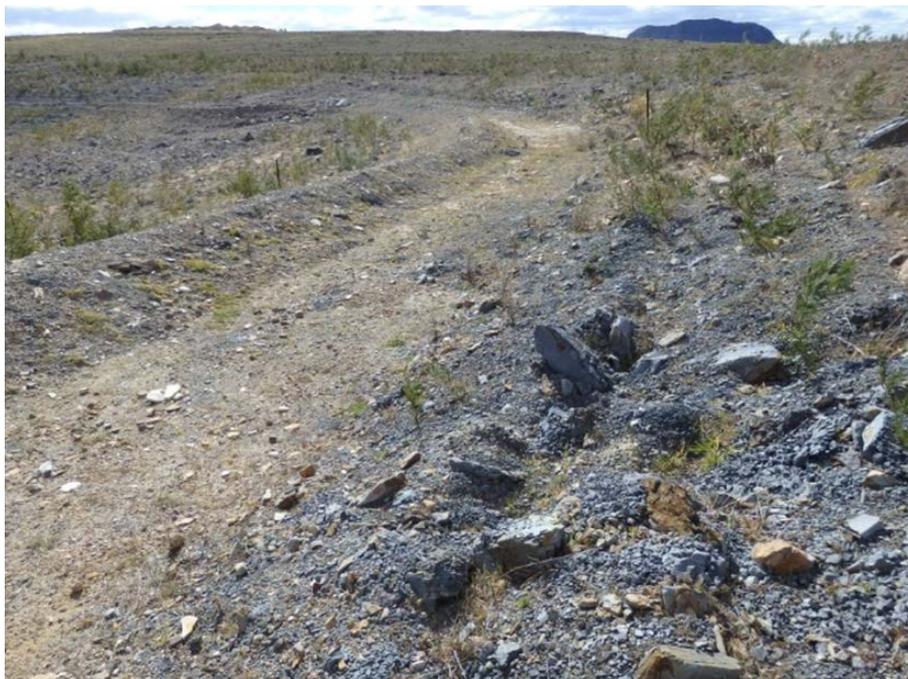
Figure 2 Contour berm at Stony Creek rehabilitation, protecting a slope from erosion

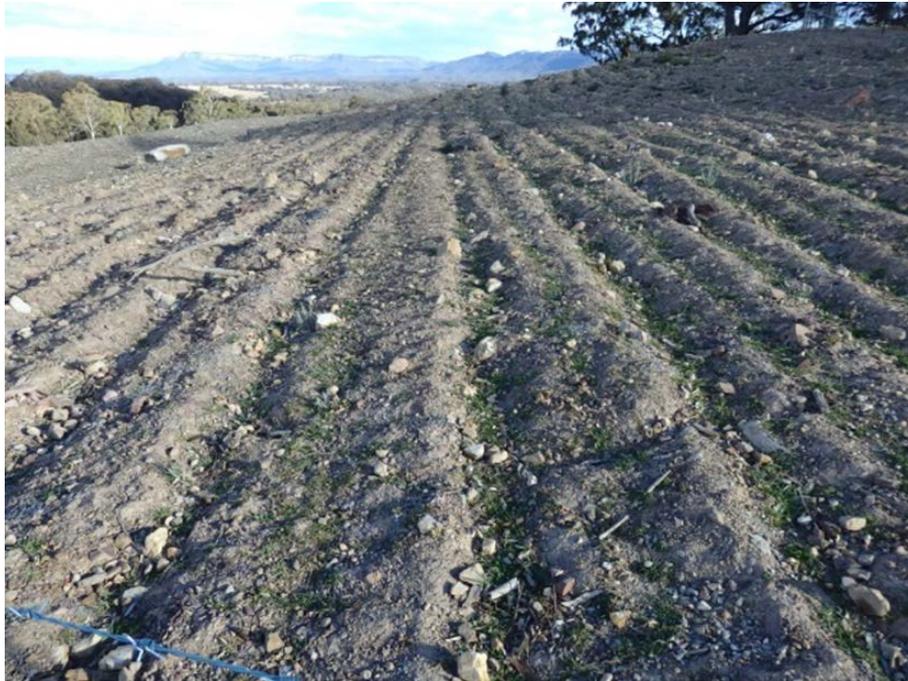
Figure 3 Rip lines on the contour providing protection against erosion and establishment sites for seedlings

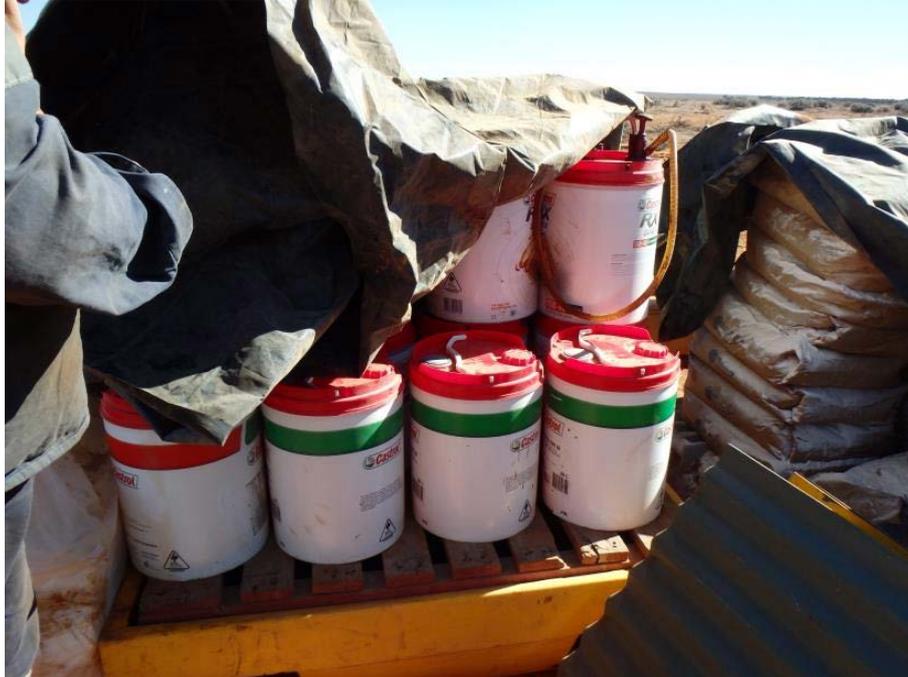
Figure 5 Oil drums stored on a bunded pallet covered with a tarpaulin

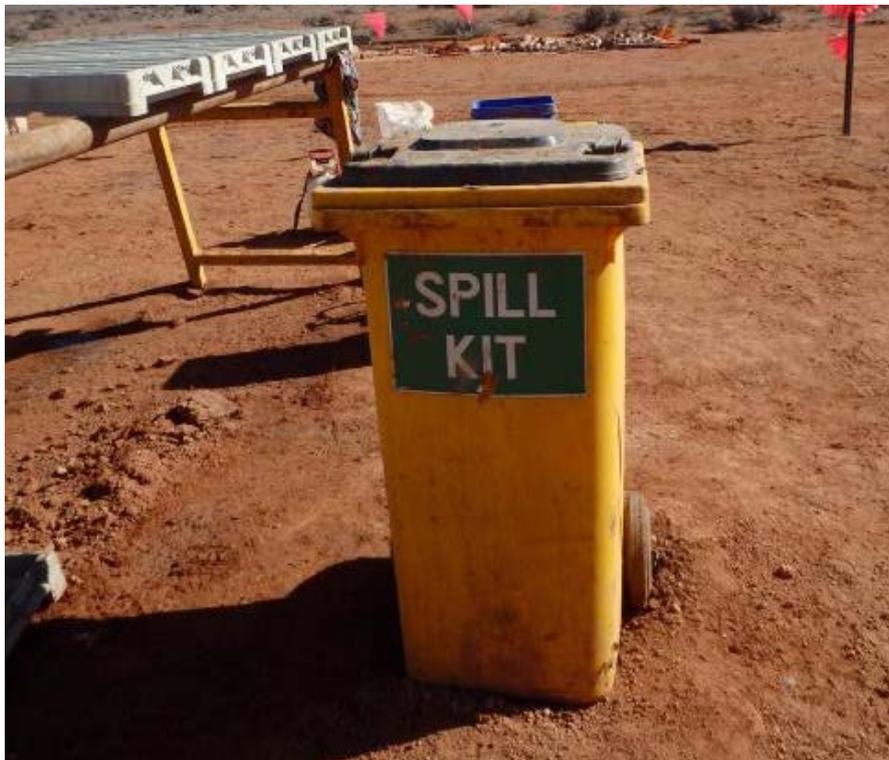
maintained by the driller, along with safety data sheets for each of the products. All products were in original containers, in good condition, and fully labelled. A fully stocked spill kit was also available on site (refer to figure 6) and an interview with drilling staff indicated that they had been trained in the use of the spill kit. Spill control matting was in place under the drill rig (refer to figure 7) and other pieces of plant, to catch any drips or spills of hydrocarbon-based fluids used.

Figure 6 Fully stocked spill kit available on site

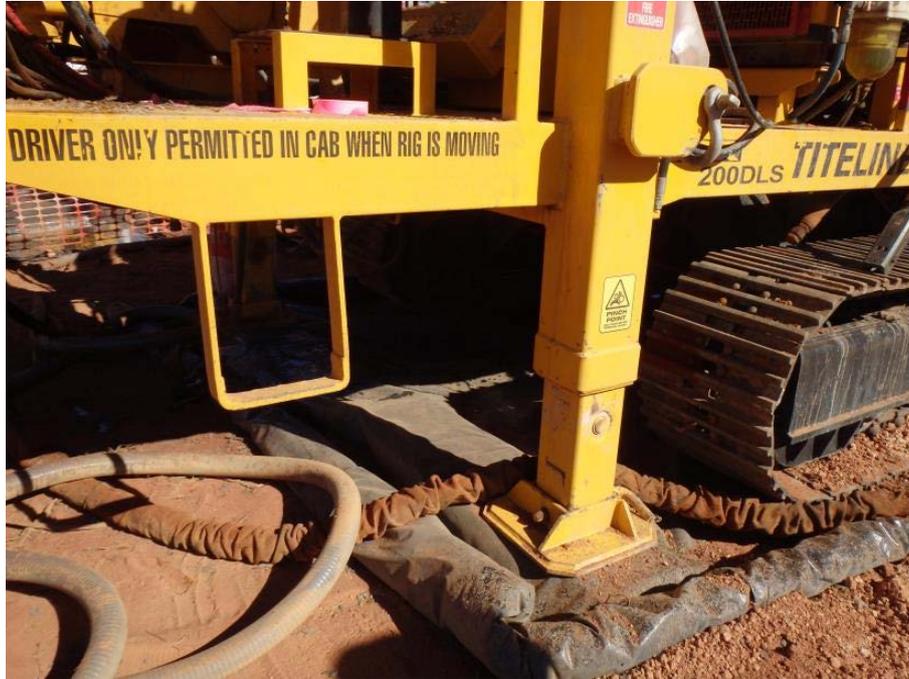
Figure 7 Spill control matting under the drill rig

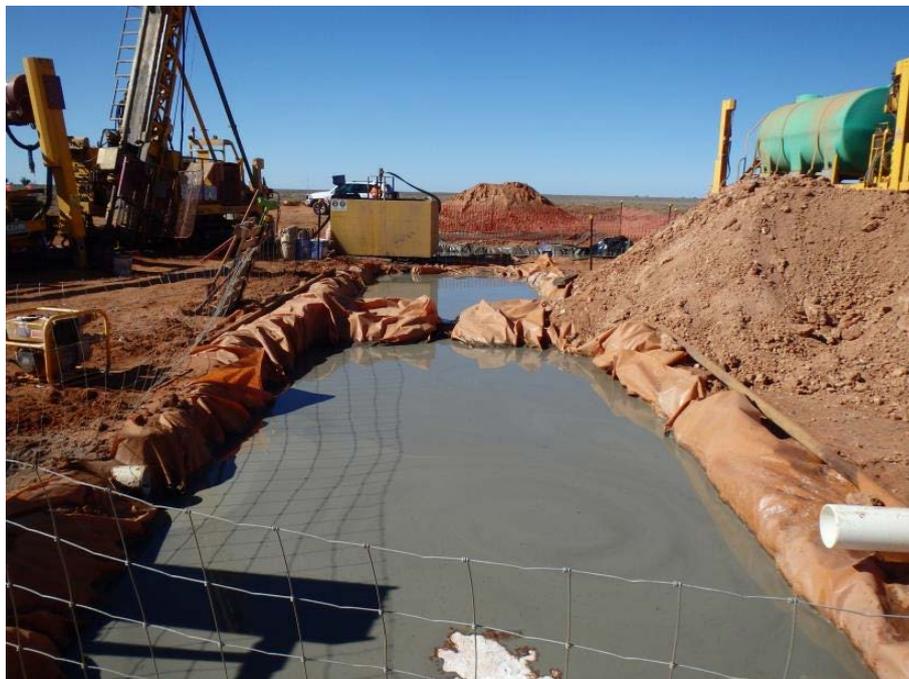
Figure 8 Inground sumps lined and fenced

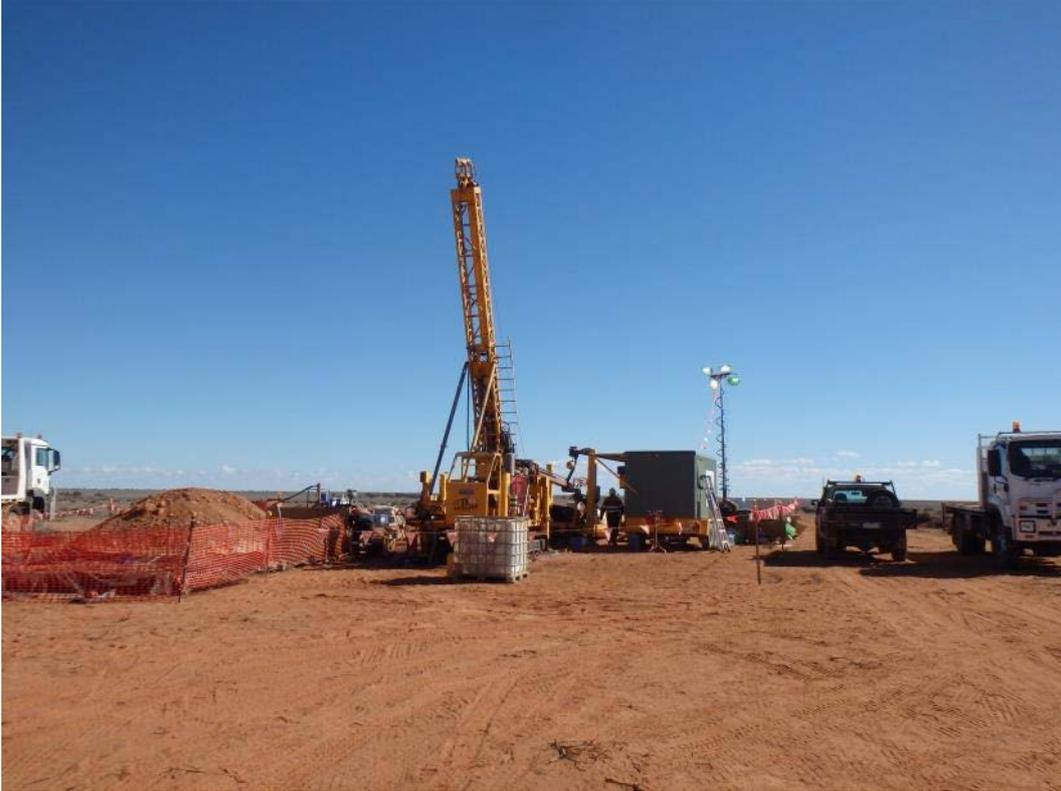
Figure 9 Drill site marked with flagging tape and barrier fencing
