# FIRES ON MOBILE PLANT

April - June 2019

**Mobile plant fires reported during this period include autonomous vehicles and nine underground fires**

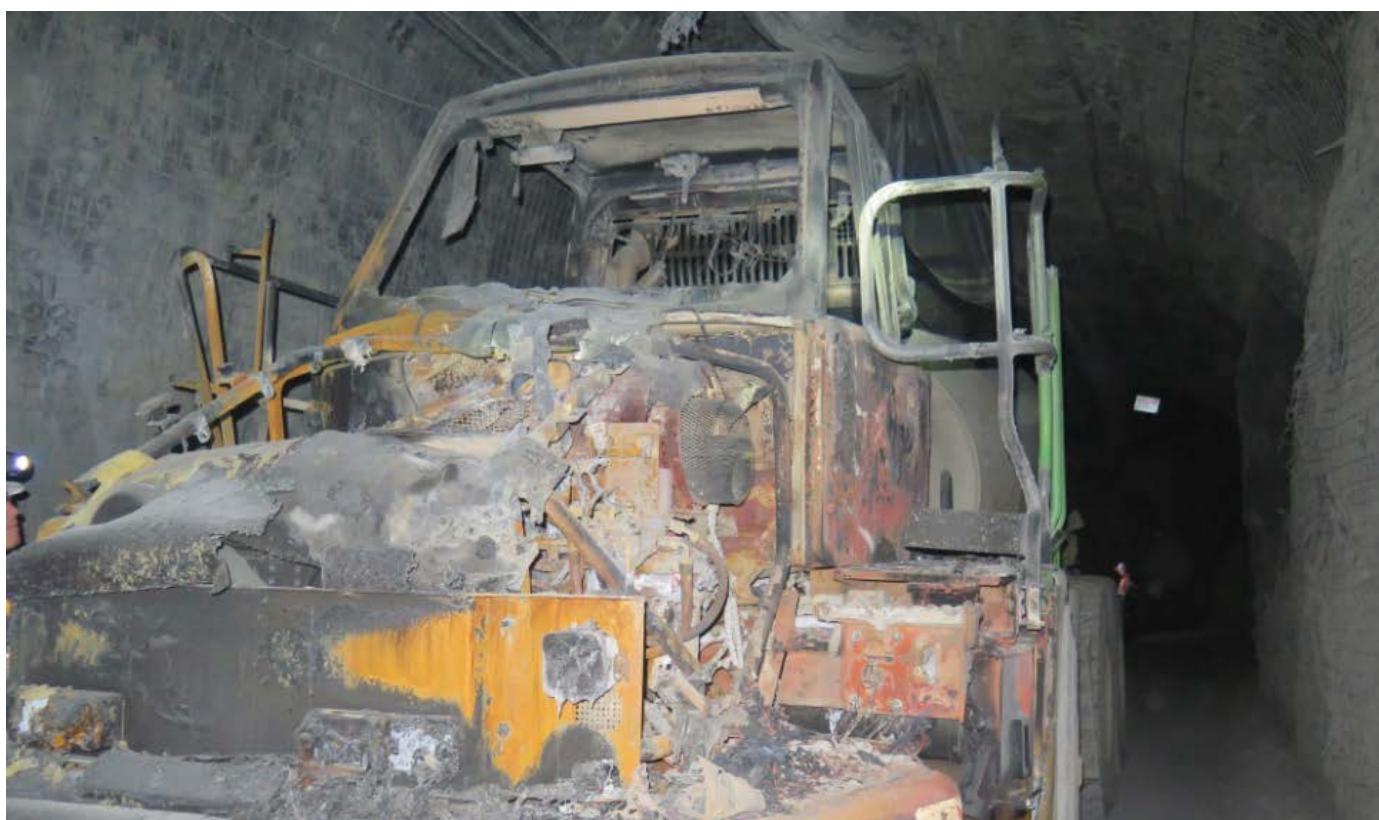
*Figure 1 One of the nine underground fires fuelled by diesel and non-metallic materials*

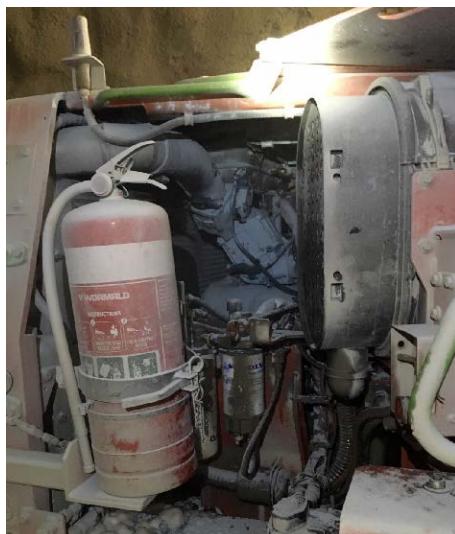
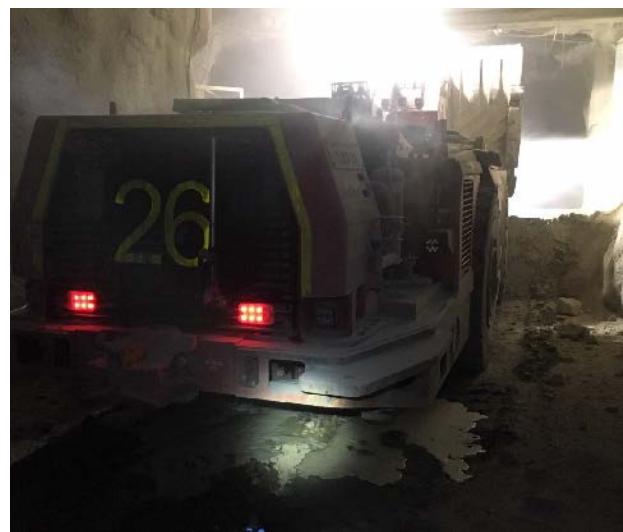
*Figure 8 Northparkes Mine incident*

A remote operator identified that the fire suppression had been discharged. A team leader was nearby and responded to find flames coming from the back of the loader. The fire was extinguished with a hand-held fire extinguisher. An investigation found fuel leaking from a pin hole in a worn fuel line.

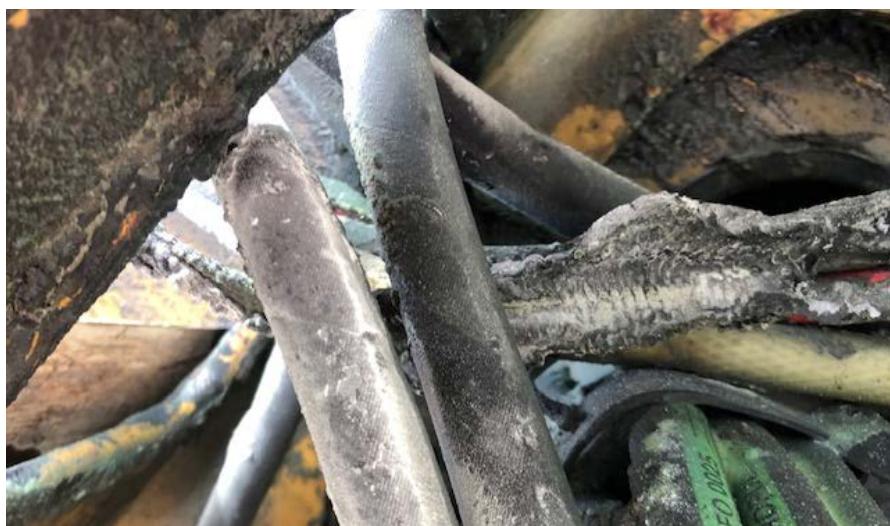
*Figure 9 Bates Quarry incident*

A power cable for a cooling fan rubbed through on the frame of a machine.

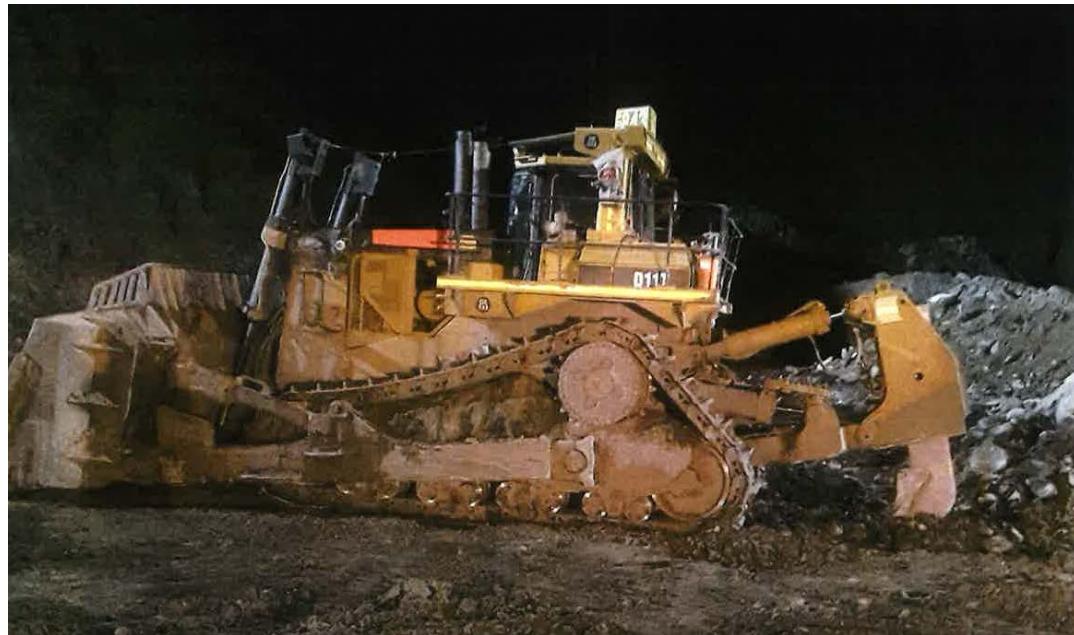
*Figure 10 Tarrawonga Coal Mine incident*

A broken fuel line bracket caused a fuel line to rub. The fuel line developed a leak, which fuelled a fire.

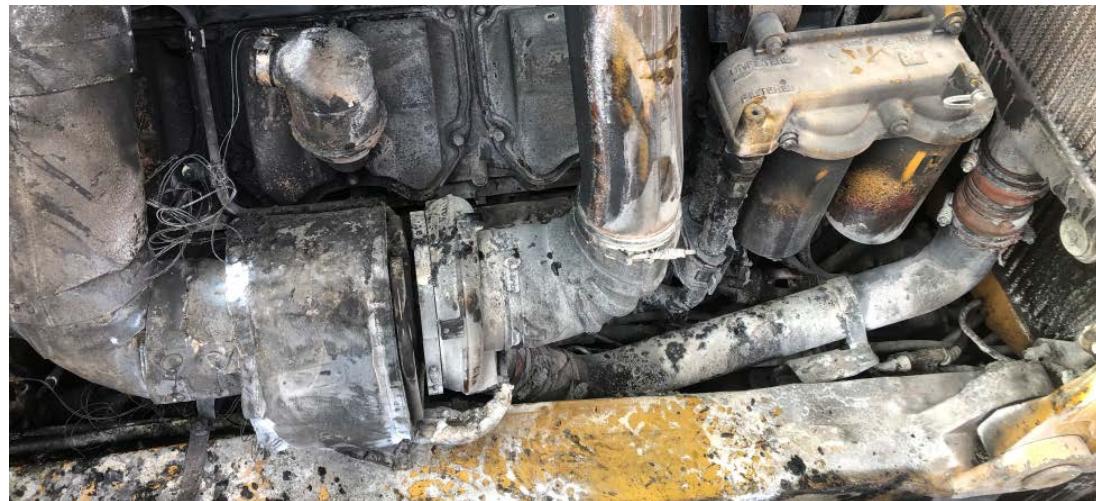
*Figure 11 Wilpinjond incident*

A dozer was operating in autonomous mode. The operator in the SATS caravan had two dozers working. The cameras were on DZ2010, which was behind DZ2002, and two slots to the north. The operator saw flames and smoke coming from the right-hand side of DZ2002. The operator activated the fire suppression system and called emergency. Failure of the blade tilt pilot hose led to the uncontrolled release of hydraulic oil onto the exhaust system.

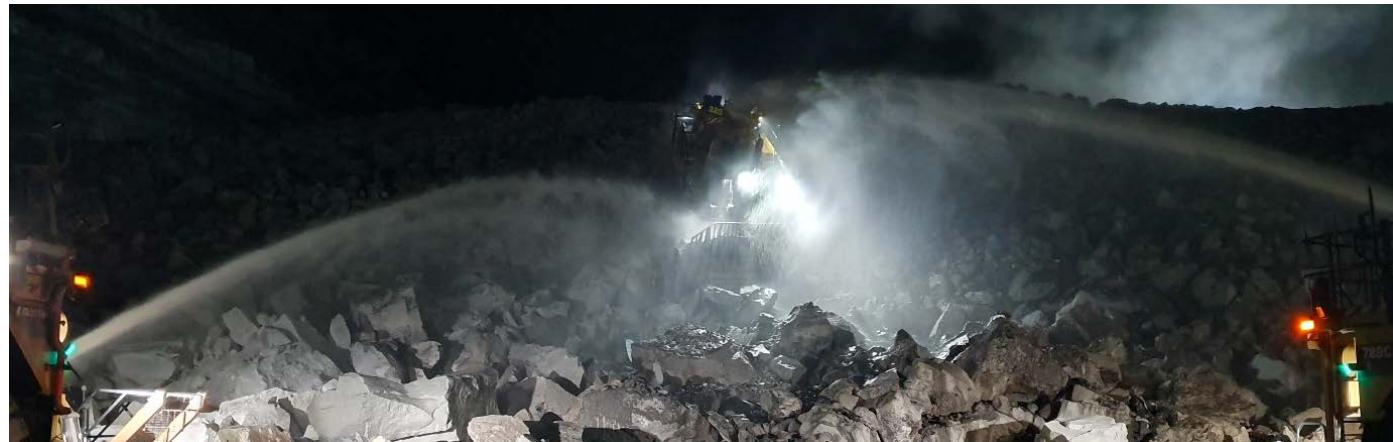
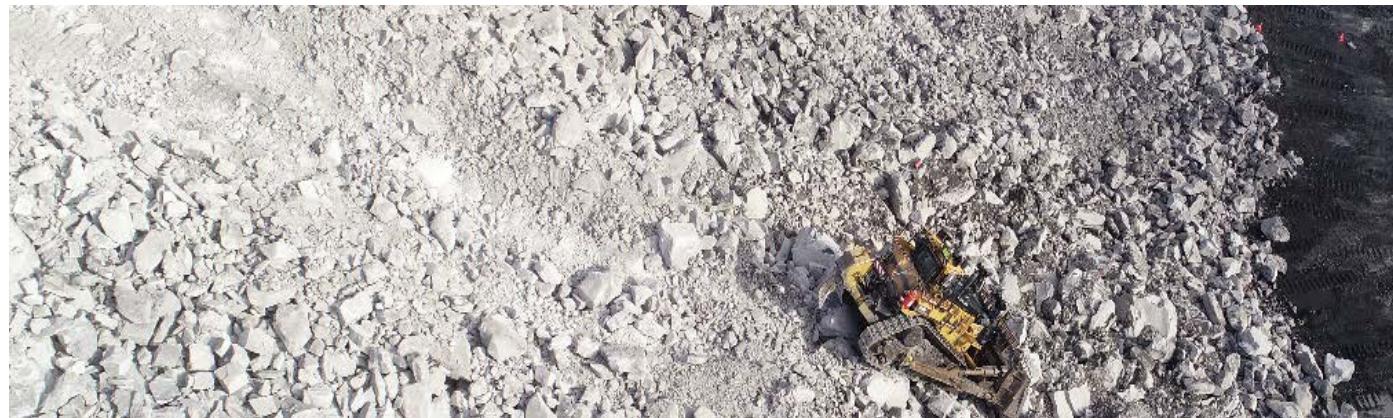
A dozer had pushed past a crest and was some way down a slope when the operator noticed a fire in the engine bay. A decision was made to continue dozing down the slope to the lower level and then the operator was to park up and get out of the dozer. Before getting to the base of the slope, the dozer became caught on a large rock. Once realising that the dozer was stuck, and not knowing how long it would take to free the dozer, the operator activated the fire suppression system and left the dozer.

*Figure 12 & 13 Bulga incident showing the dozer at the bottom of the push (night and day)*

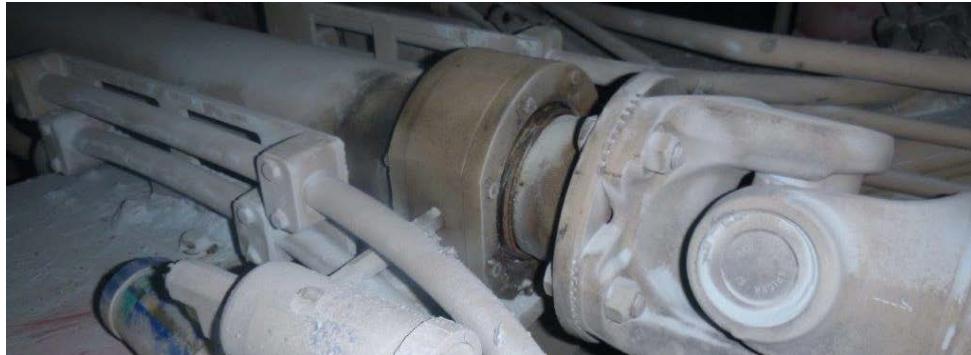
*Figure 13 The Rasp Mine incident*

A loader operator saw a glow emanating from the drive shaft bearing on a Sandvik TH551 ejector truck. Review our [Safety Bulletin – Drive shaft failures causing fires.](#)

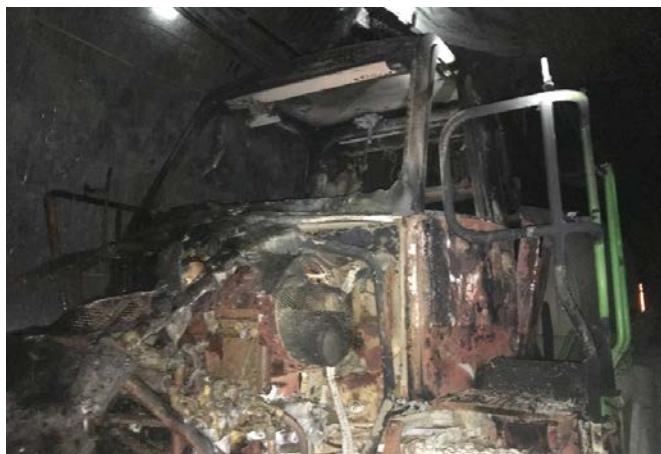
*Figure 14 The Peak Gold Mine incident*

An agitator truck fire, fuelled by a diesel leak, spread quickly because non-metallic engine covers and guards added to the fuel load and the intensity of the fire. Nineteen workers were underground at the time of the incident and had to retreat to refuge chambers while the fire was extinguished.

An agitator truck was taking shotcrete underground. As the truck was travelling up a grade, a Jumbo operator saw smoke coming from the truck. The fire was spreading rapidly as the operator exited the vehicle. He tried to hold the wheel chocks but found them hard to reach. An explosion came from the other side of the cabin, followed by two more. A rock was put under the rear wheel and the operator retreated to safety. The fire suppression system had not extinguished the fire, and the cabin of the vehicle was gutted by fire. After the incident was notified to control via an emergency call, workers went to the underground emergency chambers. Once the fire was confirmed extinguished, the workers were brought out of the mine. Fuel had found its way on to a hot surface and ignited, causing a fire that burnt the cab area of the machine.

The use of non-metallic materials that burn and produce toxic emissions should be stopped or minimised on all mobile plant.

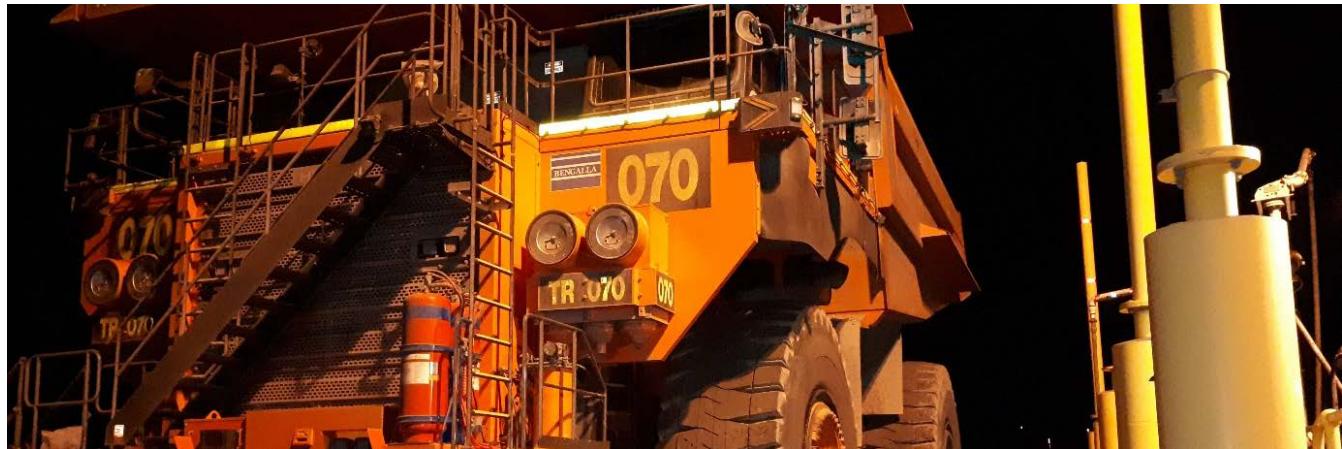
*Figure 15 Bengalla fire incident*

There was a turbo fire on a haul truck while it was parked at a fuel farm. There was a split in the Teflon® liner of a rear right-hand side turbo oil feed line (possibly from being adjusted without loosening the hose end adequately).

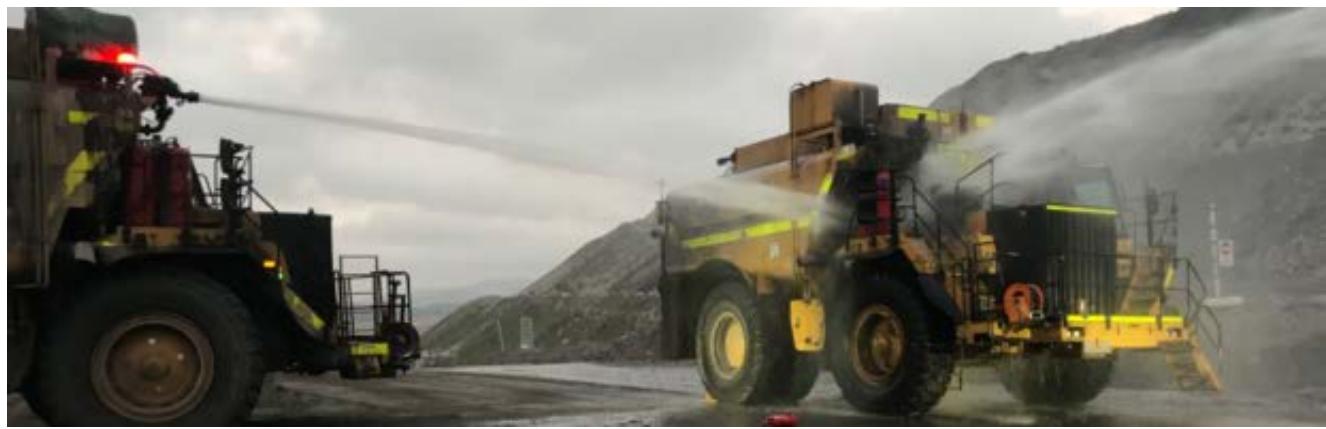
*Figure 16 Mt Arthur incident*

A fire occurred on a water truck at the top of a ramp. The fire was not extinguished by the fire suppression system. Failure of a brake cooling hydraulic pipe at the flange allowed hydraulic fluid to escape onto a hot surface to cause a large fire.

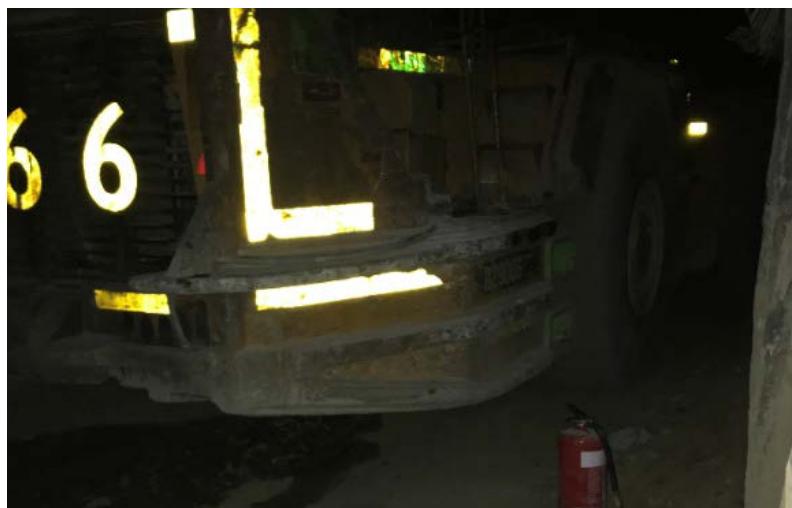
*Figure 17 The Peak Gold incident*

An underground Caterpillar 2900 loader experienced a fire while it was underground. The fire suppression automatically activated. The operator used a fire extinguisher to completely put out the fire. A loose electric cable from the main isolation switch rubbed against a radiator housing and caused a short-circuit, which melted plastic insulation of the cable and caused a small fire and smoke.

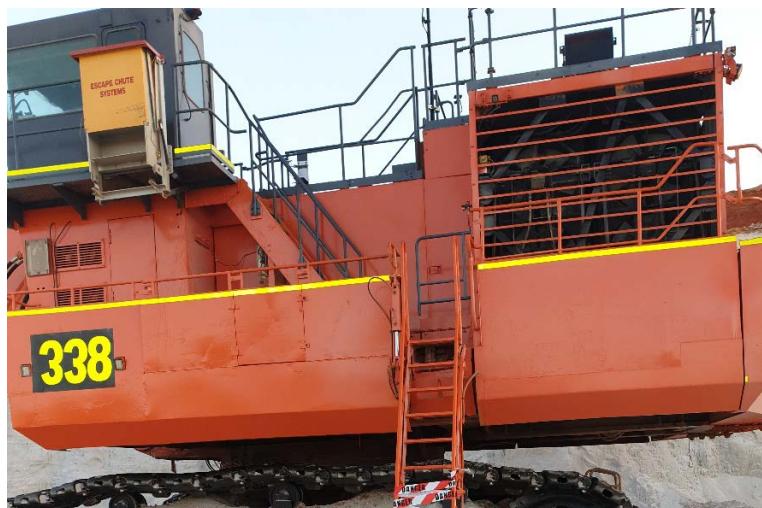
*Figure 18 Snapper Mineral Sands incident*

An excavator operator reported seeing flames emitting from the exhaust stacks on the machine. He shut the machine down and the flames self-extinguished. As part of overhaul works on the excavator, 20 millimetre bolts on a hydraulic coupling were not torqued to the bolt specifications. This allowed the recently replaced O-ring to fail under pressure, resulting in spraying hydraulic oil into the atmosphere, that subsequently landed on the excavator's exhaust tips.

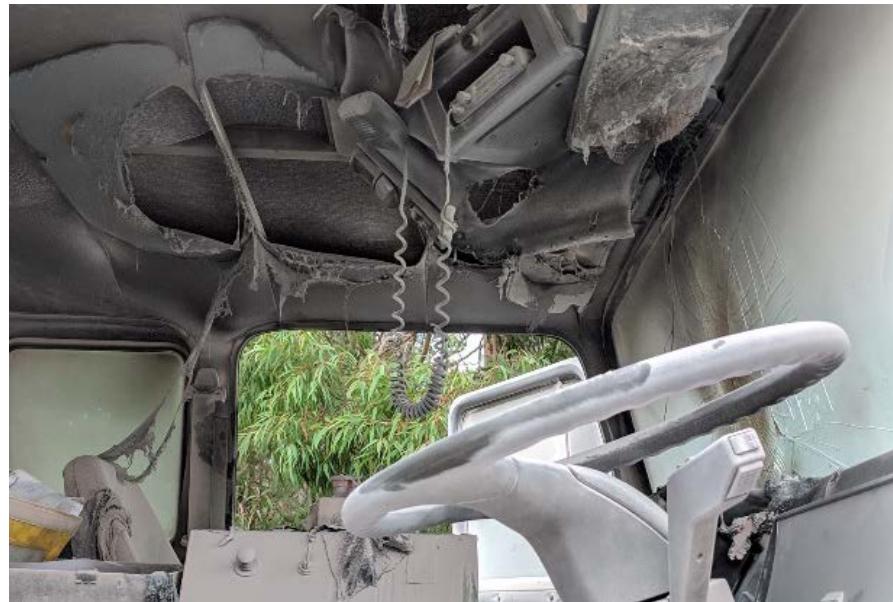
*Figure 19 Chain Valley Colliery incident*

Wiring short in the roof lining of a road registered water truck.

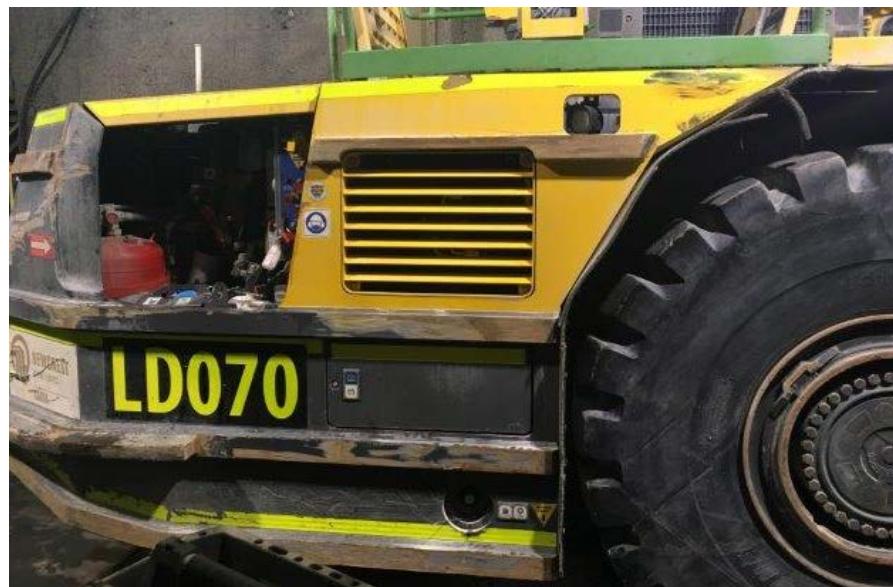
*Figure 20 Cadia Valley incident*

An underground loader's power supply cable to up-box temperature sensor and flow sensor failed at a splice, generating heat and causing the insulation to ignite.

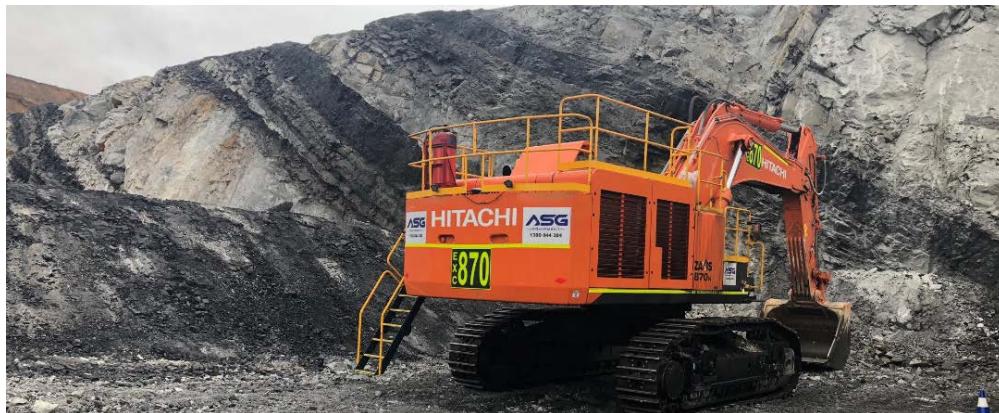
*Figure 21 Werris Creek incident*

An excavator was parked up off the bench for cleaning and de-greasing when a fire was discovered in the exhaust area. The low flash point degreaser ignited when it came into contact with the hot exhaust surface.

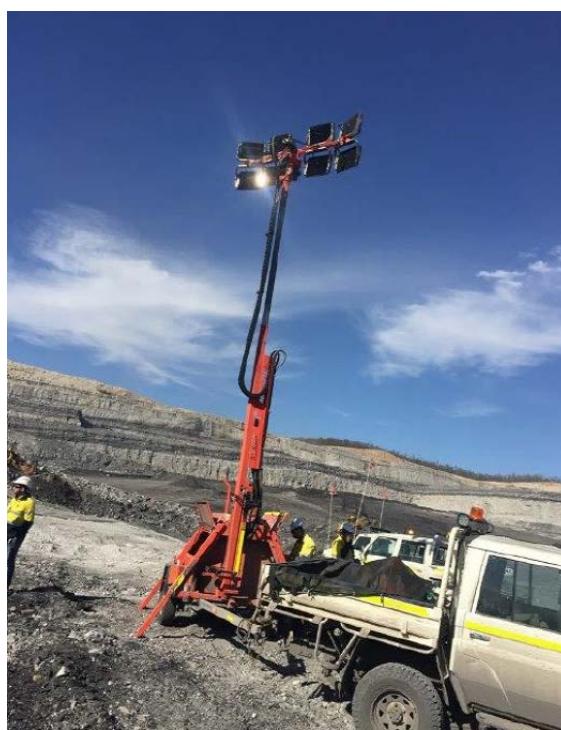
*Figure 22 Maules Creek incident*

An operator opened a lighting plant to operate hydraulic legs to move the plant outside a 500 metre blast exclusion zone. The battery exploded and the operator was splashed with battery acid. A fireball the size of a football erupted.

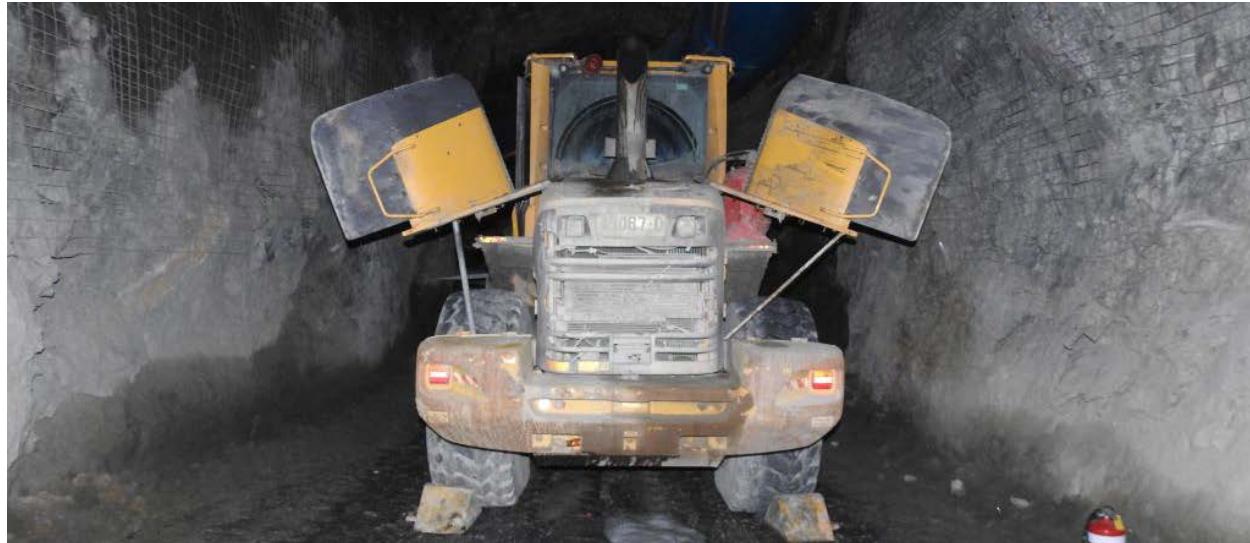
*Figure 23 Tritton Copper Mine incident*

Flames from a motor bay extended over the cabin. The fire suppression system was activated and smoke filled the cabin. There was an internal mechanical failure of the turbocharger unit.

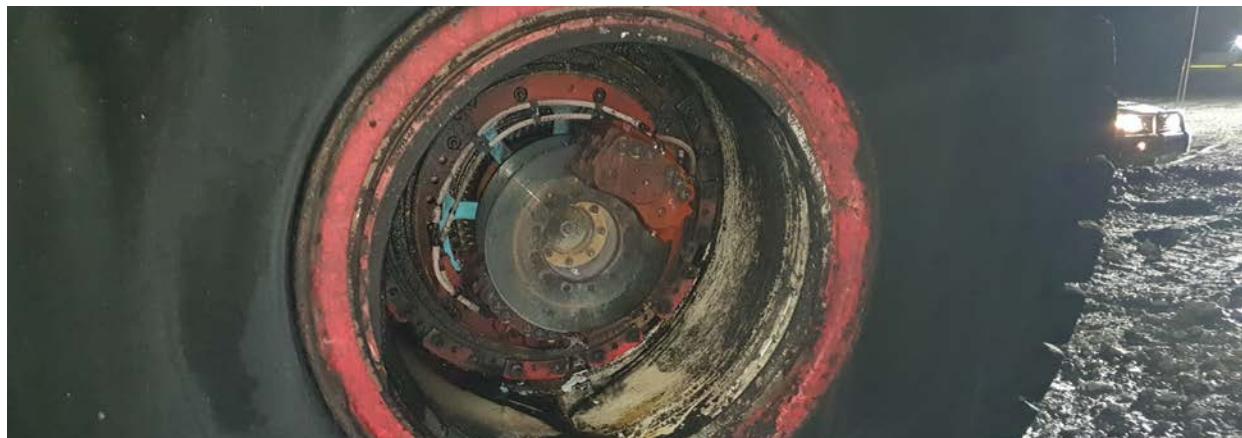
*Figure 24 Hunter Valley Operations incident*

A truck's brake lines were damaged as a result of spillage just before the incident occurred. This spill entered the brake hub area and damaged the brake lines, which resulted in a hydraulic oil spray. A loss of hydraulic oil pressure in the POS 3/4 brake calliper also resulted in automatic application of the park brake, which generated an ignition source from the brakes dragging while the truck was travelling to the park-up area.

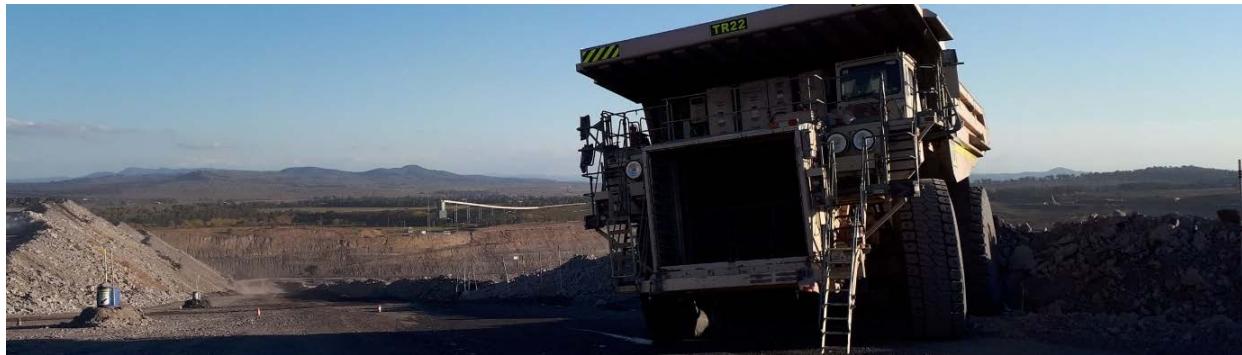
*Figure 25 Bengalla incident*

Internal failure of auxiliary transformer on the offside deck of a truck.

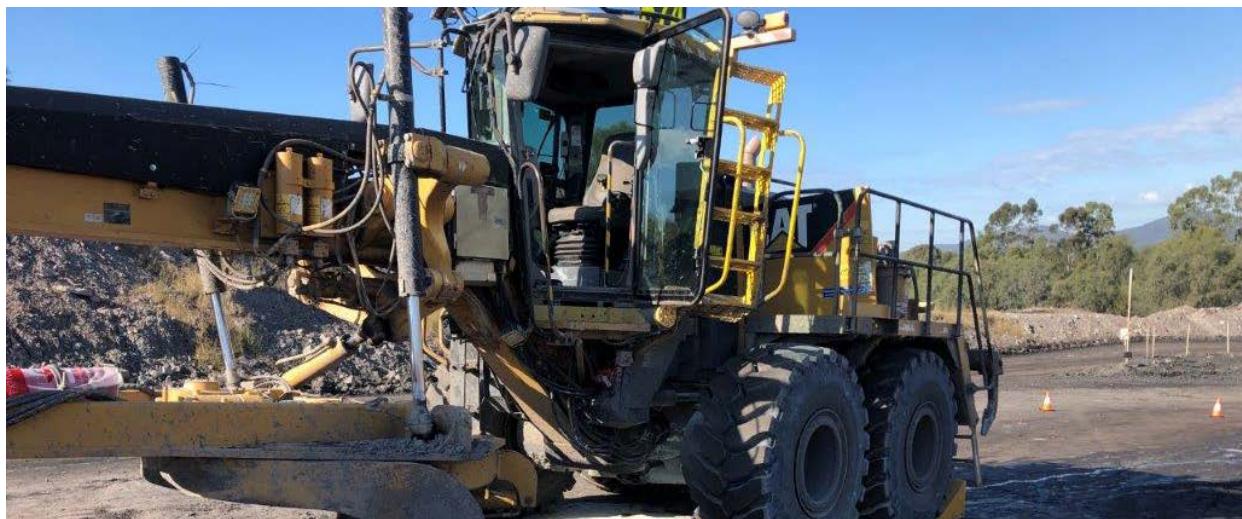
*Figure 26 Wambo incident*

The electrical lead between a battery and an emergency steering electrical motor went to ground resulting in heating and ignition of the cable insulation.

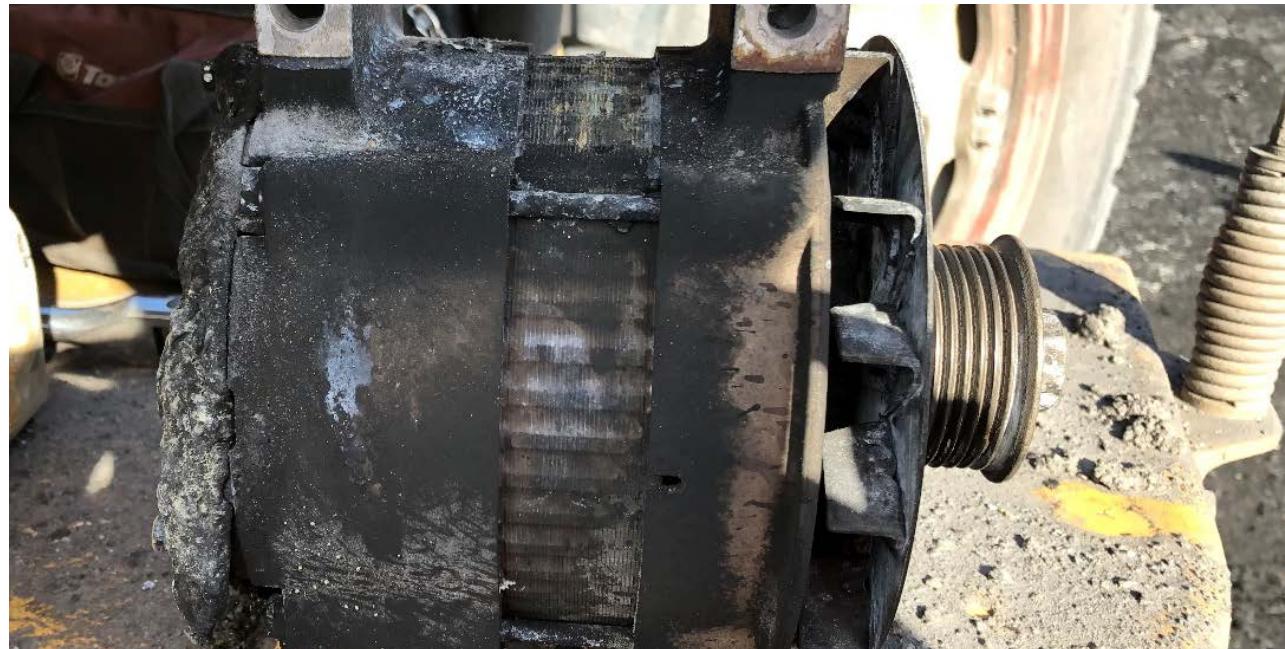
*Figure 27 Wilpinjong incident*

The cause of a water cart fire was attributed to fuel leaking into an alternator from a failed fuel line. Arcing occurred in the field coil windings in the alternator, igniting the leaking fuel. The fuel line failed due to abrasion with hose sheathing and clamp.

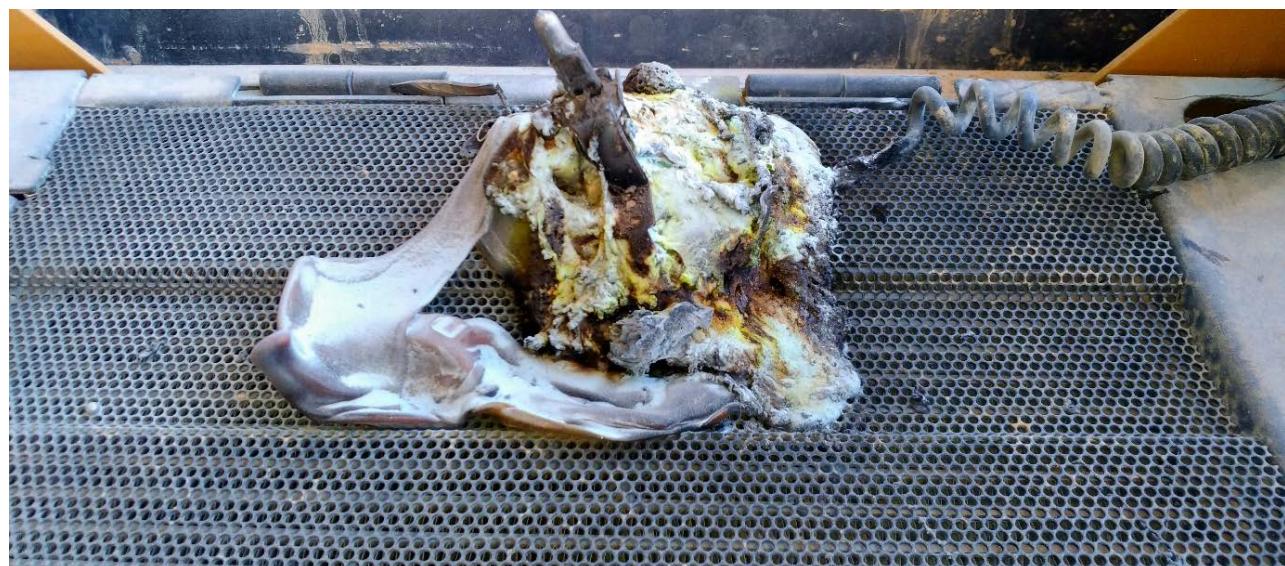
*Figure 28 Tomingley Gold Mine incident*

A flashing beacon, which was held by a magnet, fell onto an engine bay.

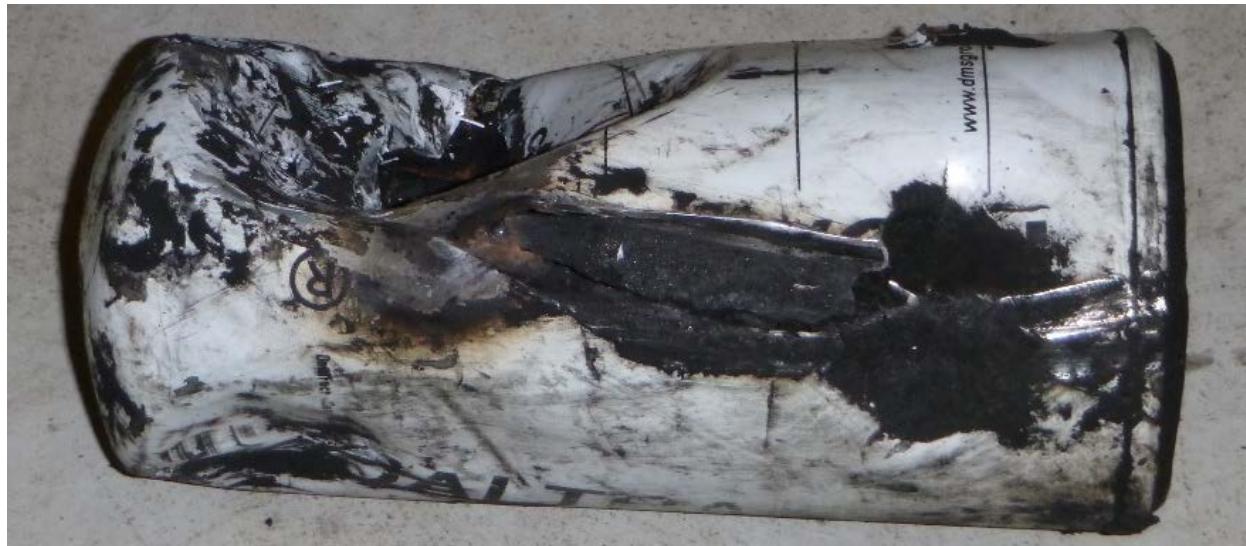
*Figure 29 Airly Underground Coal Mine incident*

During the night shift, a fitter was completing a 250-hour service and repairs to a coal tram when he found an old fuel filter within the engine bay that had evidence that the paper element had been on fire previously.

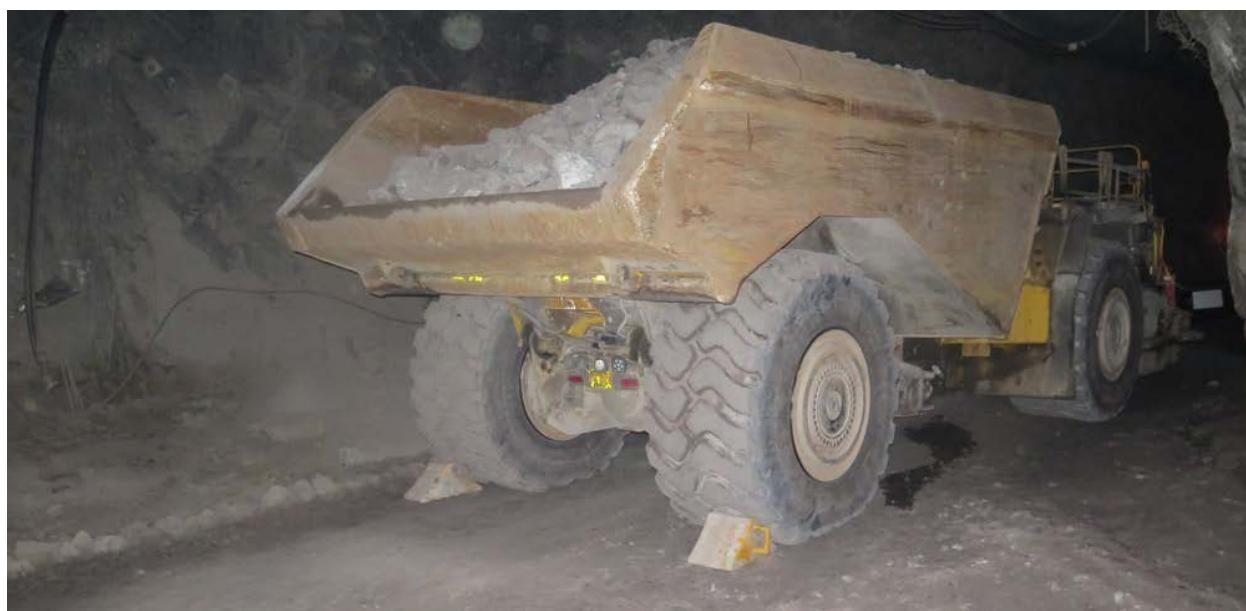
*Figure 30 Potosi incident*

A hydraulic oil hose failed due to rubbing against a turbo cover. The fire was extinguished by a hand-held fire extinguisher.

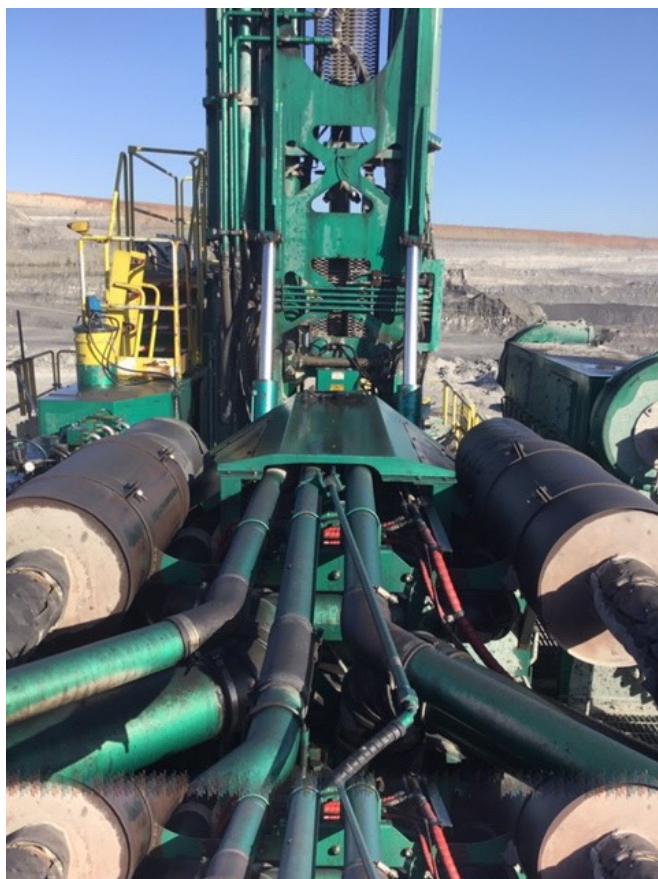
*Figure 31 Mt Arthur North incident*

Hydraulic oil ignited on a lagged exhaust, adjacent to a turbocharger. Incorrect adjustment of the feed chains on the drill mast allowed the rotary head to travel further up the mast, causing the rotation motor hose to hit the mast weldment. This caused a mechanical failure to the hose and a large amount of oil was sprayed over the rig.

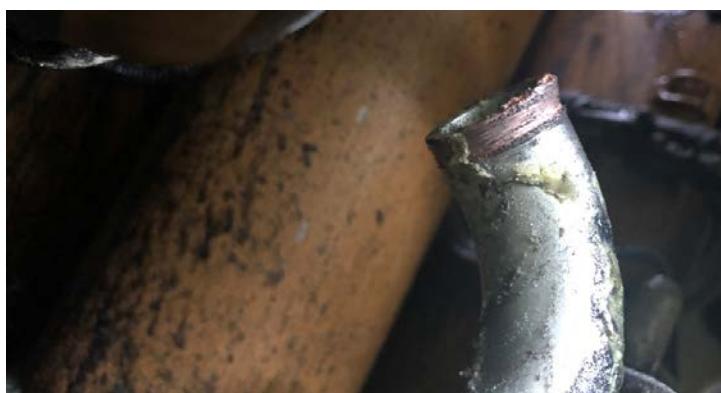
*Figure 32 Wilpinjong incident*

A poor copper brazed assembly joint in a dozer led to premature failure.

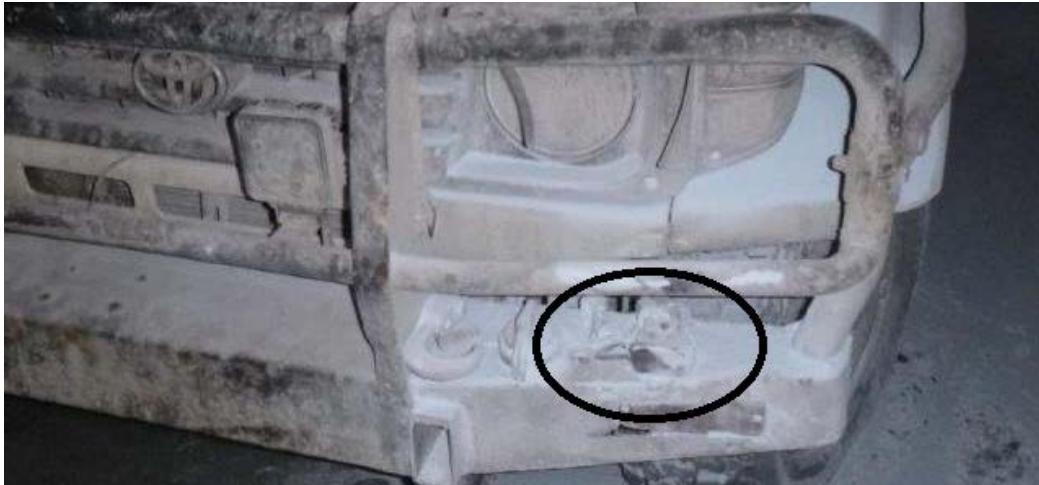
*Figure 33 Rasp mine incident*

Corrosion on terminals of an Anderson plug (jump start) allowed a short circuit to be formed with the mounting bolt of the Anderson plug to the bulbar of the light vehicle.

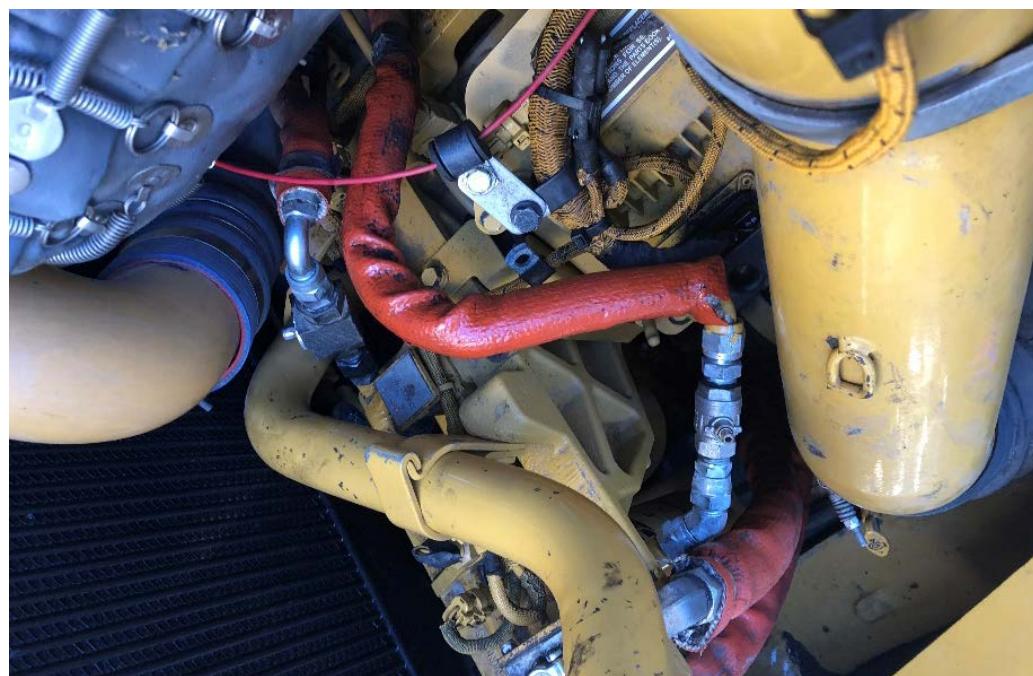
*Figure 34 Wilpinjong incident*

Diesel from a fuel filter tap was leaking in an engine bay and came into contact with the exhaust system. A defect was identified at the scheduled service however the repair was not executed effectively.

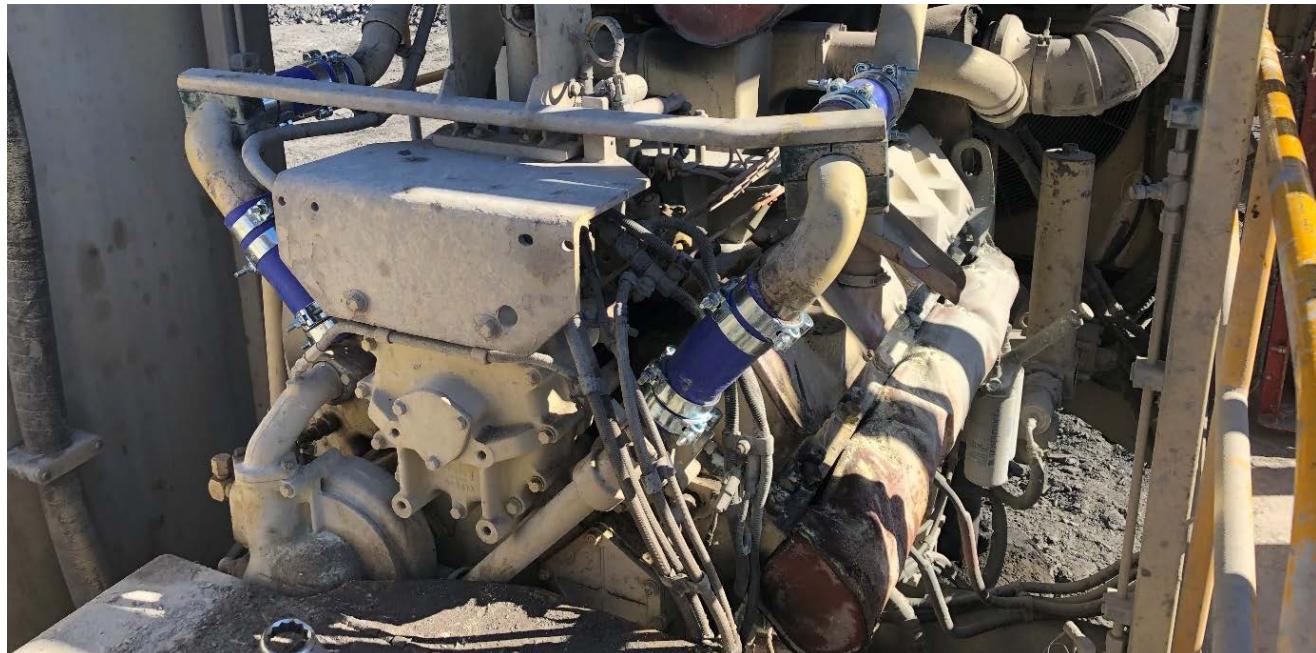
*Figure 35 Wambo Open Cut Coal Mine incident*

A coolant leak occurred on a drill rig from a short rubber hose that connected two hard pipes.

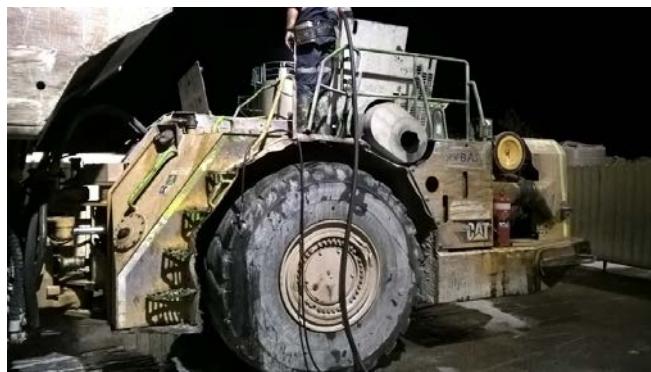
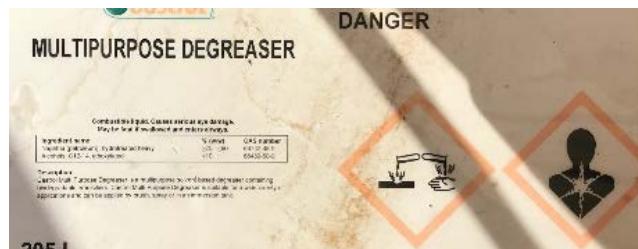
*Figure 36 & 38 The Hera Mine incident*

While spraying degreaser around a truck's engine bay, some of the degreaser ignited. The flame burnt through the burn tube of a fire suppression system in the engine bay, which extinguished the fire. The workers were trying to wash hydraulic oil off the machine from a blown hose that had occurred earlier that day.

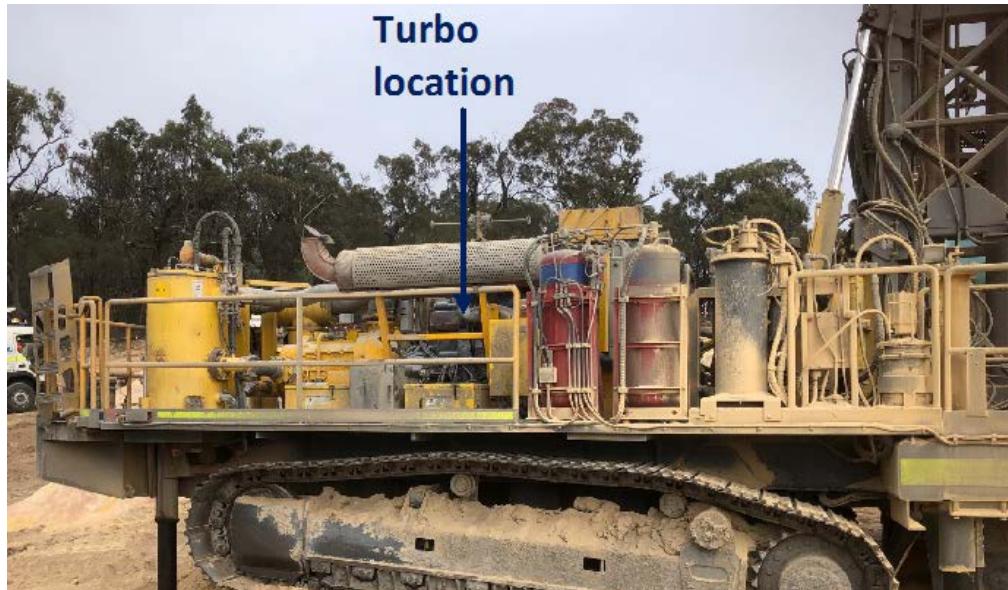
*Figure 37 The Moolarben incident*

While operating a drill, the operators observed a small fire around the turbo. The turbo drain line was loose, causing the fire.

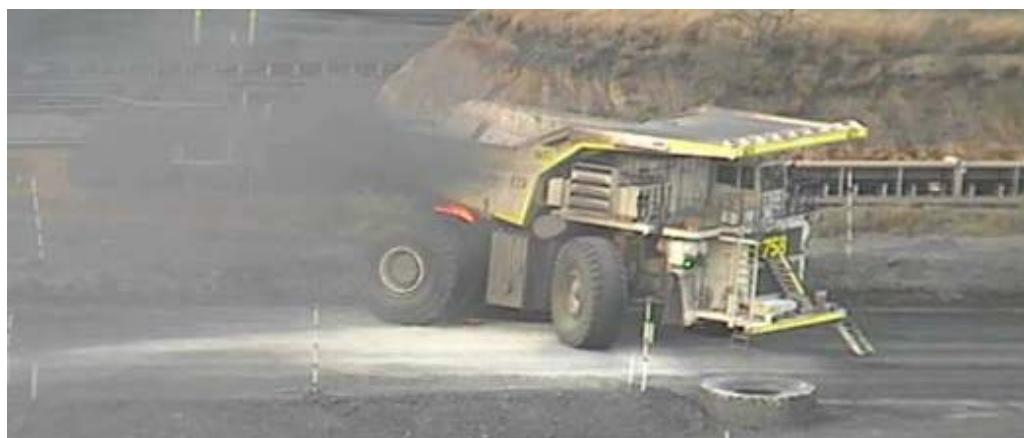
*Figure 38 Mount Thorley Walkworth mine incident*

A fire occurred as a result of a wheel rim rubbing on a wheel hub.
