# FIRES ON MOBILE PLANT

July - September 2019

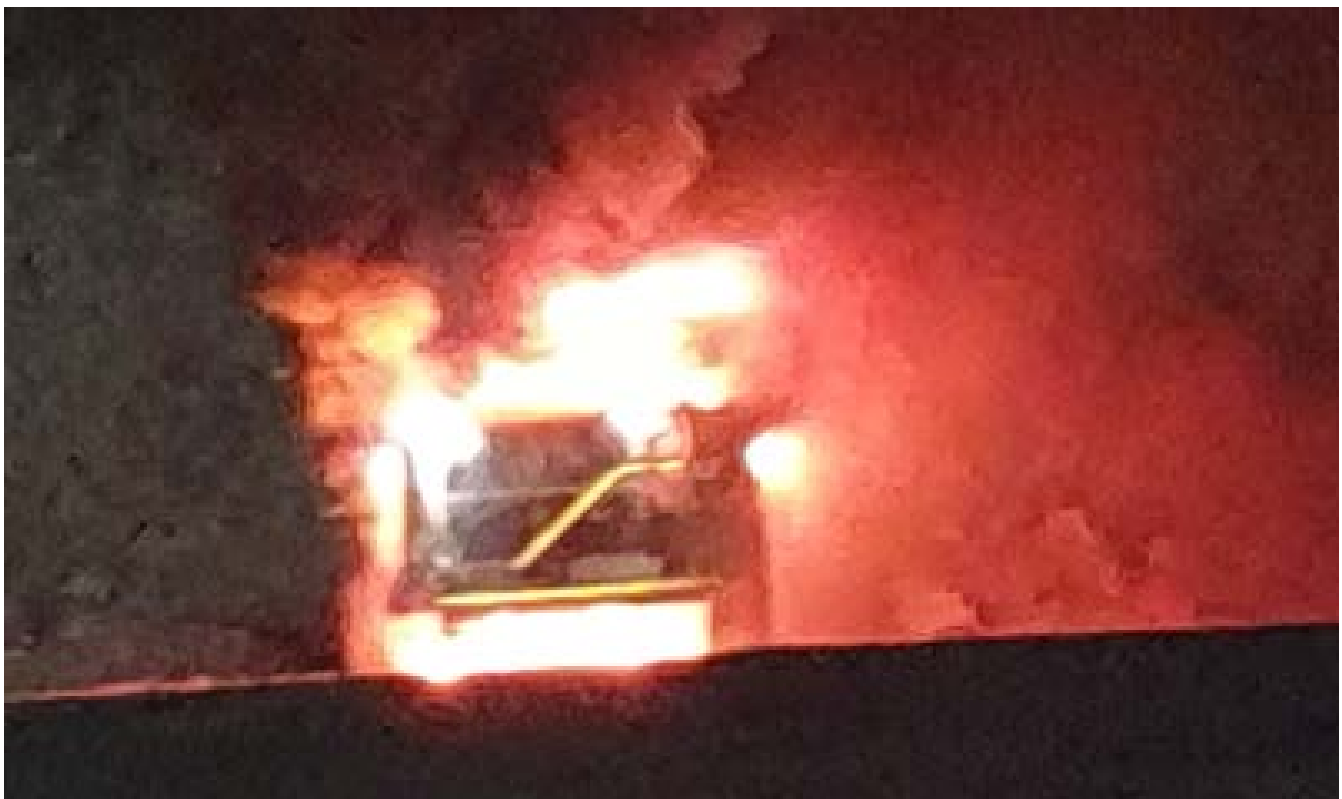
A mine's decision to abandon firefighting has been commended as the risk of burning tyres presented a wide danger zone for an extended time. The decision determined that a 500-metre exclusion zone was required for an extended time when an uncontrolled truck fire was left to burn.

*Figure 1 A haul truck destroyed by fire*

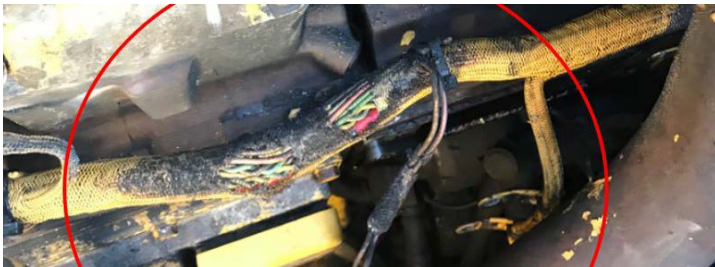
*Figure 7 Rix's Creek incident*

A fuel injector plunger failure on number 16 cylinder, allowing unburnt fuel to combine with oxygen on the hot surface of the outside of the exhaust manifold. It was due to a pre-existing exhaust manifold leak on the same cylinder.

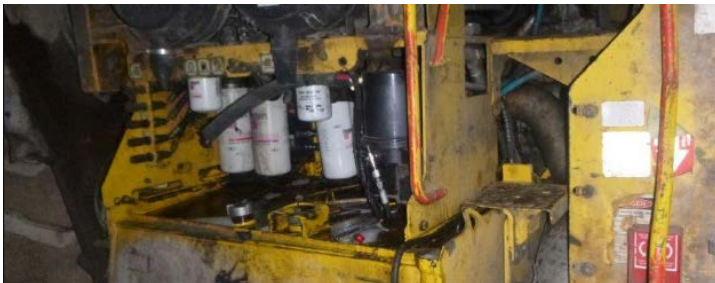
*Figure 8 Potosi Operations incident*

A truck was refuelling at the fuel bay at the surface of the mine. Fuel splashed out of the breather and ignited when it contacted hot engine parts. The refuelling system was a dry break system.

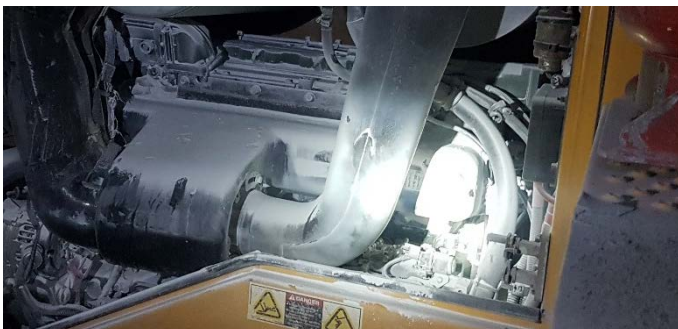
*Figure 9 Peak Gold Mine incident*

An operator noticed smoke after repairs were undertaken. Dried residual coolant fluid was exposed to a heat source.

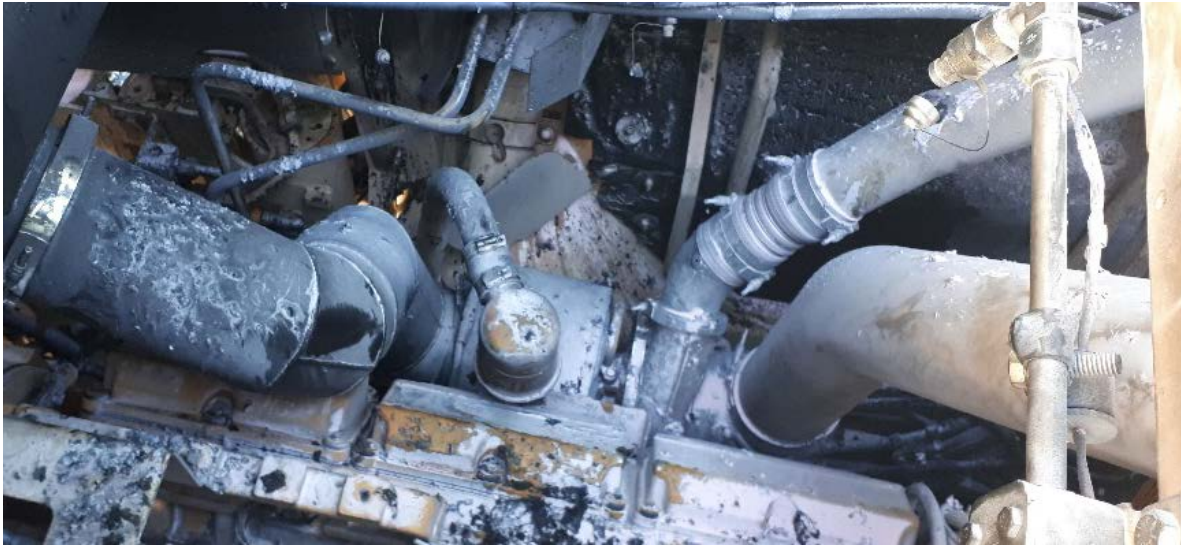
*Figure 10 Bengalla incident*

An investigation found that a brake fluid leak occurred on a water cart at the brake manifold fitting on the line to the brake valve, from an O-ring failure. It was most likely caused by inadequate bolt tensioning during brake valve replacement.

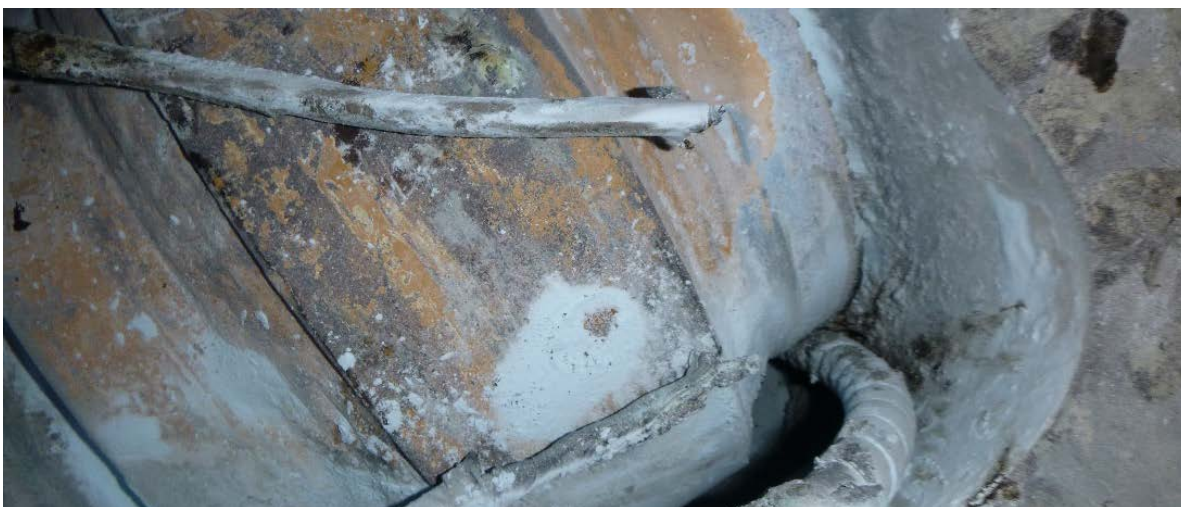
*Figure 11 CSA incident*

A fire was caused by a short circuit of a lighting circuit on the boom of a loader. Wiring loom was damaged as a result of rock deposited in the pivot point.

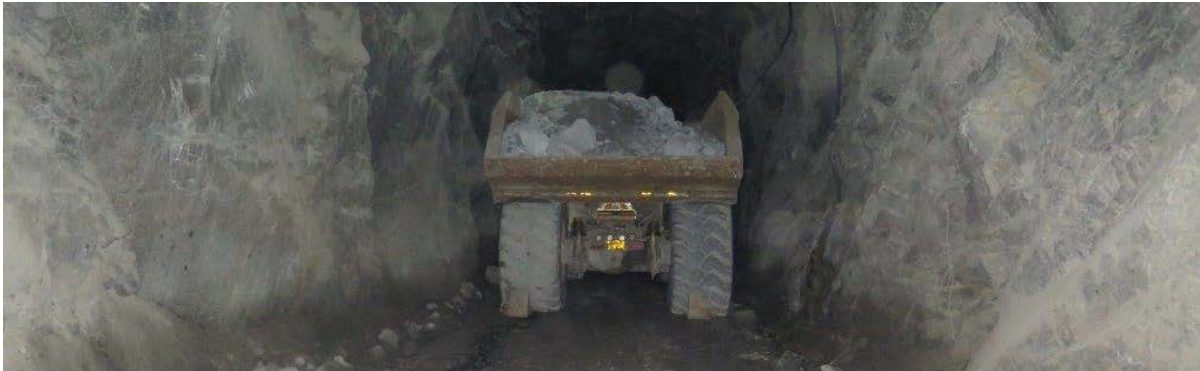
*Figure 12 Potosi Operations incident*

Diesel fuel was found to be leaking from the back of an outer fuel feed pipe. The sealing grommet on the outer pipe was not present at the time of the incident. The event occurred after major engine maintenance was carried out.

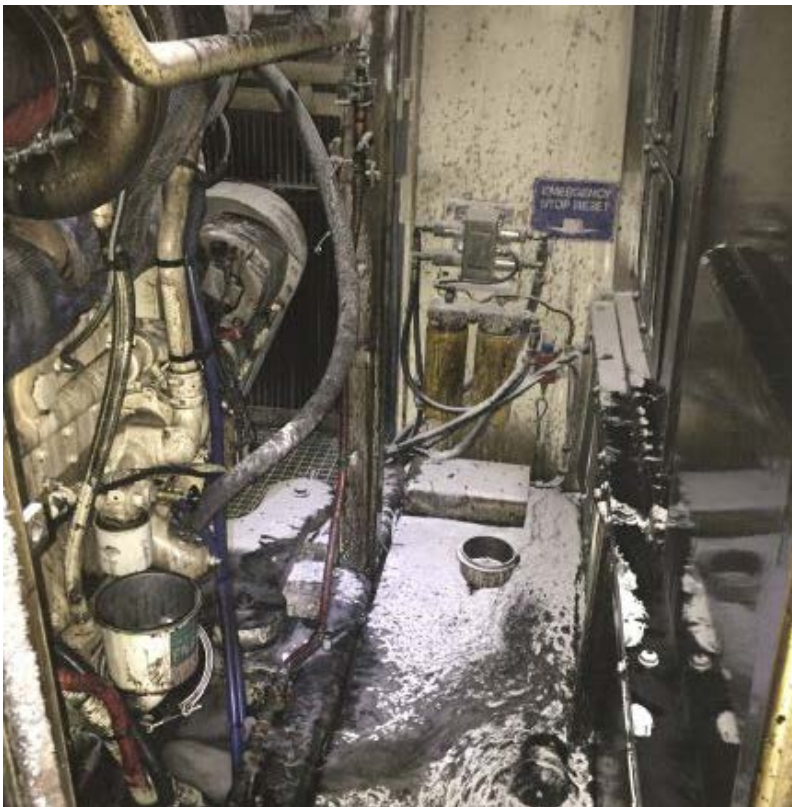
*Figure 13 Boggabri incident*

A filter housing failed due to debris and fatigue in the restraining clamp, causing oil to spray onto a turbo.

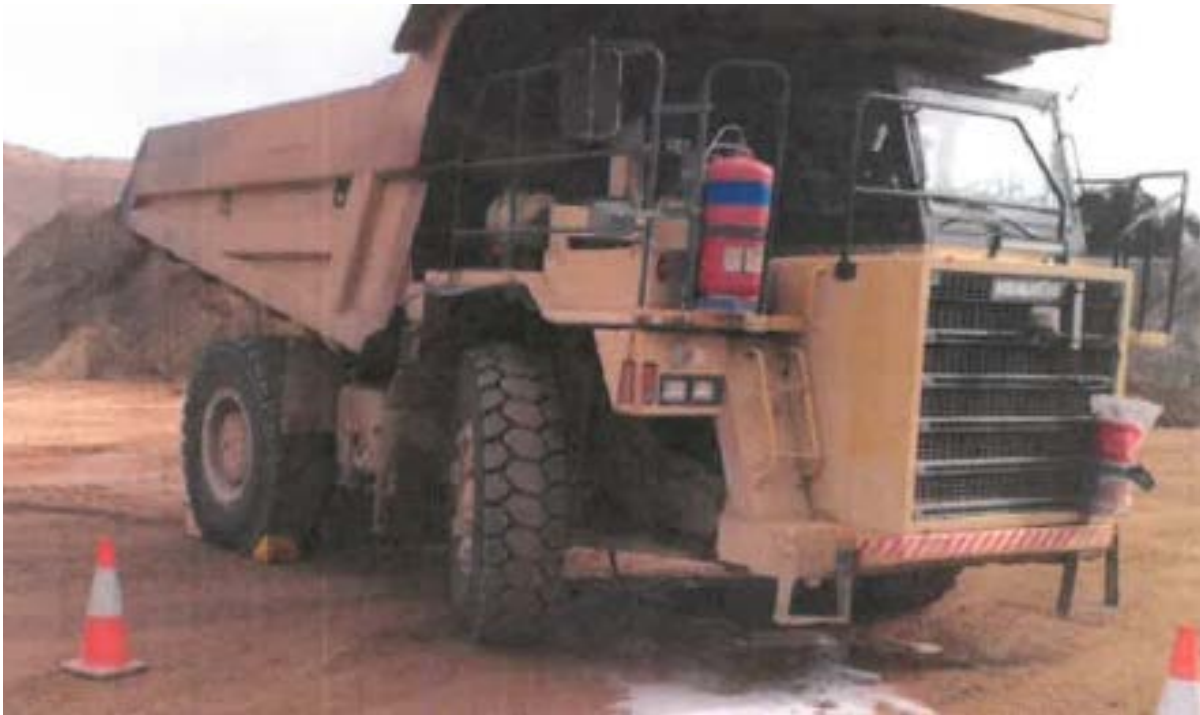
*Figure 14 Austen Quarry Hartley incident*

Hydraulic fluid was released from a hydraulic hose and made contact with a hot exhaust.

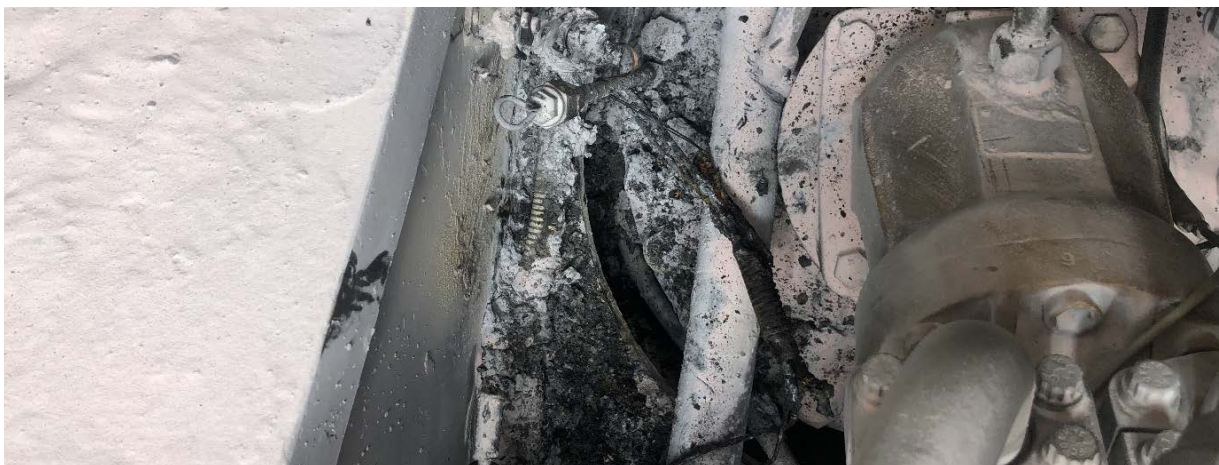
*Figure 15 Tarrawonga incident*

An electrical fire occurred on an excavator. The electrical harness rubbed through and caught fire.

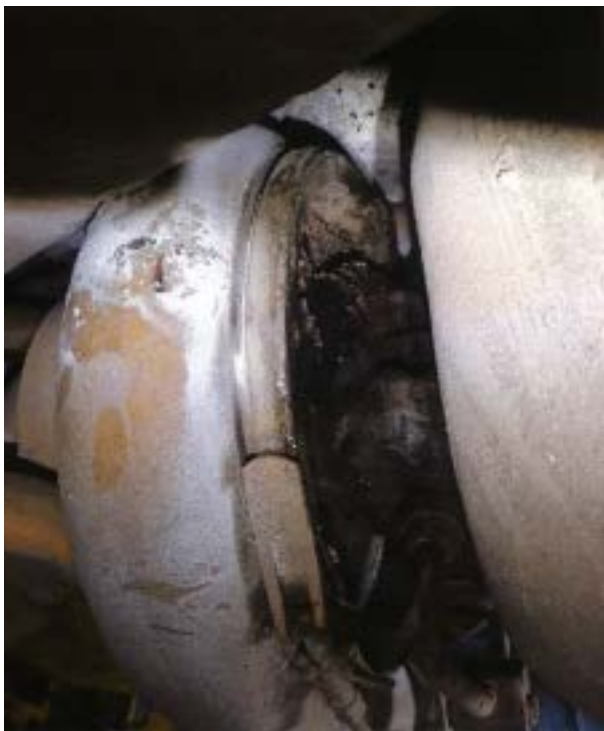
*Figure 16 Wambo Open Cut incident*

The turbo failed internally and the fire was largely contained inside the engine exhaust pipe.

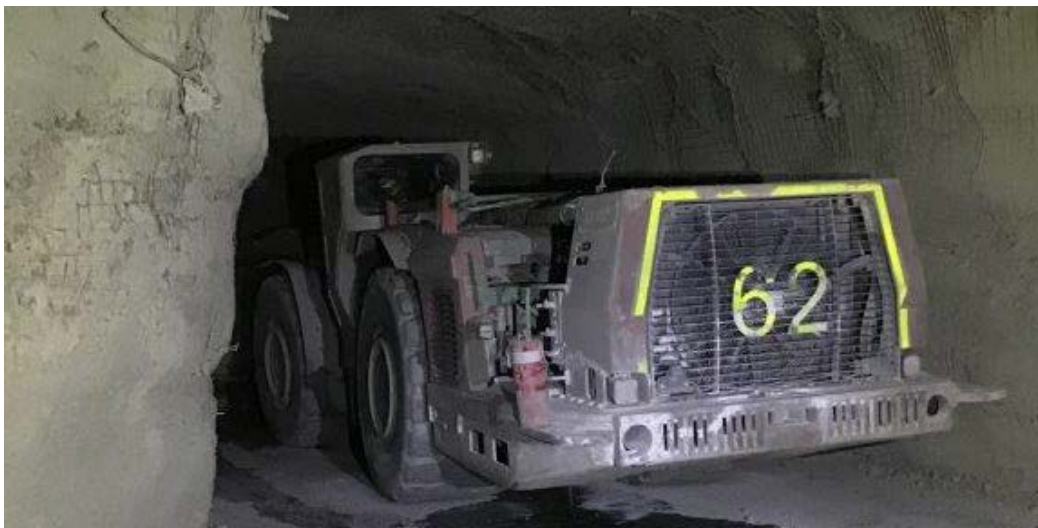
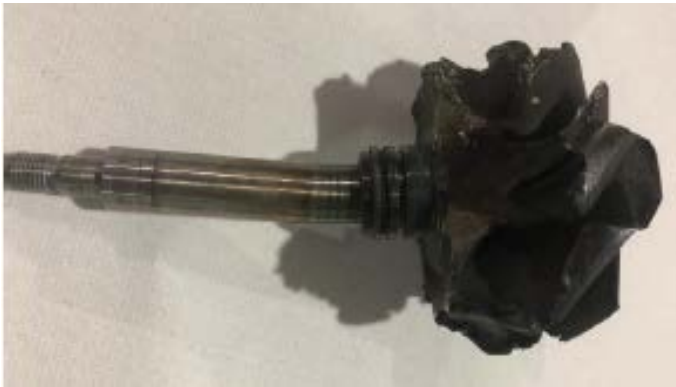
*Figure 17 and 19 Cadia East incident*

Fire in the exhaust system of a loader. Based on the evidence gathered during the tear down inspection on LD062, the most probable root cause of the failure was a section of turbine wheel fractured away during operation at the welded joint, between the turbine wheel and main shaft.

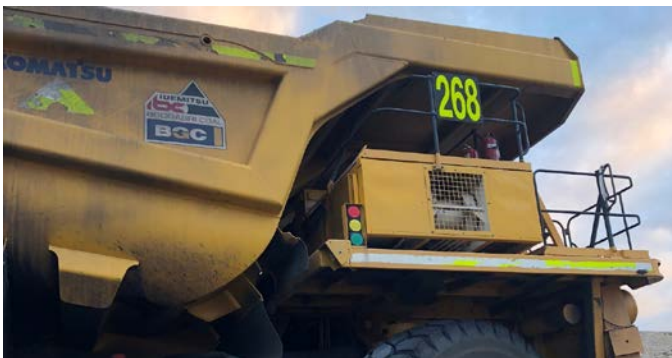
*Figure 18 Boggabri incident*

An electrical fitter failed to reconnect a conductor to the grid box blower motor No 1 after removing it during repairs.

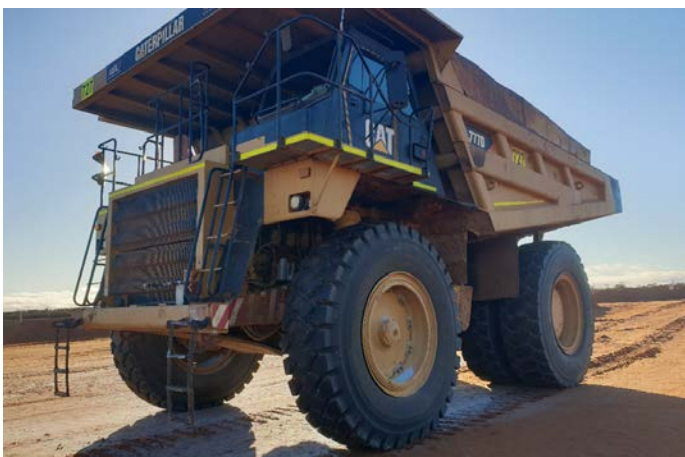
*Figure 19 Crayfish Mineral Sands Mine incident*

Brakes appear to have locked on a 777D truck, resulting in a fire.

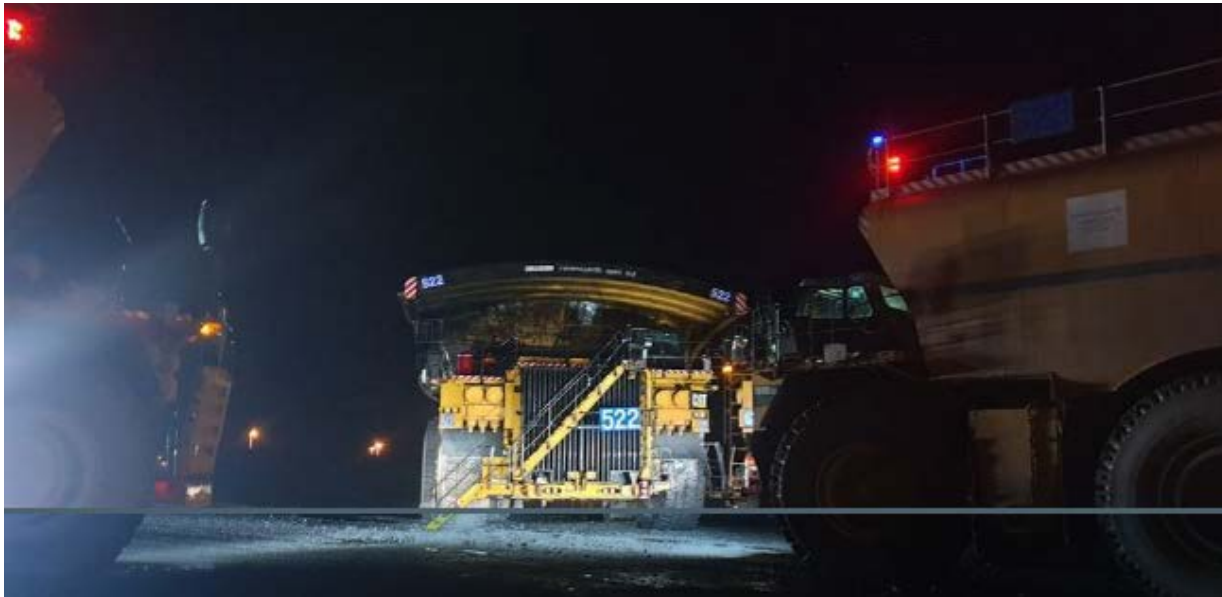
Figure 20 Ravensworth incident

The operator identified smoke in his rear vision mirror and saw flames emanating from the engine bay deck. The left-hand side turbo oil feed line was dislodged from the turbo fitting.

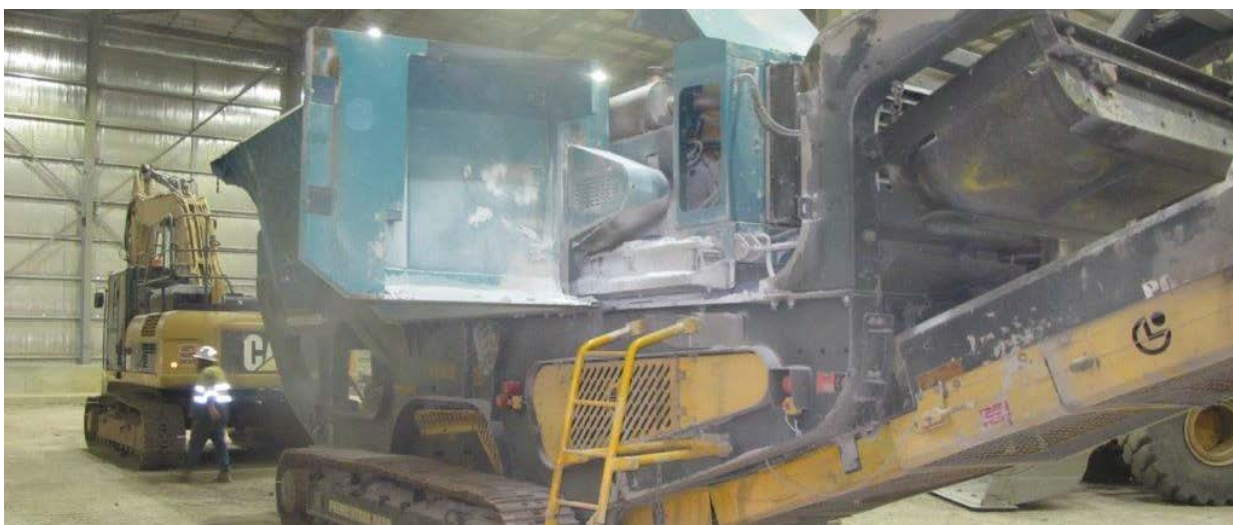
Figure 21 Perilya North incident

Guarding over a pulley system cracked, allowing guarding to make contact with batteries and battery wiring.

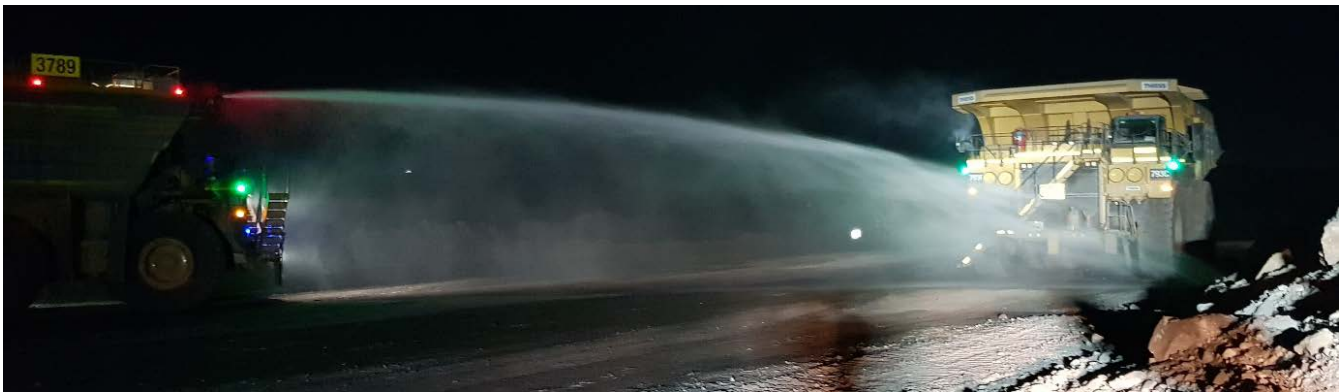
Figure 22 Mt Arthur incident

A turbo fire has occurred on an unloaded rigid dump truck that was returning to the dump. The operator noticed the truck losing power. Workers then noticed excessive smoke coming from the exhaust, so they pulled over on the haul road. They heard a loud noise and noticed flames coming from the exhaust of the truck.

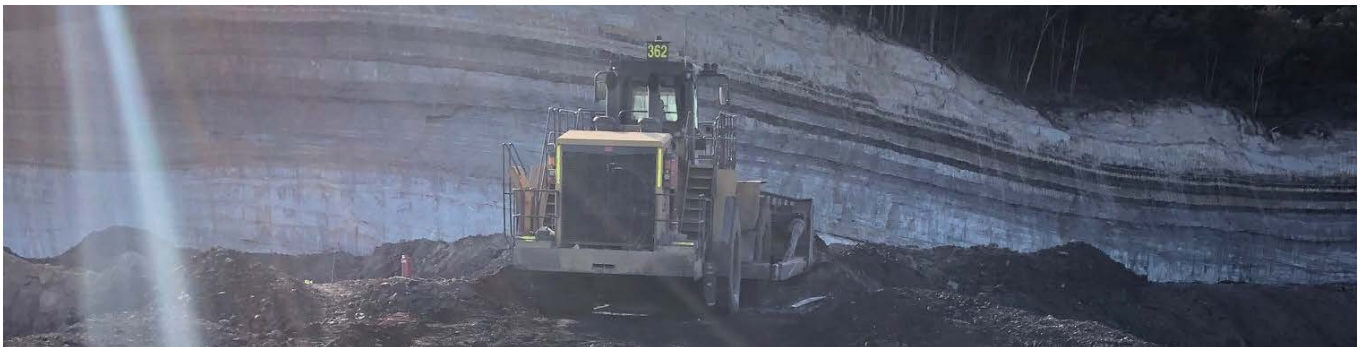
Figure 23 Moolarben Open Cut incident

An unprotected hydraulic hose came into contact with the fire wall. The hose rubbed through, releasing an oil mist that hit the hot exhaust and ignited.

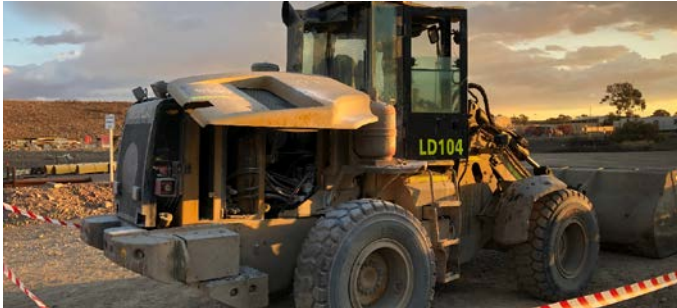
*Figure 24 Northparkes Mines incident*

The preliminary findings revealed overfilled hydraulic oil. Oil flowed over hot component hydraulic oil tank breather, allowing overflow oil to drain into the engine.

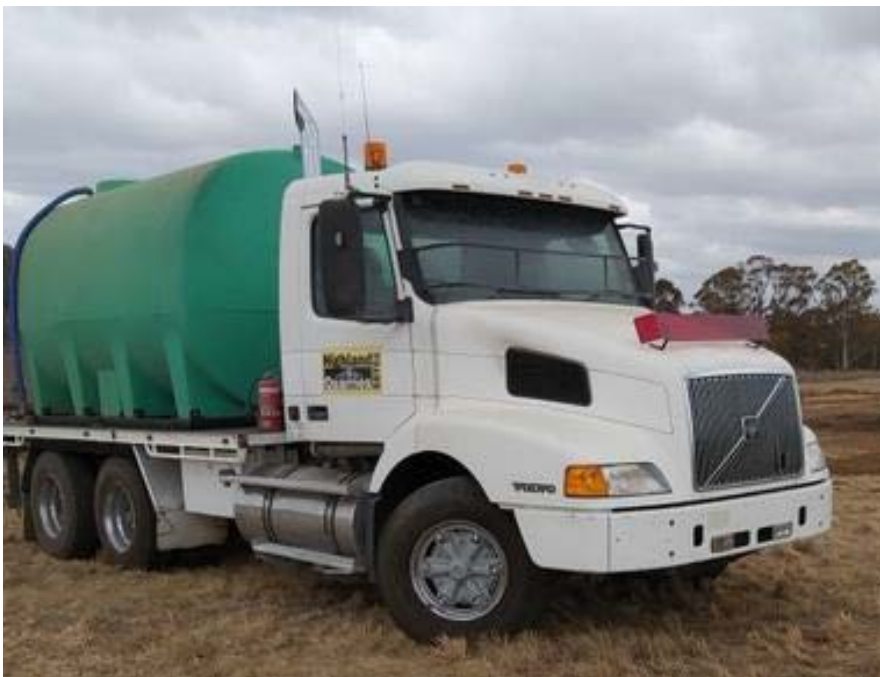
*Figure 25 Highland Quarries incident*

There was no apparent cause other than an air filter catching fire.

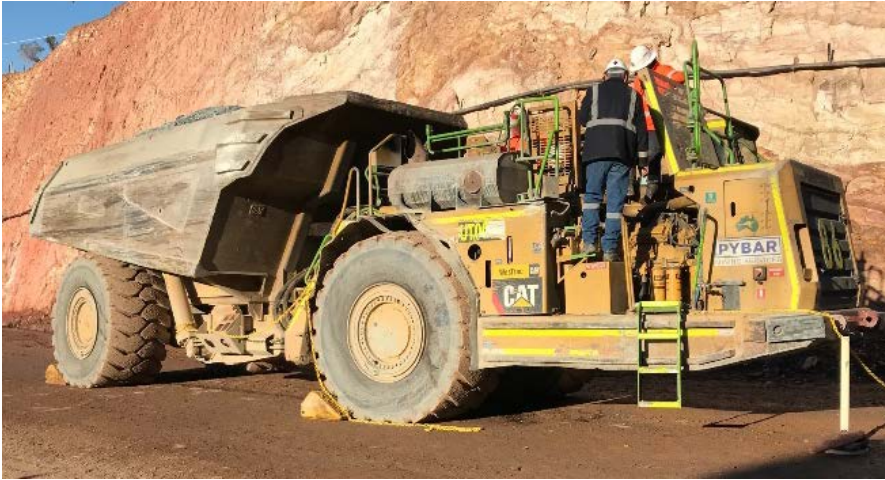
Figure 26 Peak Gold Mines incident

An O-ring in a hose/valve block arrangement for the radiator pump assembly failed and caused a mist of hydraulic fluid to be sprayed on coat hot engine components, which had not been tightened correctly after repairs were carried out.

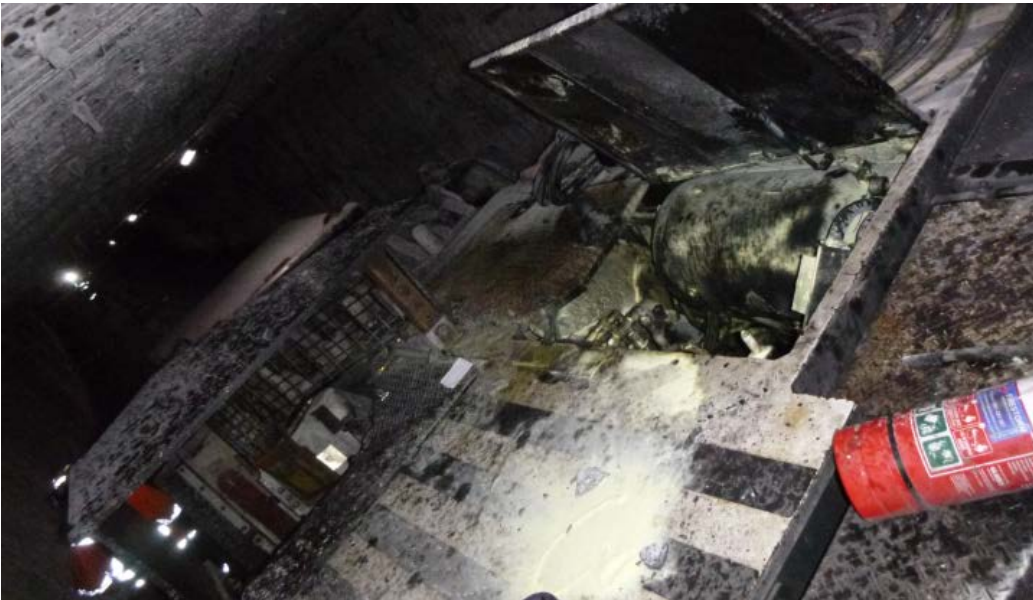
Figure 27 Ulan West incident

A Caterpillar heavy haulage load haul dump machine (LHD) was towing a feeder breaker into the mine on a sled when a uni-joint on the tailshaft catastrophically failed. The tailshaft damaged hydraulic hoses within the engine bay, resulting in a fire.

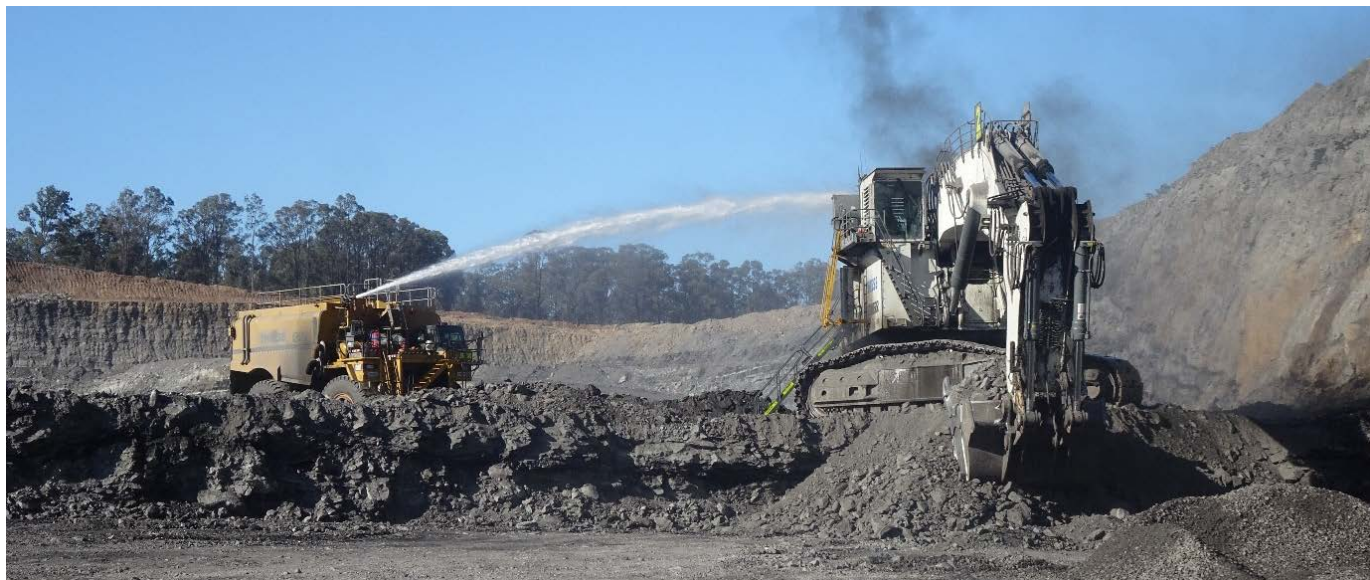
Figure 28 Mt Owen incident

A loose fastener on a valve bank caused an O-ring to fail, releasing a spray of atomised oil. The atomised oil ignited when it came into contact with a hot surface.

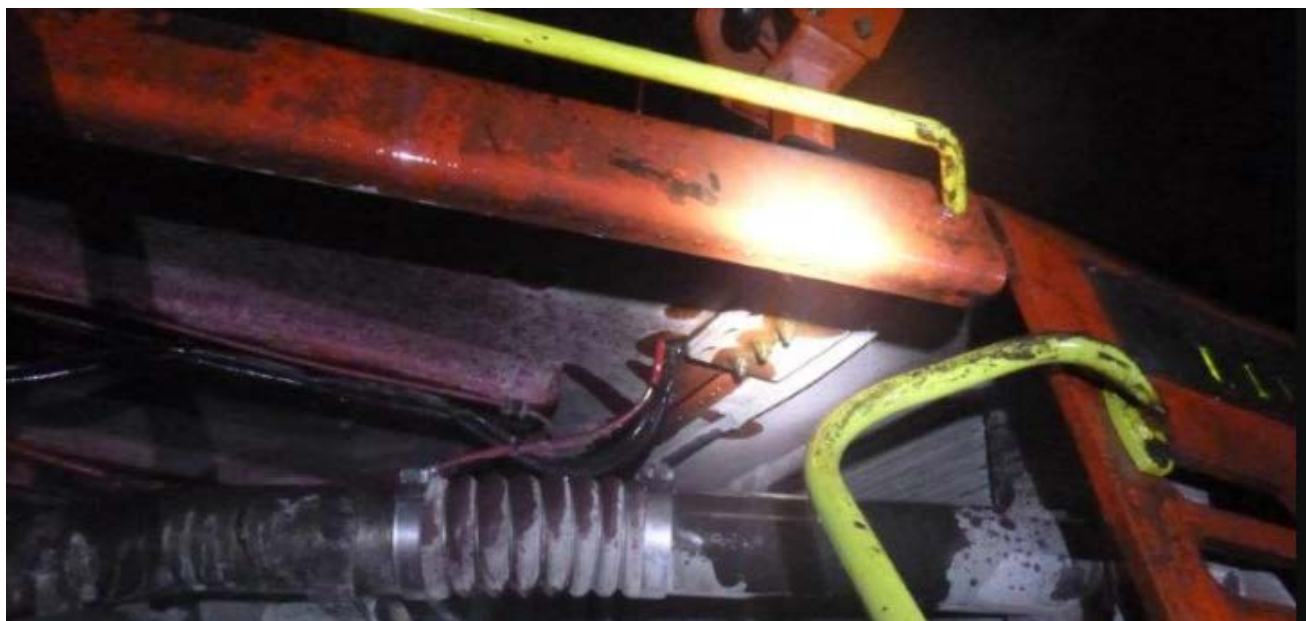
Figure 29 Rasp Mine incident

A loader was bogging in Level 11 on the Far North Stockpile when the loader operator noticed oil spraying from the rear of the machine and saw flames within the engine compartment. The fire was caused by a failed hydraulic hose, causing oil to spray onto hot engine components.

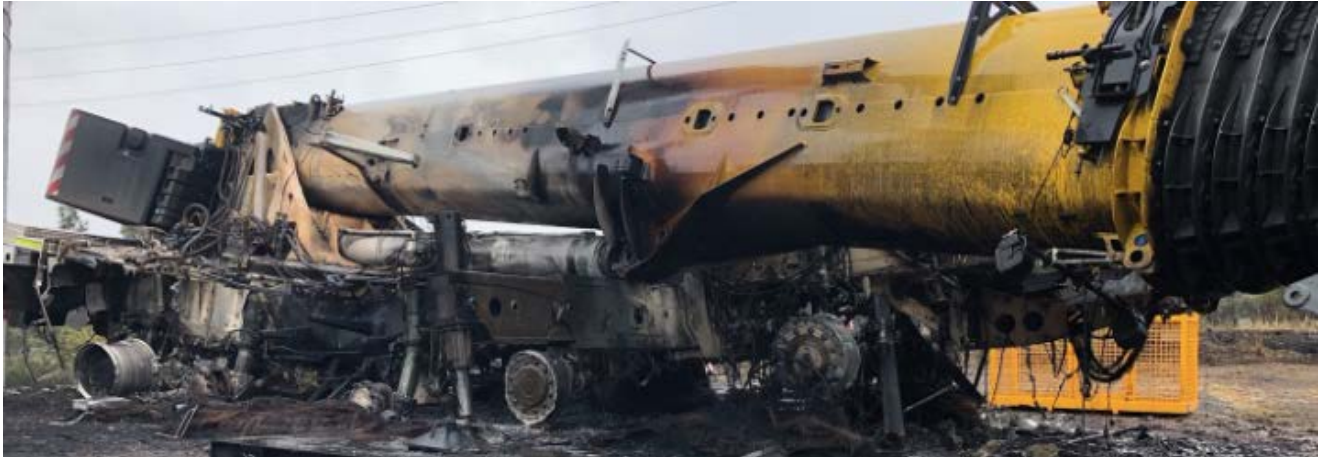
Figure 30 Ravensworth incident

An unattended mobile crane caught on fire after a scrub fire came through the mine. The NSW fire brigade and the mine's emergency response team extinguished the fire.

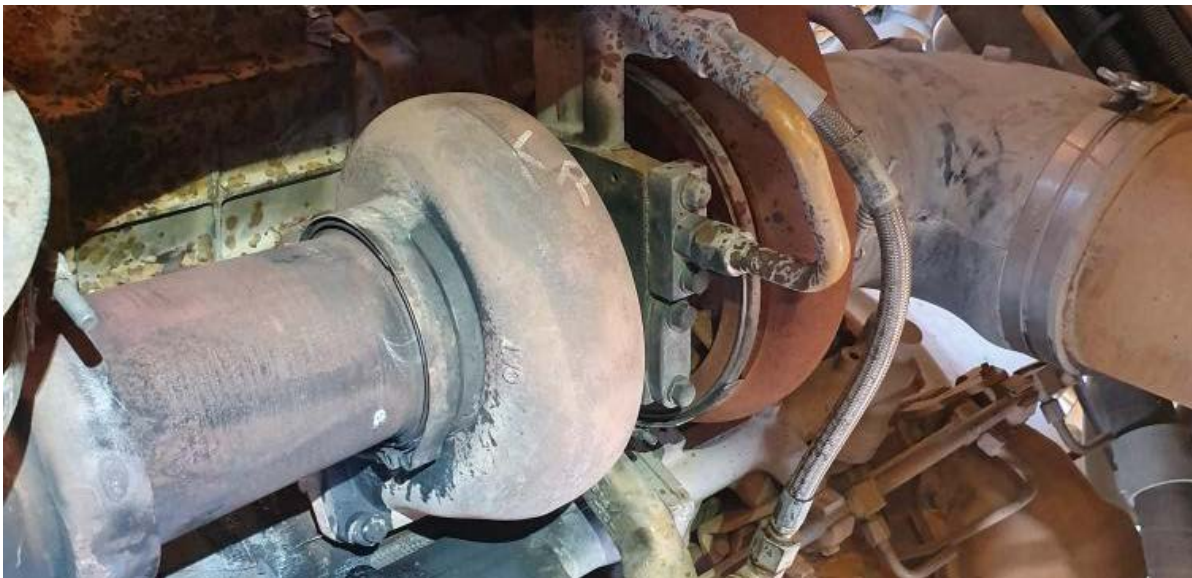
Figure 31 Cowal Gold Mine incident

A haul truck was travelling up a ramp when it experienced a turbo fire. The operator could not operate the fire suppression system. There was a water truck travelling behind the haul truck. The fire suppression actuator pin was unable to be pulled out due to an additional safety tag on the pin. The location of the fire suppression actuator made it difficult to remove the pin.

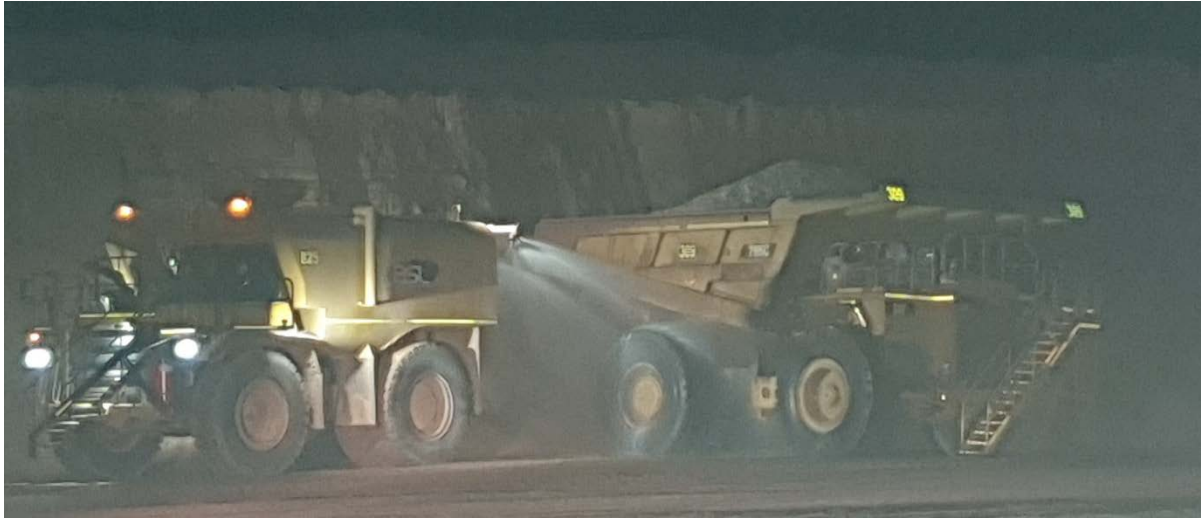
*Figure 32 Crayfish Minerals Sands incident*

The integrity of a tyre failed, causing separation between the tread and the tyre belt. The tyre carcass sustained some damage with some bead wire's integrity damaged.

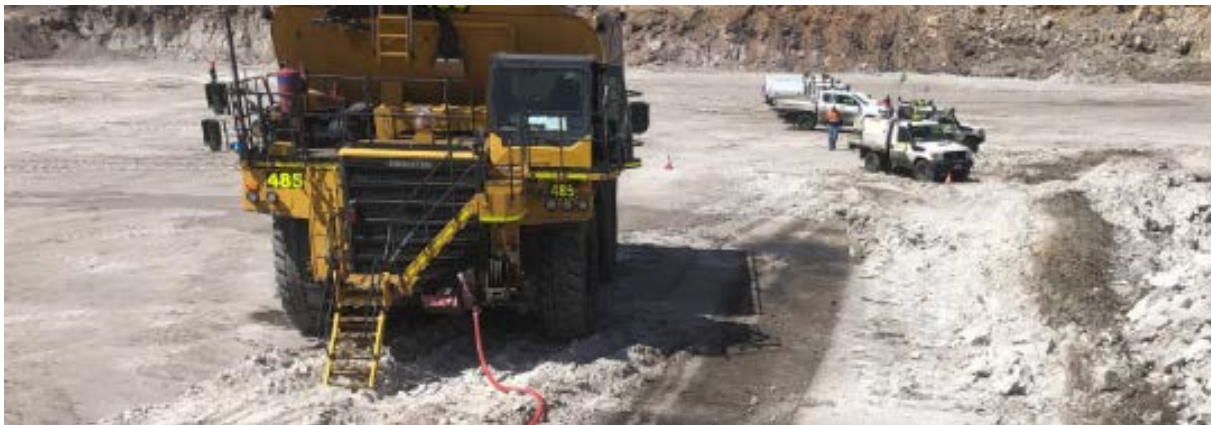
*Figure 33 Moolarben Open Cut incident*

Air ingress to the secondary suction bellows allowed a fan pump to suck air into a circuit, causing the cavitation of the hydraulic pump. The cavitation caused the fan circuit steel lines to pulsate rapidly, leading to the fatigue cracking in the steel pipe.

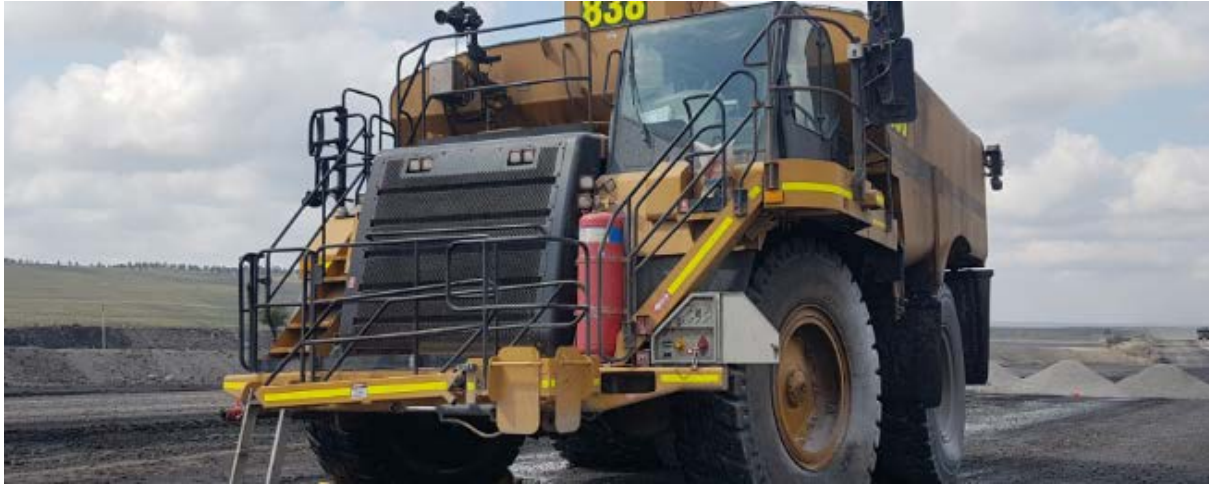
Figure 34 Glendell Open Cut incident

The root cause of the uncontrolled fire was determined to be the failure of a high pressure hoist supply hose, between the main pump and the high pressure screen. As a result, hydraulic oil ignited at the furthest extent of the exhaust system. The hydraulic hose failed due to poor routing and restraint.

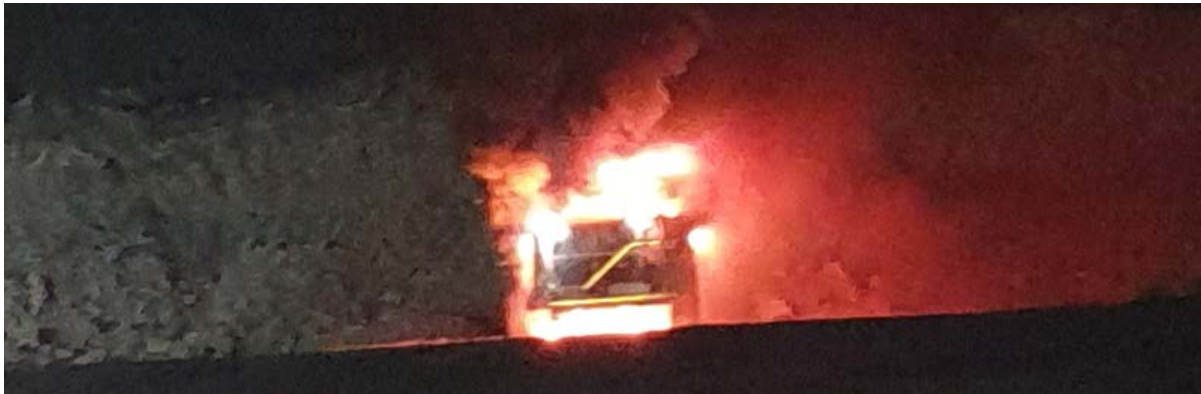
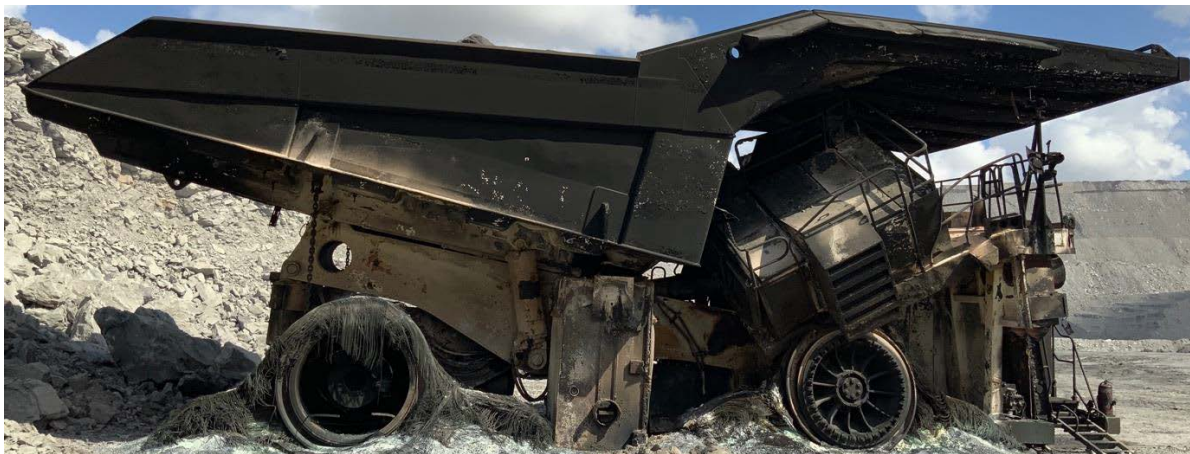
A fire occurred on a Komatsu 830 truck at 341 shovel. Fully ablaze, the area was barricaded and the truck was left to burn. An operator applied the fire suppression system and left the truck. No injuries were reported. One tyre exploded. It was observed that the fitting on the balance hose between fuel rails had separated from the hose. The fire occurred the day after the balance fuel hose was replaced. Considering when the fire occurred, it was considered likely that there was some factor of the hose replacement that resulted in the hose fire.

Figure 35 and 38 HVO incident and after fire extinguished
