FIRES ON MOBILE PLANT

October - December 2019

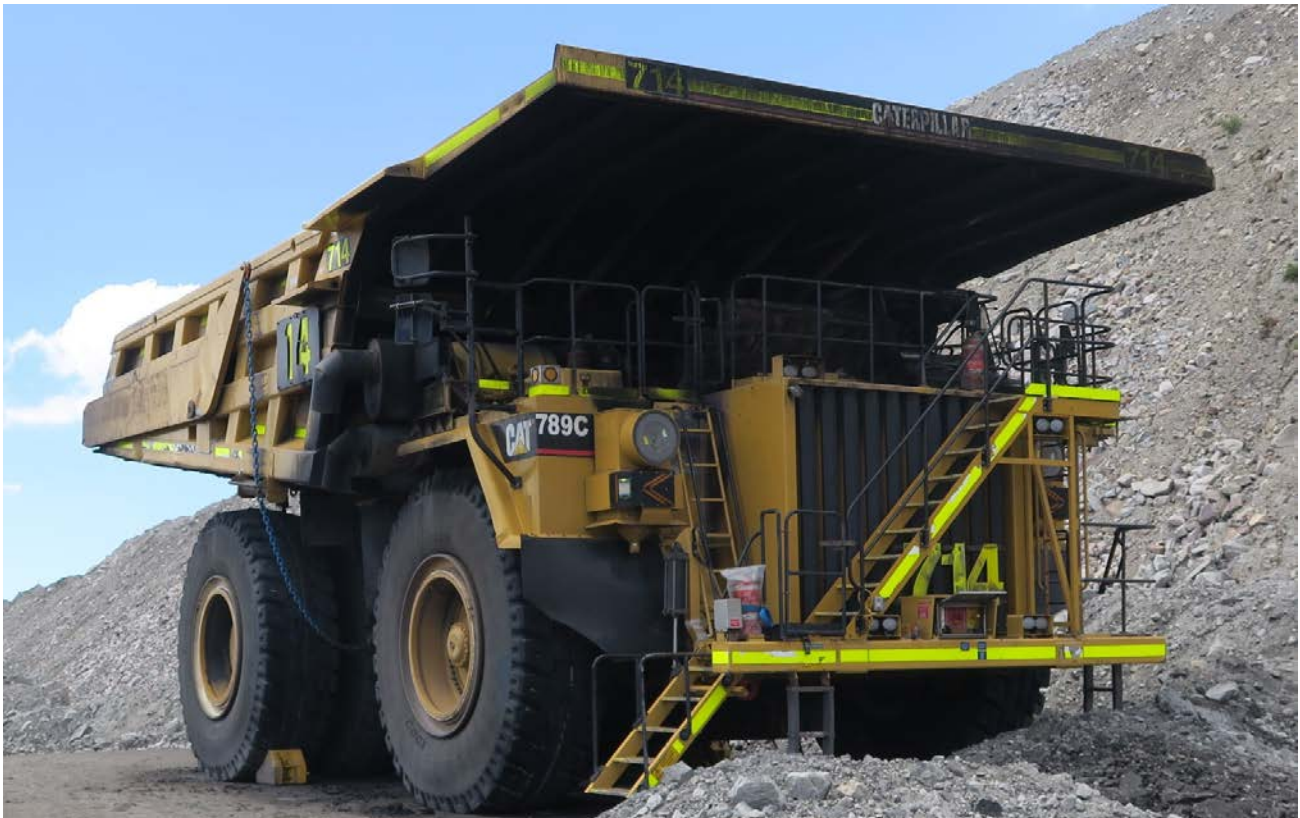
Figure 1 Dangerous haul truck fire exposes operator to immediate safety risk.

I saw an orange flash from the left rear of the truck and a noise like a flat tyre. I got out of the cab on the driver's side, tried to put the boarding ladder down. It didn't move at all.

Smoke was coming through the door seals, thick in the cab. I started to wonder how I was going to survive. Felt around in the dark. Light in the cab wouldn't work. Felt around, pulled the pin on the fire suppression. Removed the pin. Hit the button.

The sticker that is on the railing caught my eye. Flames were coming up the front and passenger side of the cab. I pushed the door open, moved to the emergency gate, opened latch, couldn't see to get down so felt my way with my feet.

The fire originated in the lower front left side of the engine compartment as a result of an atomised spray of engine oil being ignited by hot surface ignition. A trail of oil 100 metres long was observed behind the truck. The account of the operator's experience is included at the beginning of this report.

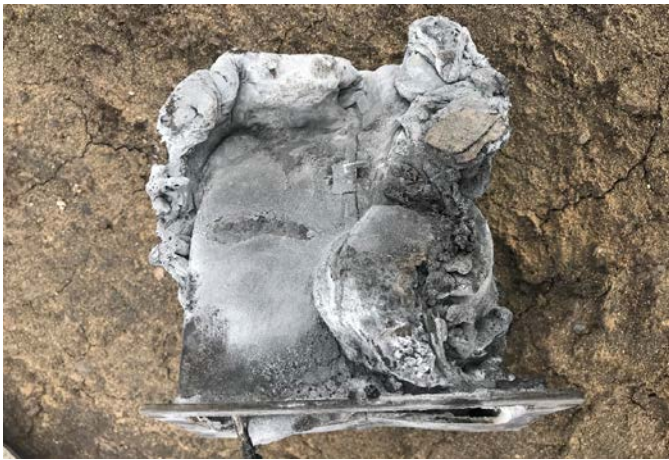
Figure 10 Wilpinjong incident

An operator was using an excavator when he smelled smoke in the cabin. The operator shut down the machine and went out of the cabin. He noticed the cabin air pressuriser was smoking. The circuit breaker installed was 25 amps for a circuit that runs between 1.6 - 2.2 amps.

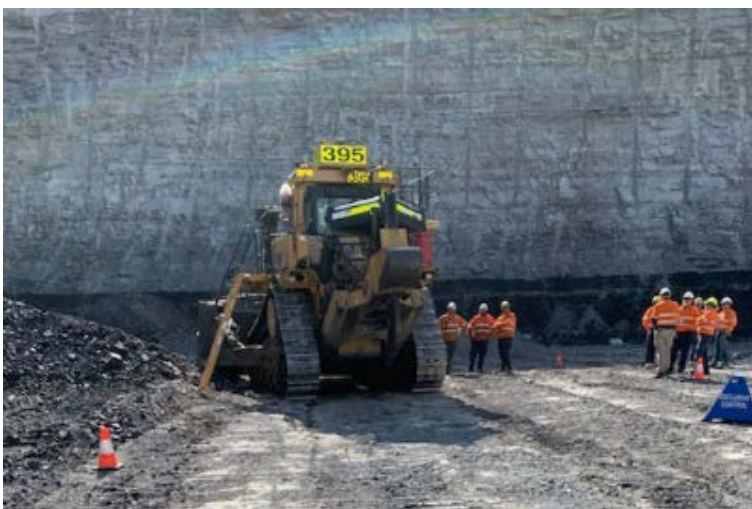
Figure 11 Mt Arthur Coal incident

A small hose rubbed through on the corner of a metal component where the hose was too tight. The hydraulic fluid atomised and was sucked into the engine bay where it was ignited by a hot surface. Fire suppression failed to deploy from a cabin. Deployment required hitting the actuator to puncture the canister. 'I had to hit the actuator three times but couldn't get it to work.'

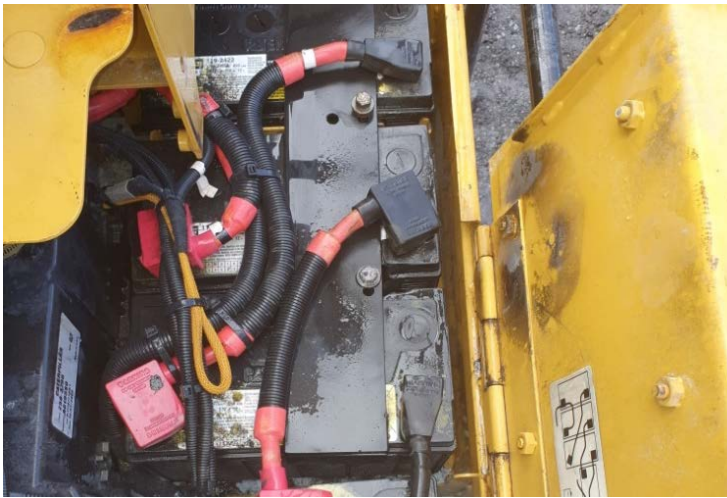
Figure 12 Metropolitan Colliery incident

A dozer operator saw the battery warning light come on. The operator looked at the battery cabinet and could see sparks and flames. The non-original equipment manufacturer battery retaining bracket came into contact with the negative terminal, short circuiting to earth. This caused sparks and flames to be present.

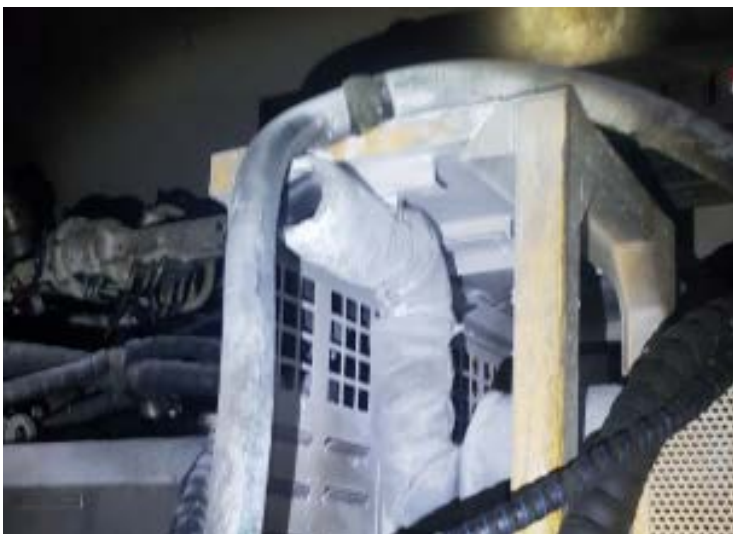
Figure 13 Northparkes Mine incident

Workers were trammung a shotcrete rig from the top of bins to fuel up. As they were trammung, the rubber delivery hose dislodged and fell in front of the exhaust discharge. The rubber delivery hose was burnt by exhaust discharge.

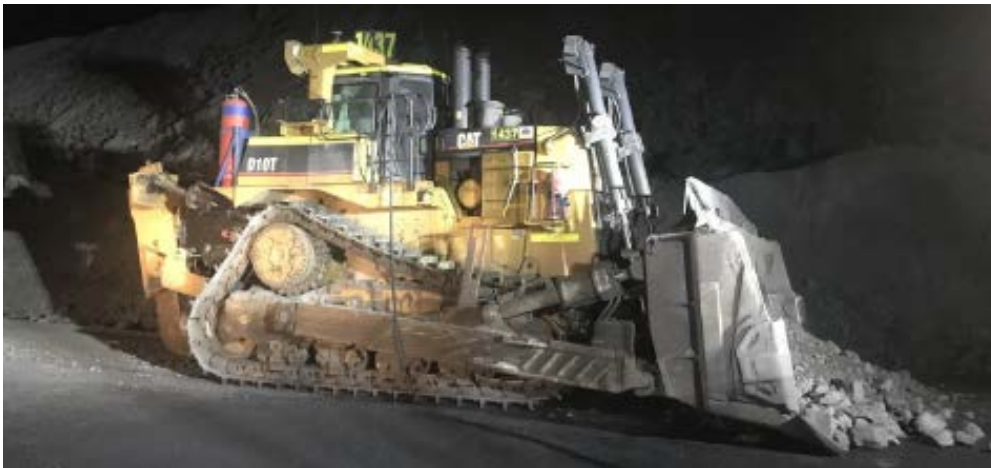
Figure 14 Muswellbrook Coal incident

A hydraulic pilot hose rubbed on the hydraulic pilot filter, creating a pinhole failure in the hose casing. Oil sprayed onto the nearby exhaust/turbo on the right side of the engine. While the turbo and hot exhaust sections were covered in heat shielding (lagging), some oil made its way between sections and ignited.

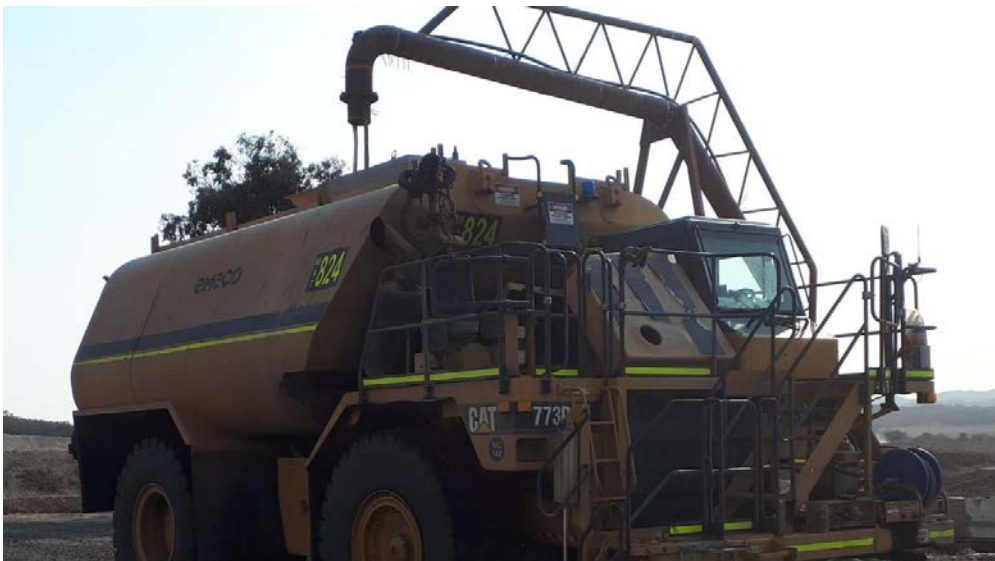
Figure 15 Tarrawonga incident

A water cart was taking water at the southern side fill point when the operator saw flames out of the window. The OEM procedure was not followed by the fitter when installing the fuel filter.

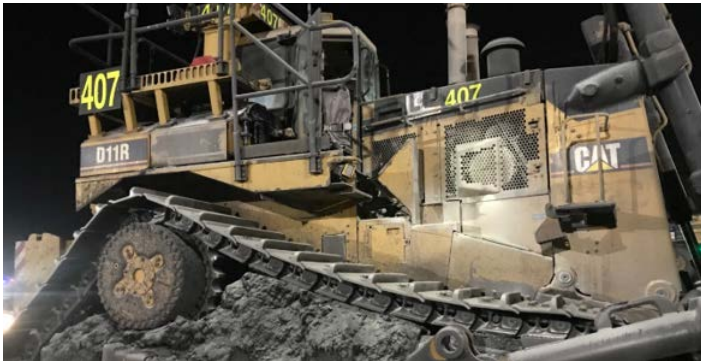
Figure 16 Liddell incident

A fire occurred in the engine bay of a dozer that was operating on the run of mine stockpile. The apparent cause of the fire was a build-up of coal dust within the alternator housing.

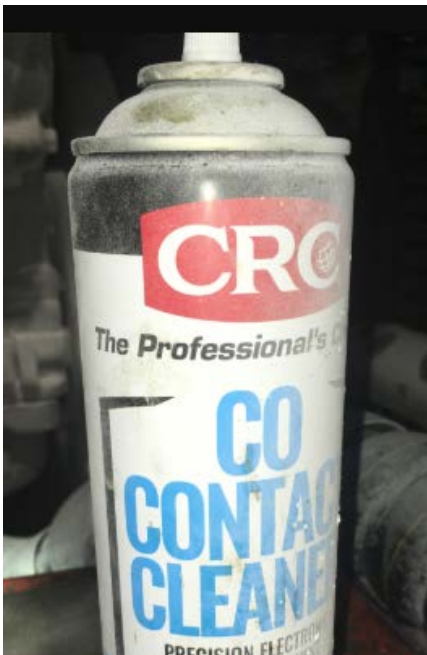
Figure 17 Cadia incident

A fire occurred in the underground workshop during maintenance of a Sandvik loader. A contact cleaner was used to prepare for sealing the battery isolator box. Before closing, a broken wire was identified. During the repair of the wire, a spanner and the start receptacle made contact. A small flash occurred and a small residual flame inside the box was extinguished by a single fire extinguisher.

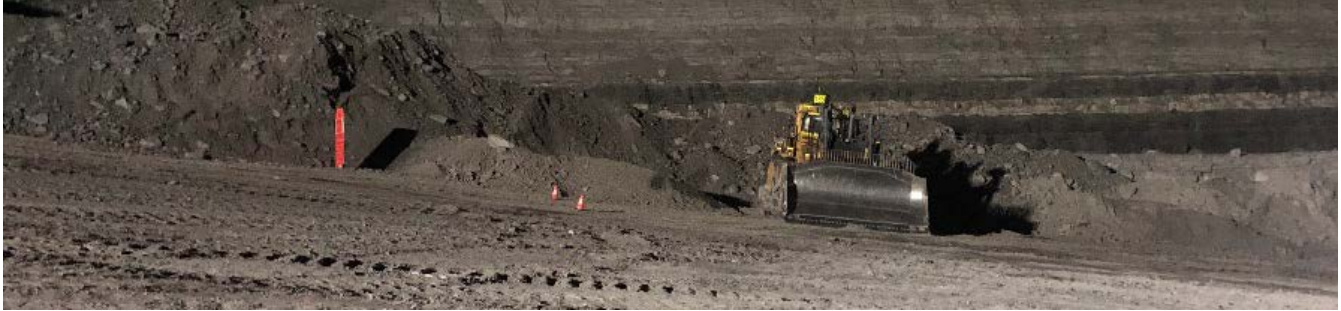
The secondary drive train hydraulic oil filter was not correctly tightened during a service and this allowed oil to leak into the engine bay and be ignited by hot surfaces, most likely the turbo.

Figure 18 Dozer engine bay fire

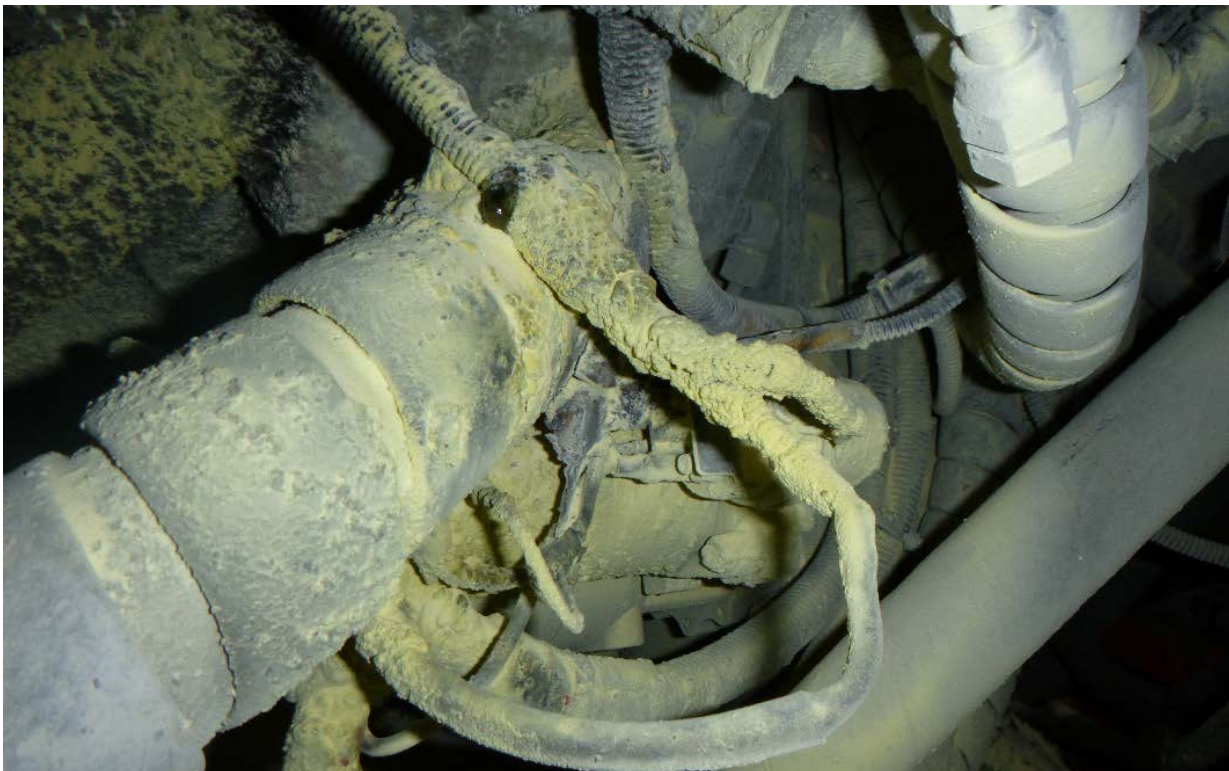
Figure 19 Tritton Copper Mine incident

A small flame was observed due to the short circuit of a low voltage wire in a starter circuit. The machine master isolator was isolated at the time of the incident, under maintenance in the surface mobile workshop.

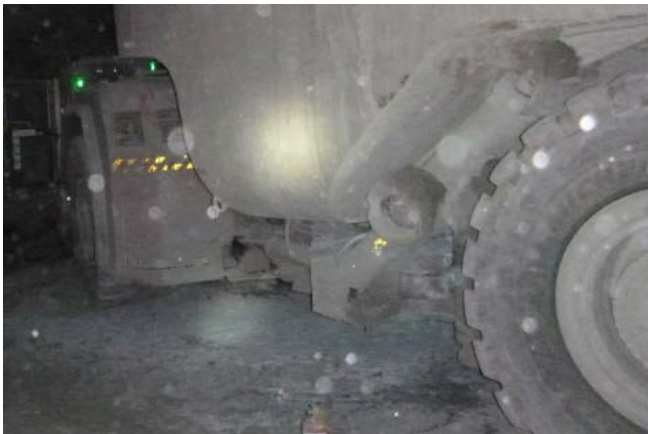
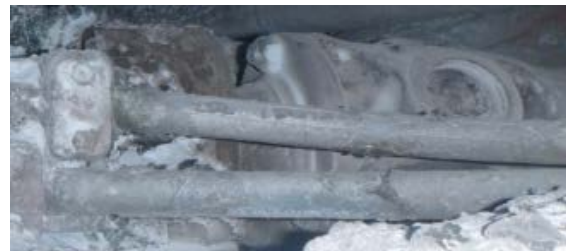
Figure 20 and 21 Tritton Copper Mine incident

A bearing failure resulted in a fire. An investigation by a maintenance team indicated that the rear driveshaft support bearing overheated, causing the fire. The bearing was under the tub area and was not adjacent to any significant fuel source. The fire was presumed to be from grease contained in bearing.

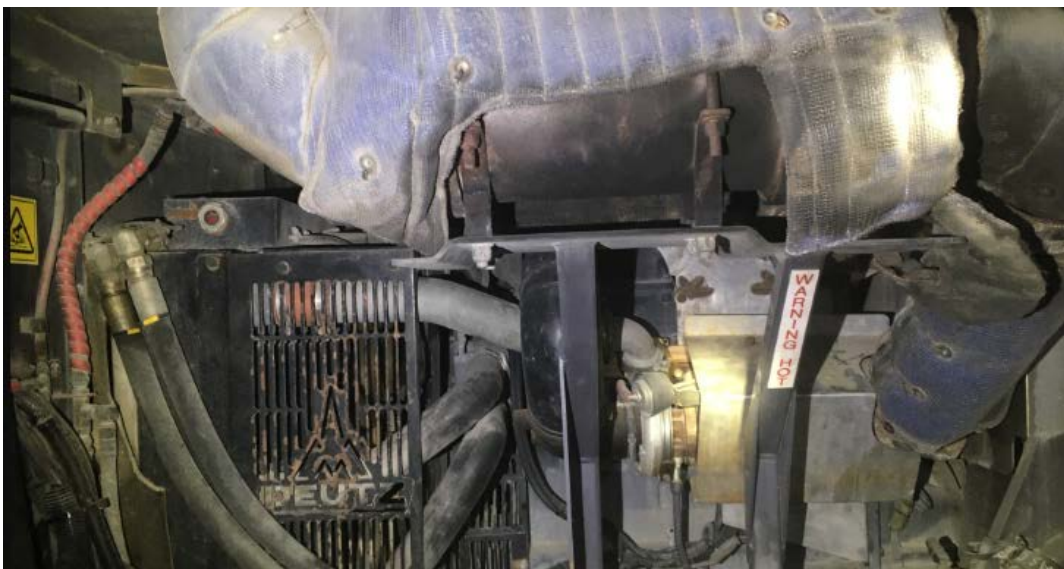
Figure 22 Cadia East incident

An Atlas Copco E2C drill rig was tramming on the VR4 main decline when the engine stalled. When trying to restart it, flames were seen in the exhaust of the machine. Residual diesel from the fuel system failure or fuel system repairs accumulated in the exhaust system.

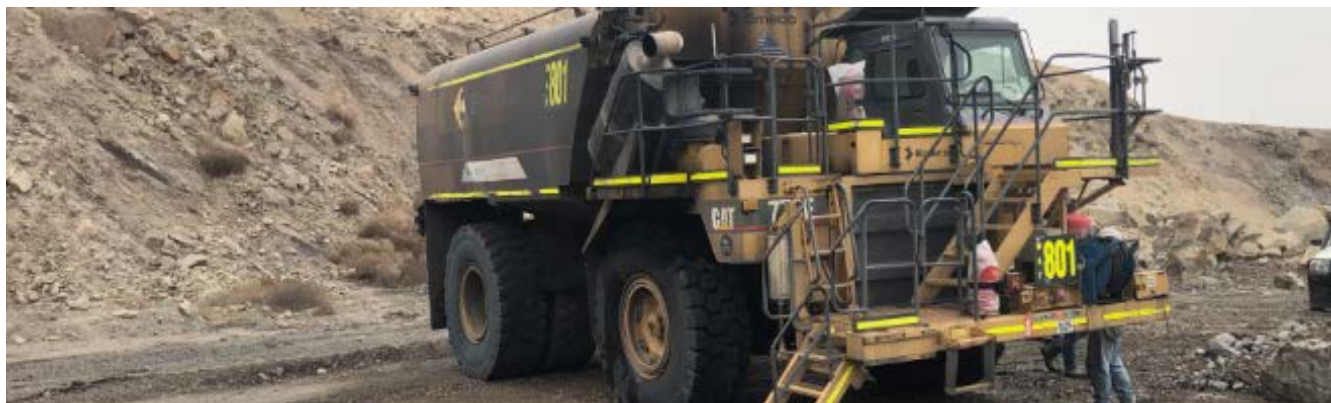
Figure 23 Werris Creek incident

A fire occurred on a water cart. The operator saw the flames and activated the on-board fire suppression system. The fire appeared to be on a tyre, so the area was evacuated as per the mine's procedure. The cause of the fire is yet to be determined.

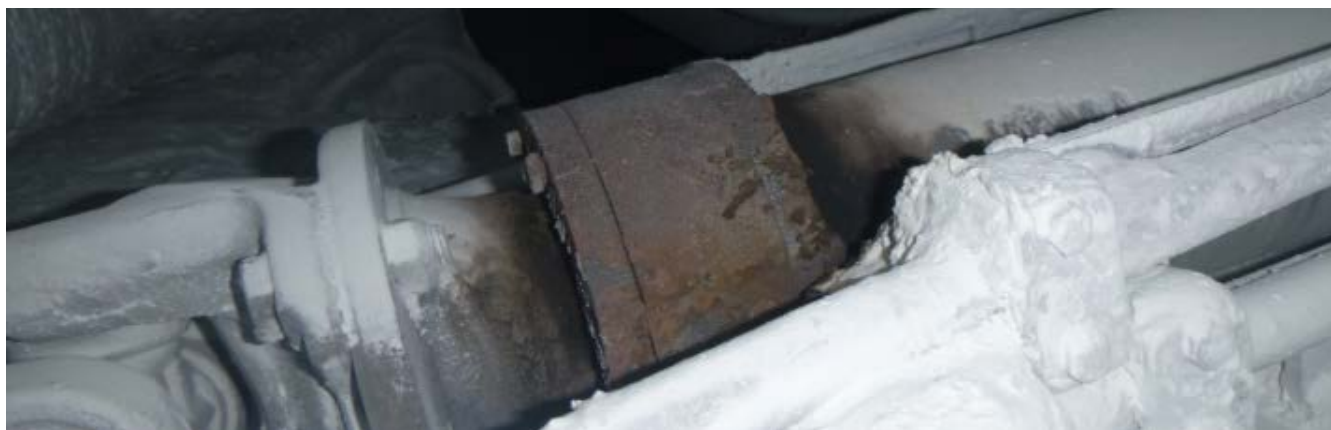
Figure 21 Tritton Copper Mine incident

A fire was caused by a bearing failure and subsequent grease ignition.

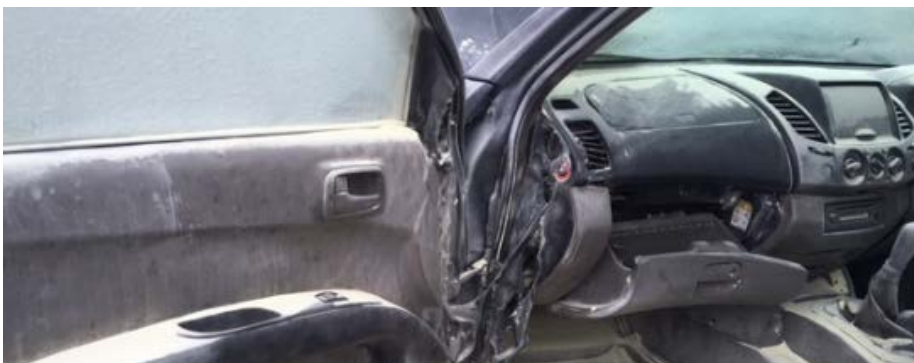
Figure 23 Southern Operations incident

Workers identified smoke in the interior of a parked surface light vehicle, when the passenger door was opened, flames were observed in the vicinity of the passenger side door trim and glovebox area. The fire was extinguished using a hand-held fire extinguisher. The investigation concluded that high resistance in an electrical plug generated heat, resulting in a fire.

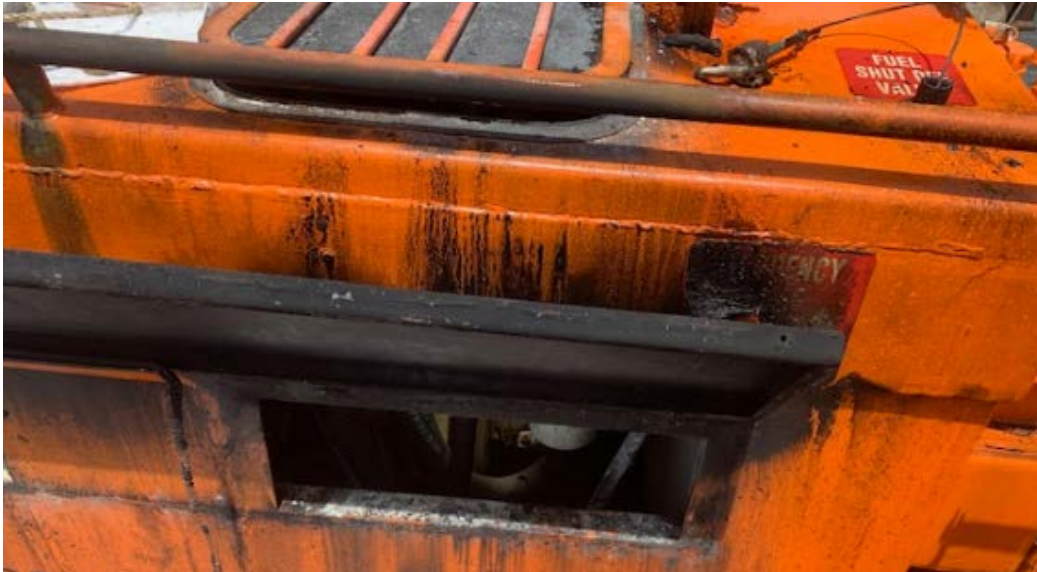
Figure 24 High Quality Sands incident

A dredge on the river, at the southern end of the extraction area, caught on fire in the engine compartment. The dredge operator followed the fire procedure, closed all the hatches and used the fire extinguisher to put out the fire. The dredge was extensively damaged, but the operator wasn't hurt.

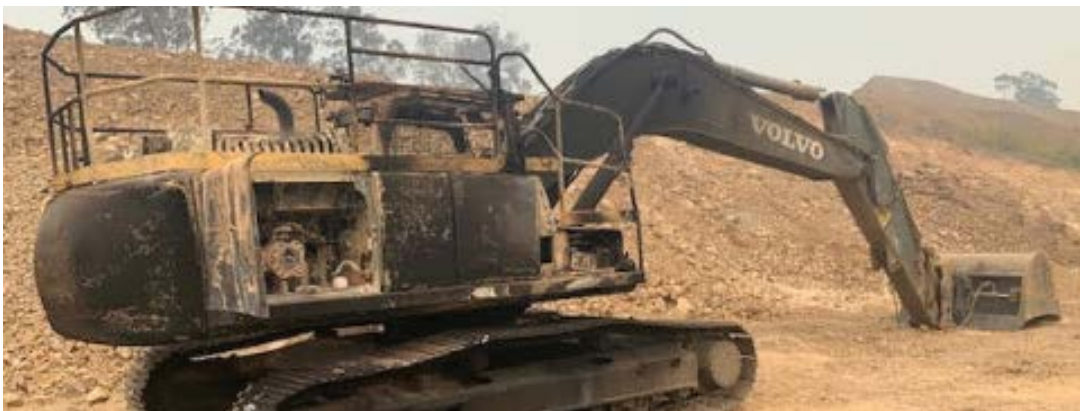
Figure 25 Mount Zion Quarry incident

A severe fire came from the west of the quarry. The fire was declared a Section 44. Machines were spread throughout the quarry, in hopes that the fire would miss the machines. Machine 143 and machine 326 were about 60 metres away from each other, facing away from the direction of the fire. The operator was unsure how the machines caught alight.

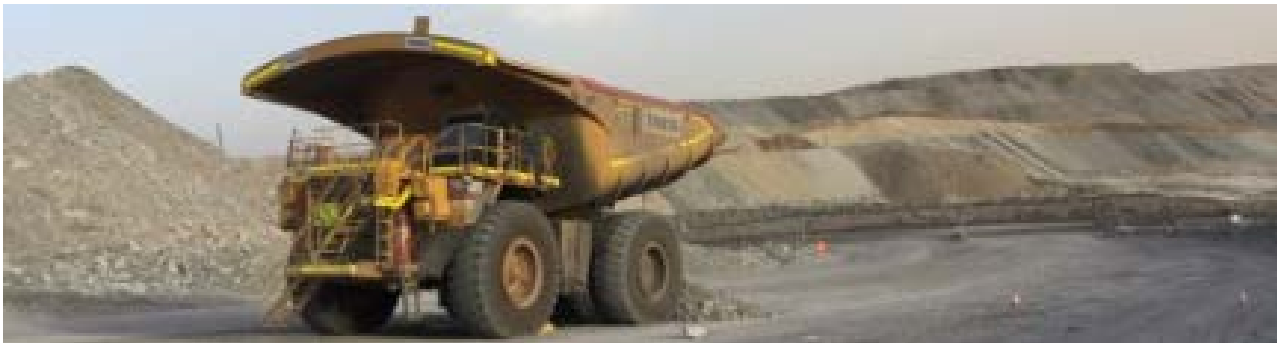
Figure 26 Mt Arthur South incident

While travelling to a dump, a haul truck shut down. The operator called maintenance personnel, who inspected the truck and found the fire suppression system had been activated. The turbo oil feed lubrication line was found to be inadequately tightened. This condition allowed oil to leak and ignite on the hot turbo surface.

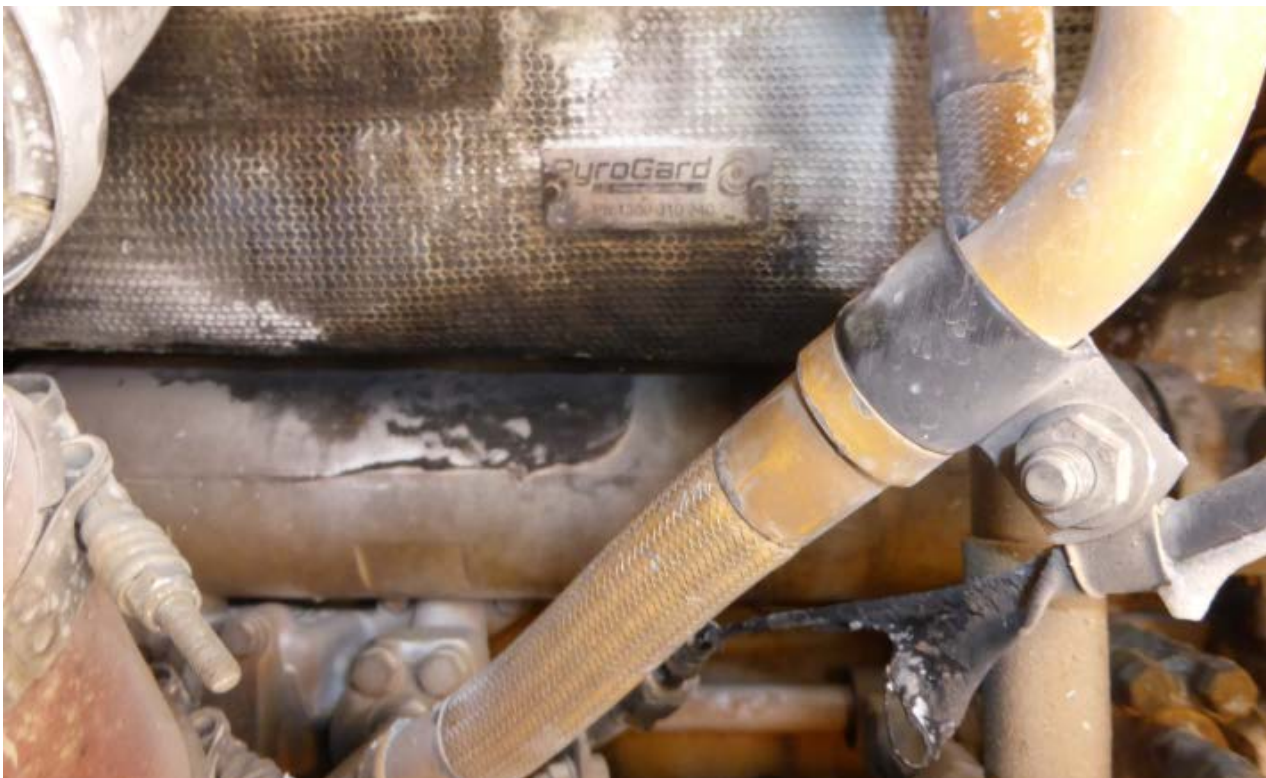
Figure 30 Coal Gold Mine incident

A fire occurred in a service truck. The exhaust manifold failed.

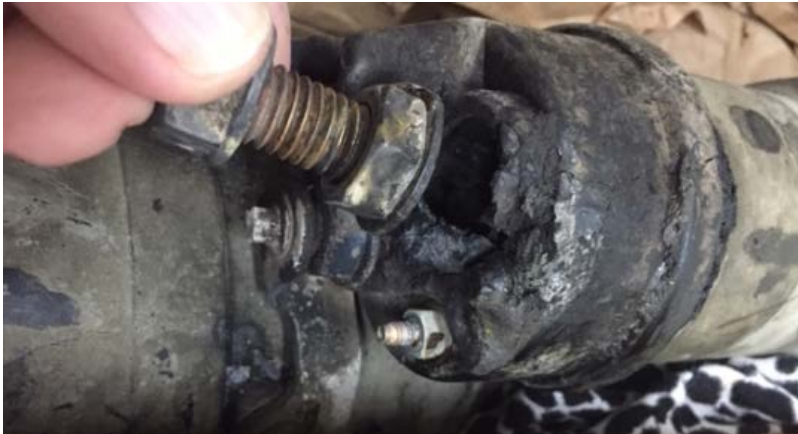
Figure 31 Peak Gold Mine incident

A starter motor solenoid failed to disengage on starting the engine. The heat from the continuously running starter motor and/or electrical contacts shorted out, caused heat and the insulation on nearby cables to melt and generate flames.

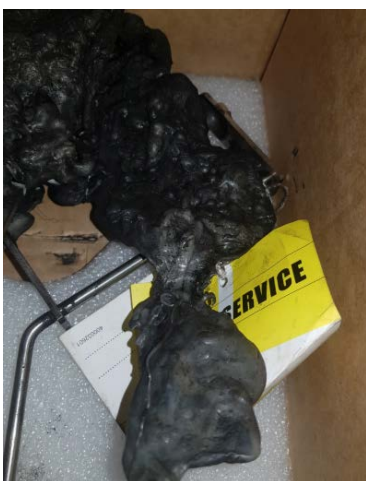
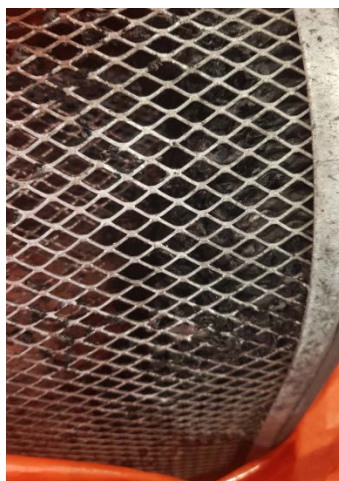
An underground coal diesel vehicle has continued to run without the explosion protection of the water-based exhaust flame trap. Without the cooling effect of the water barrier, elevated temperature in the exhaust melted, shutdown floats and burnt the exhaust particulate filter.

An operator found a burnt, melted diesel particulate filter in the filter housing and burnt, melted scrubber floats in the scrubber tank, with the water tank empty. The machine did not shut down when the scrubber water emptied. The machine continued to run in this state, increasing the exhaust gas temperature. The exhaust gas temperature sensors did not identify high exhaust gas temperature and did not shut down the machine, allowing the machine to sustain the elevated temperature while operating. This resulted in the disintegrated, burnt diesel particulate filter and the melted scrubber floats.

Figure 32 and 33 Tahmoor incident - melted low water shutdown floats and exhaust filter element

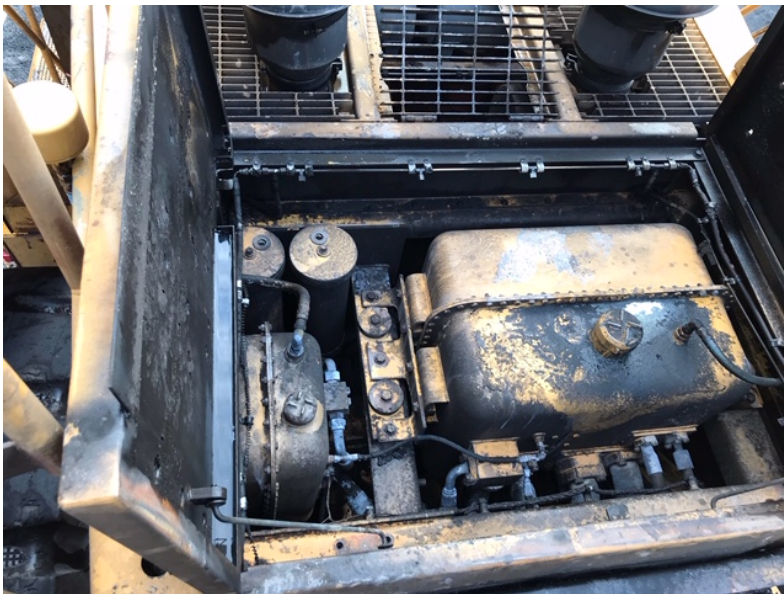
Figure 274 Rix’s Creek incident

A starter motor was the initiation point of a fire.

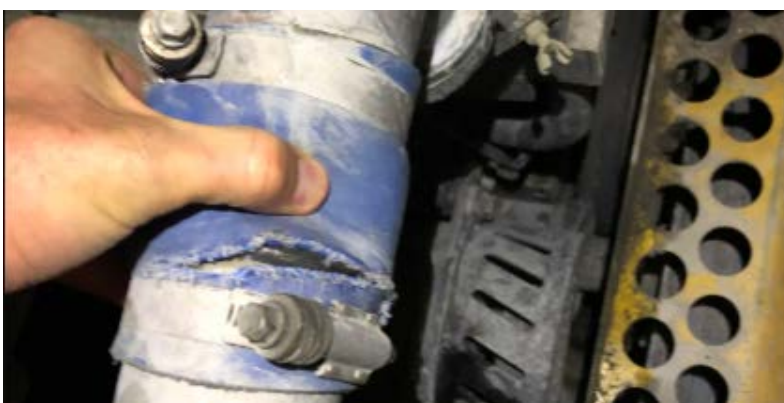
Figure 285 The CSA incident

On an Epiroc 5020 haul truck, coolant released from a damaged hose onto a hot surface initiating a fire.

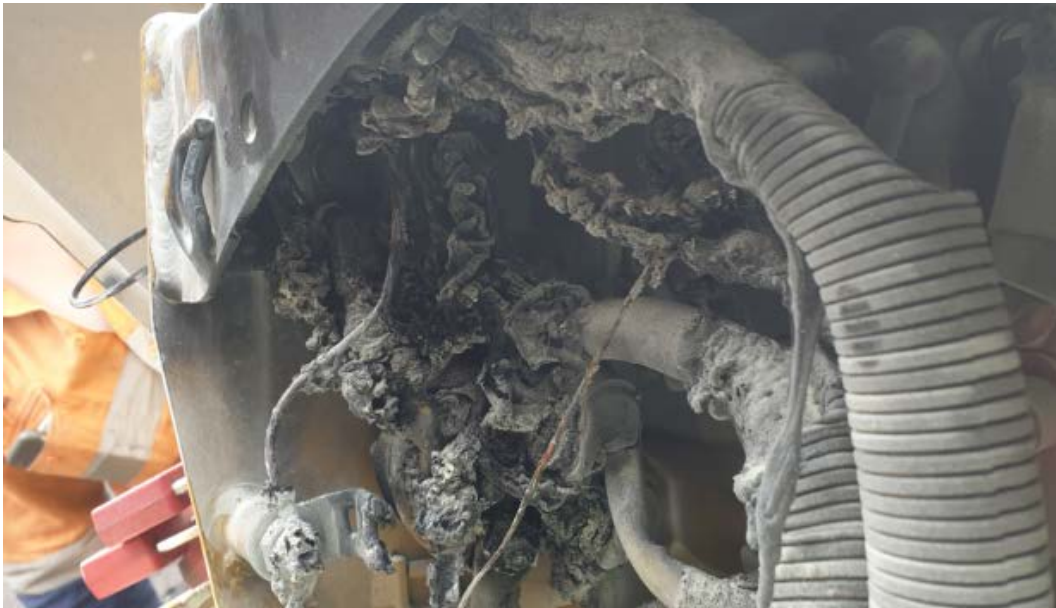
Figure 296 The Wilpinjong incident

An operator was driving a water cart along a haul road when smoke was seen coming from under the cab. The operator and the passenger exited the cab and activated the fire suppression system.

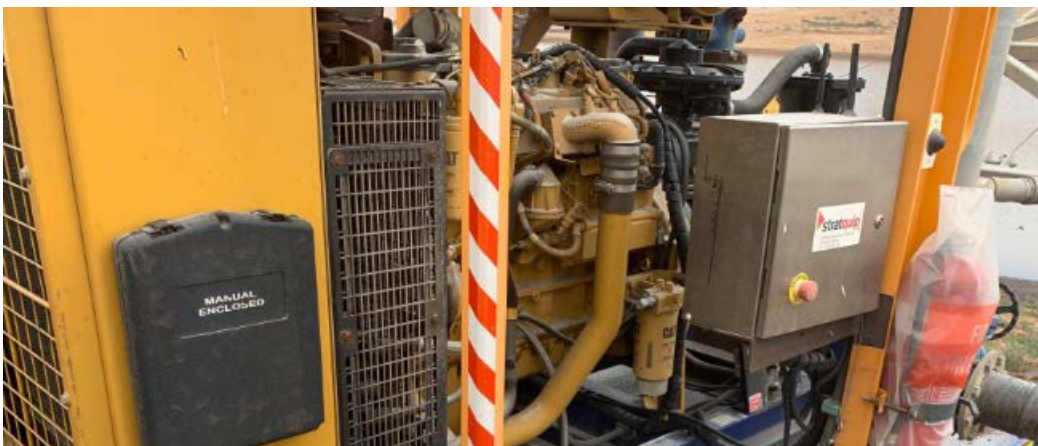
Figure 307 Mount Pleasant incident

A fire occurred in a tailings dam water transfer pump. During the warm down process of shutting the pump down, the operator saw smoke coming from the turbo area of the pump. It was thought that the cause of the fire was heat damage on a hose adjacent to the turbo.

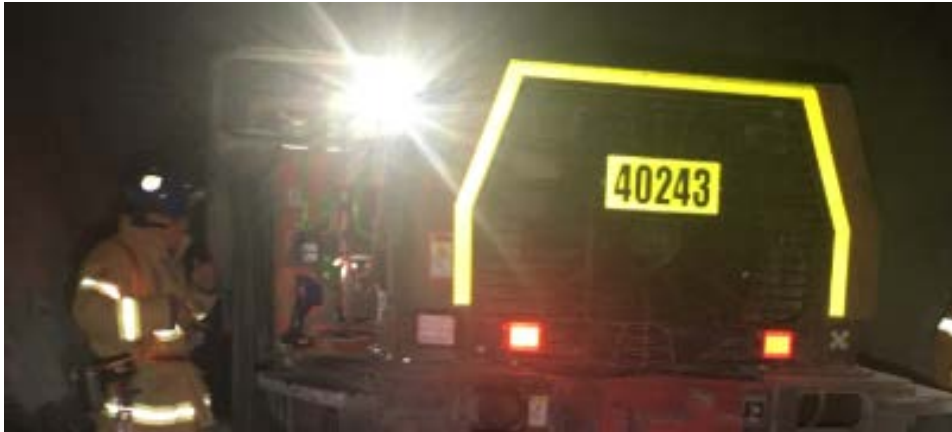
Figure 31 Cadia East incident

A fire occurred on a load haul dump (LHD) vehicle underground. The fire suppression system was activated. Three workers went to the refuge chamber as a precaution. The cause is yet to be determined.

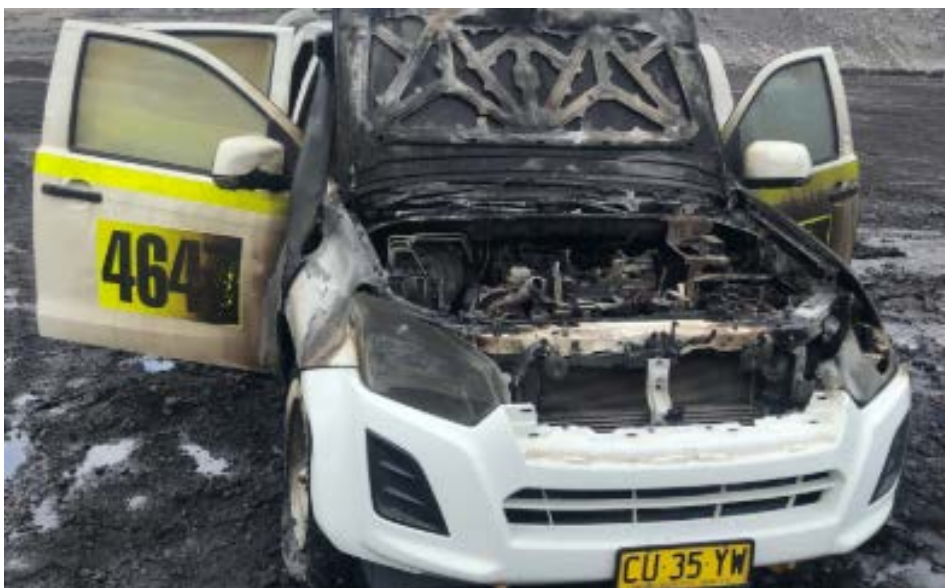
Figure 32 The Mt Arthur incident

The active cable between the battery and the isolator was installed in contact with the mounting bracket of the isolation switch. This caused some shorting of the cables, which was the potential cause of the fire on light vehicle, as the fire appeared to have originated from the area around the battery.

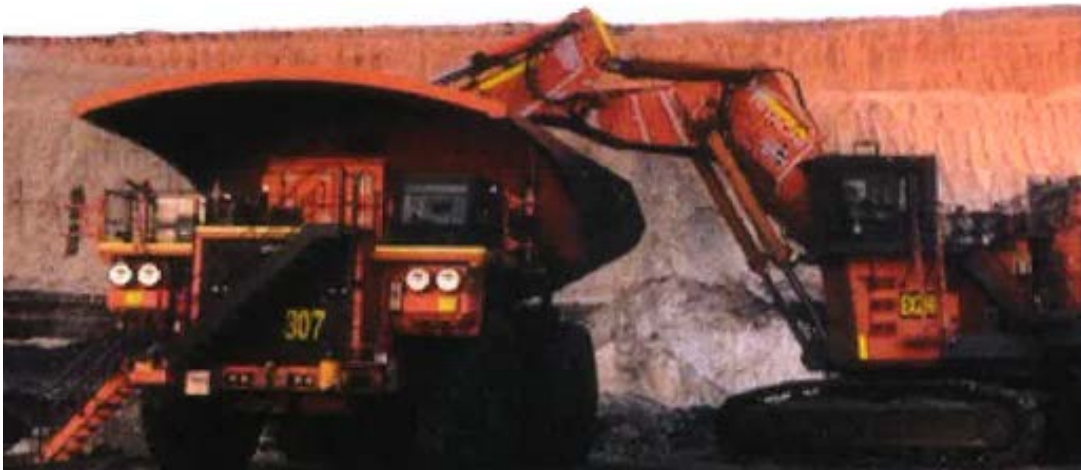
Figure 40 Boggabri incident

A bucket excavator lost power and an operator noticed a check engine light illuminated. The operator saw flames within the engine bay, so immediately activated the onboard fire suppression system. The fire was started by a fault in a wiring harness.

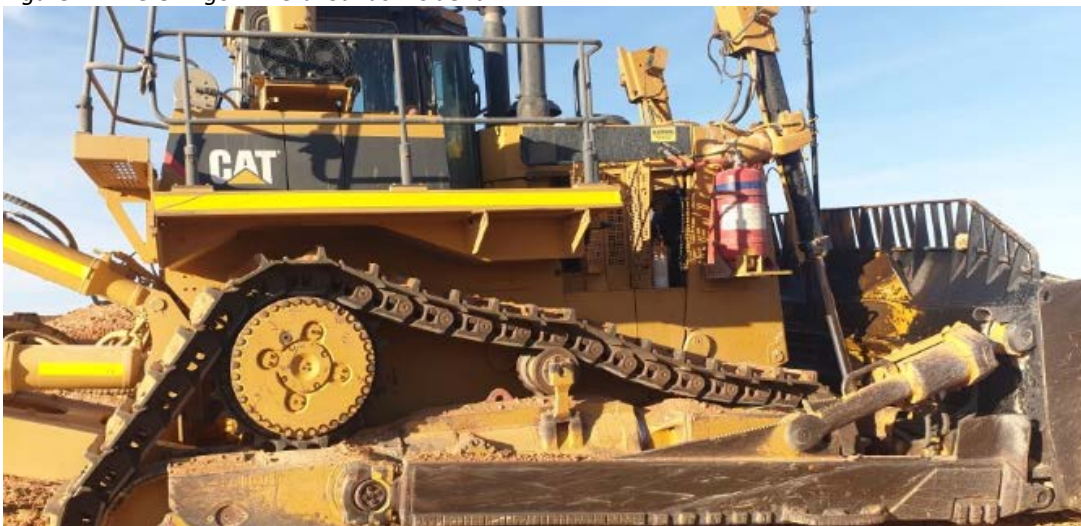
Figure 41 The Ginkgo Mineral Sands incident

The operator of a dozer noticed that the blade looked a little too shiny and suspected a fire, so went to investigate. Upon investigation, he saw a small fire at the back of the engine bay.

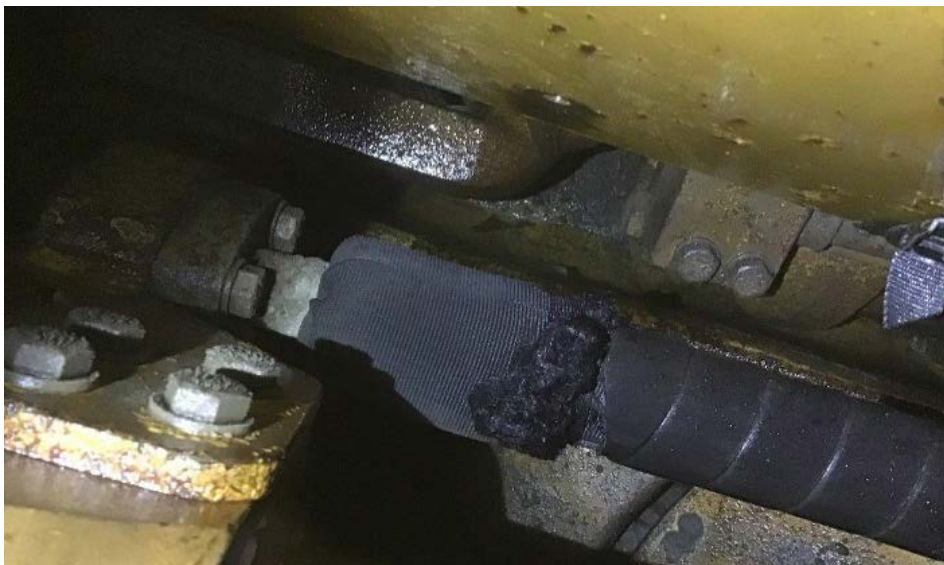
Figure 43 Cadia East incident

A fire occurred on an underground loader when a cylinder hose failed at the front of the machine. The hose failed at the hose-end ferrule crimp.

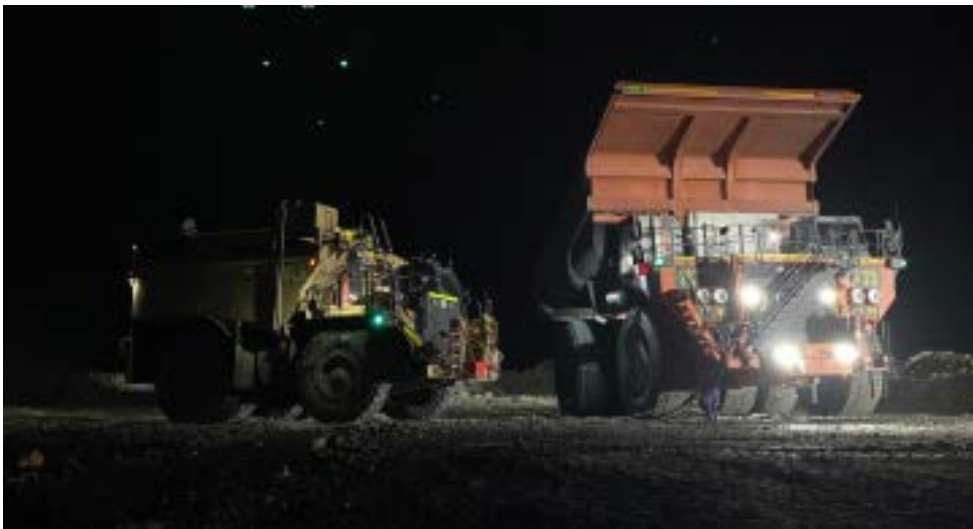
Figure 44 Bengalla incident

A fire occurred on a haul truck when the turbo feed line failed on the right-hand front turbo.

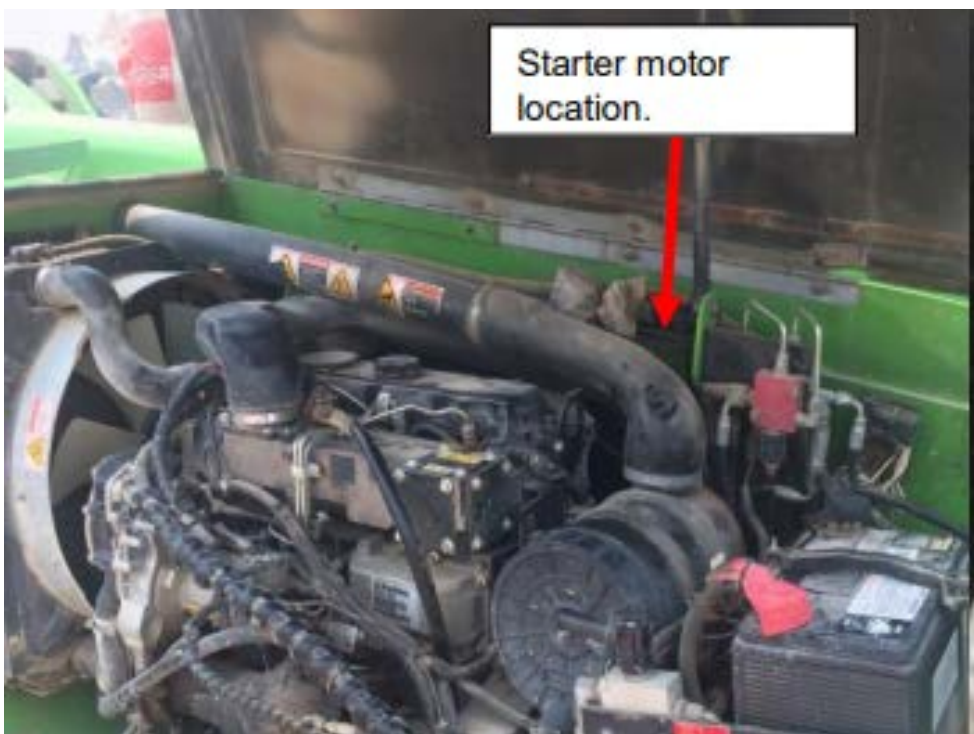
Figure 45 Northparkes incident

While attempting to jump start a telehandler, a fitter saw smoke coming from an engine bay. On further inspection, he found a flame coming from the electrical cables near the starter motor.

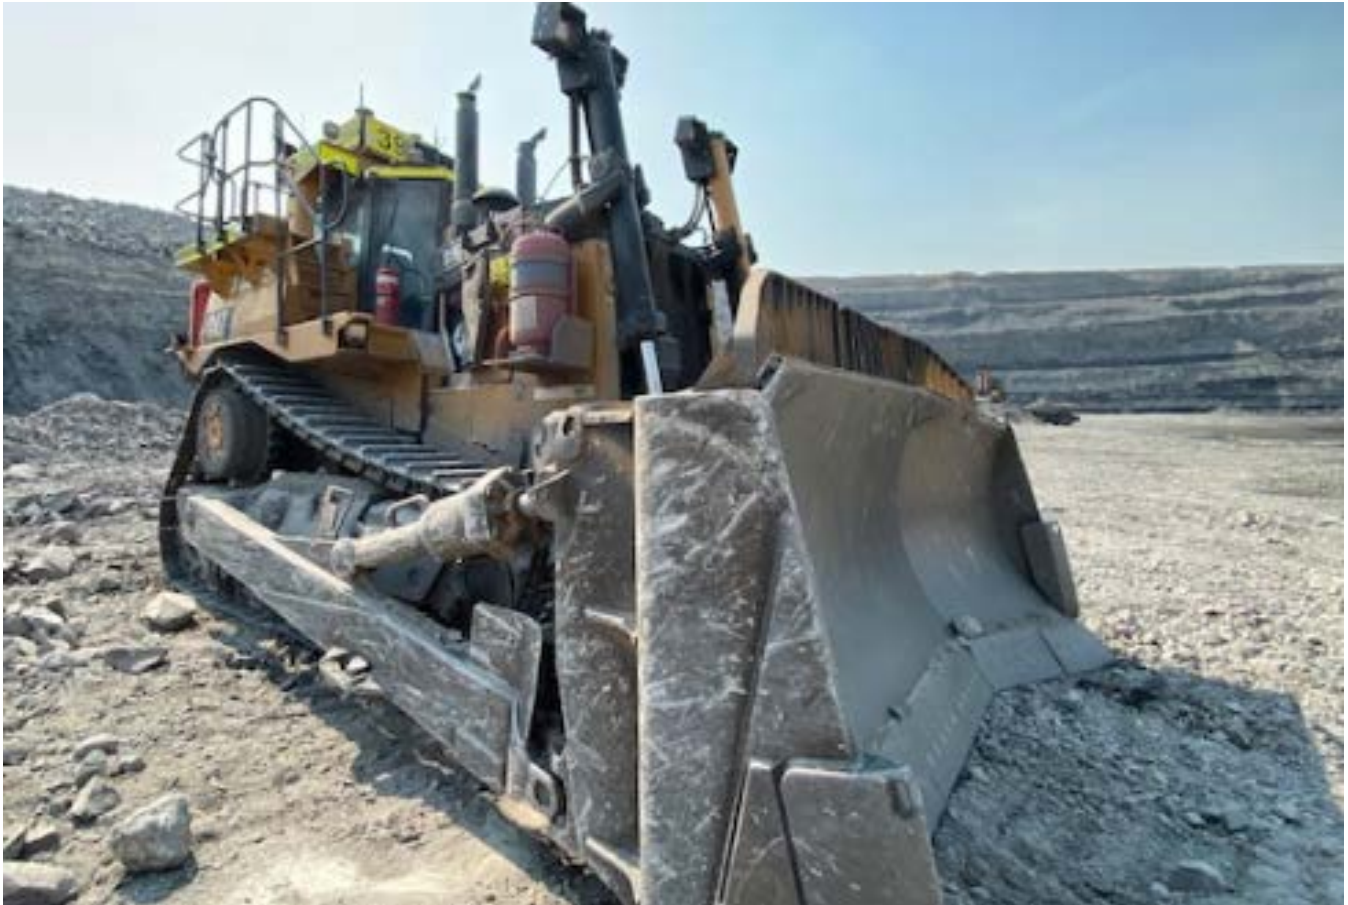
Figure 46 Mt Arthur Incident

A 'P clamp' hose support was installed but had not been properly secured to the engine. This allowed the hose to rub through allowing hydraulic oil to spray through the engine bay. Some of the oil ignited, causing a fire on the sound suppression material.

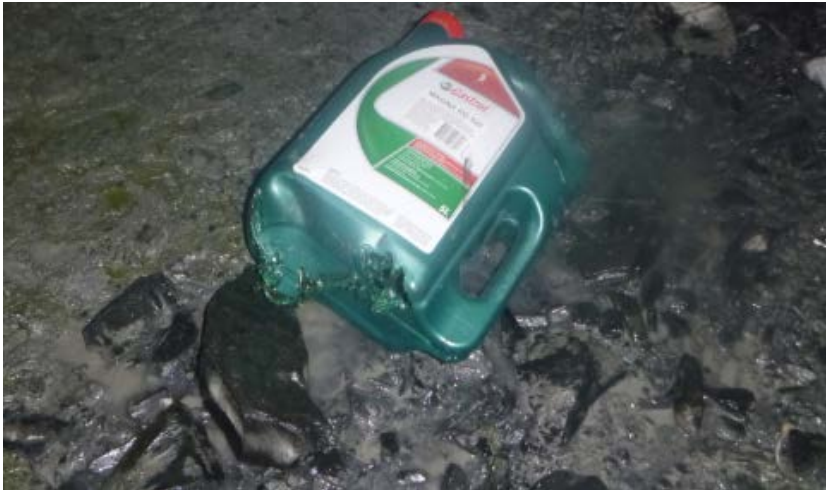
Figure 47 CSA mine incident

A 5-litre lubrication oil container placed on a Jumbo compressor motor melted, allowing oil to leak onto a hot motor. The operator went to the refuge chamber and the workers in the rest of the mine were evacuated in accordance with the mine's procedure.

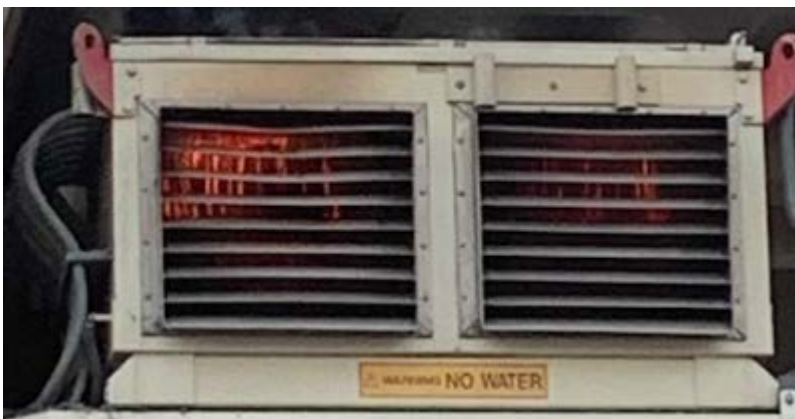
Figure 48 Mt Arthur incident

A haul truck grid box fire occurred. Investigation on the cause is ongoing.

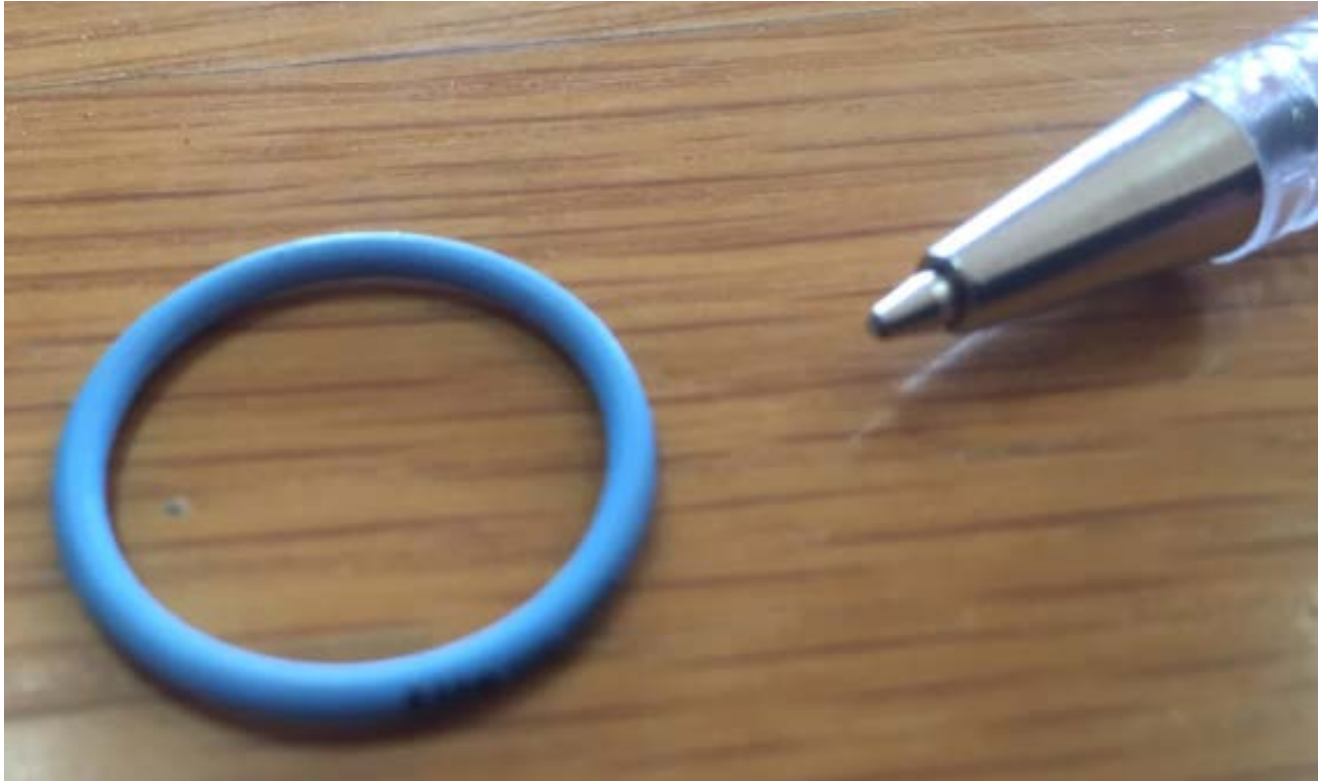
Figure 49 Marulan South incident

The fuel inlet hose from a fuel pipe (mounted to the tank) became loose, allowing fuel to leak/spray past the O-ring seal and onto the hot manifold. The estimated fuel inlet pressure was 80 PSI.
