FIRES ON MOBILE PLANT

October – December 2020

Title: Fires on mobile plant, October - December 2020

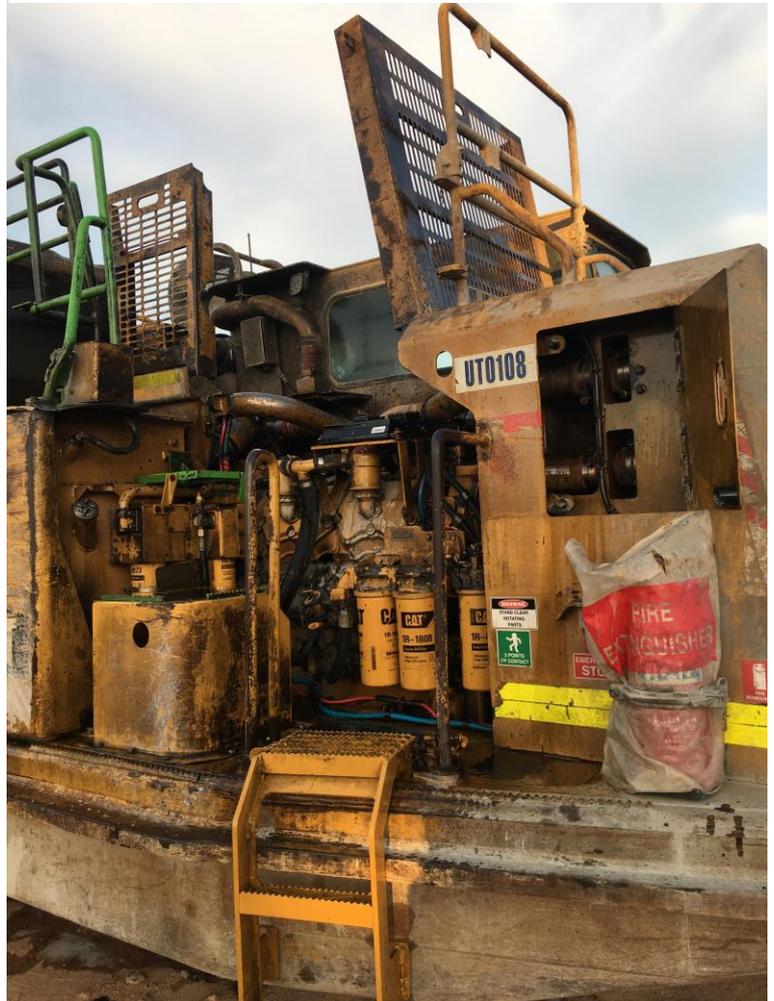
Figure 1: Engine bay covered in hydraulic oil

A Caterpillar AD55B dump truck was travelling out of the underground. As it exited the portal and was driving to the surface park up area, a small engine fire started.

The haul truck operator saw the flame coming from the exhaust guard. The operator manually initiated the fire suppression system which extinguished the flame. A large amount of hydraulic oil was evident over the engine bay.

The investigation noted that a fan motor hydraulic leak had been repaired prior to the incident. The investigation found an incorrect O ring was used during this repair. When the replacement O ring failed, hydraulic oil sprayed over the engine, assisted by the engine fan.

This incident is a pertinent reminder of the importance of quality maintenance work required. The potential existed for a much larger fire due to the fan working to spread oil over the engine.

Additionally, for this type of incident where a fuel source is sprayed over the engine, hot surface protection or fire resistant fluids are the only controls available.

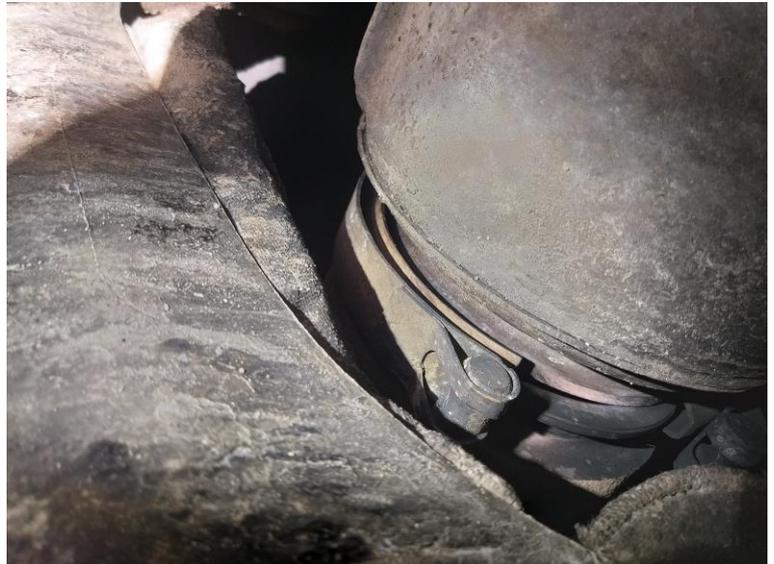
Figure 2: Failed clamp

A Sandvik TH663 dump truck was being driven out of the mine when a fire started due to the exhaust separating from the turbo which ignited the lagging.

The clamps connecting the turbocharger and the exhaust pipe had failed. The clamping bolt was missing from the clamp.

This failure caused the exhaust pipe and turbocharger to separate allowing excessive heat to flow around the heat turbo shielding. The excessive heat affected the wiring harness to the starter motor and the earthing harness at the rear of the engine.

Also, part of the turbo shielding had scorching, evident of a small fire.

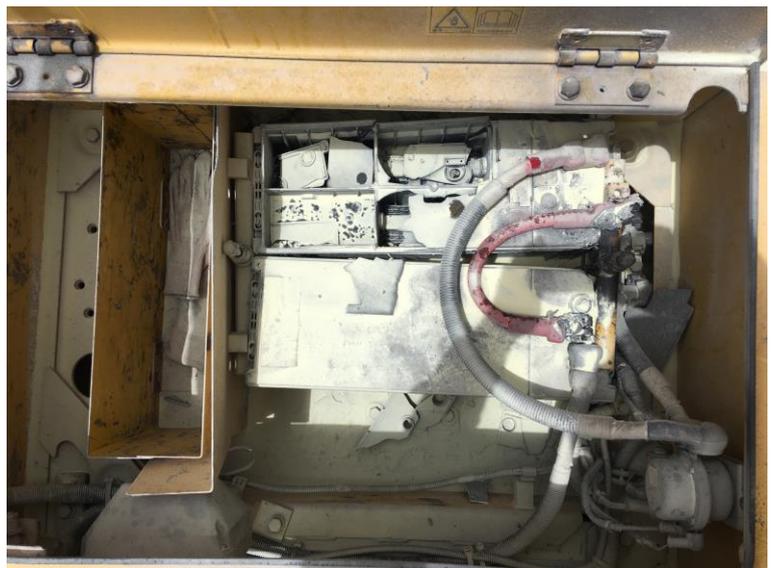
Figure 3: Damaged battery

The operator of a Komatsu PC350-8 excavator noticed smoke coming from the battery enclosure of the machine while loading a truck. The operator shut the excavator down and called the truck driver. When the enclosure was opened, the battery was on fire. The operator attempted to extinguish the fire using the fire extinguisher that was fitted to the excavator.

This extinguisher failed to work. When the operator moved away to retrieve a second extinguisher from the truck driver, the battery exploded. The worker was not injured.

The investigation conducted by the mine identified that the bracket that retains the battery had become loose. This allowed the battery to move, which has led to the bracket contacting the terminals, shorting the battery.

The fire extinguisher fitted to the excavator was found to be ineffective as the powder had settled.
