INVESTIGATION INFORMATION RELEASE

Worker injured by failed components during mobile jaw crusher maintenance

Incident date: 26 February 2021

Location: Buckaroo Mine, Mudgee NSW

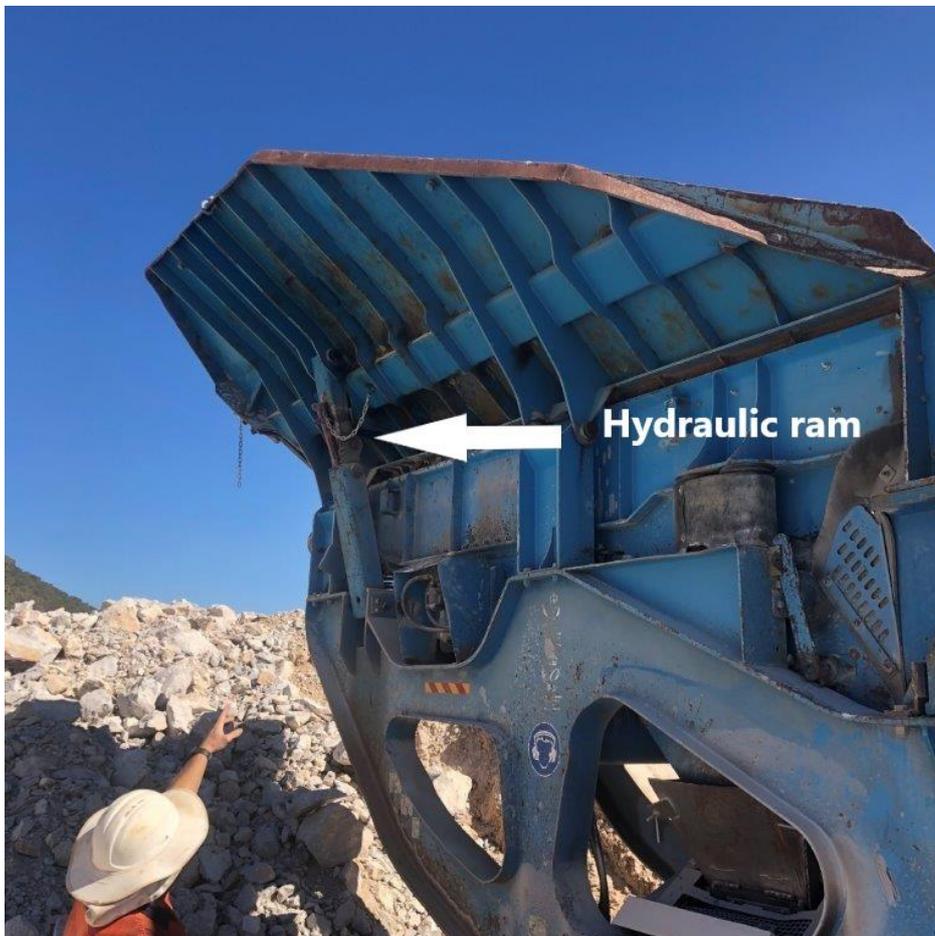
At about 8:30am on 26 February 2021, workers at the quarry were attempting to free a jammed hydraulic ram to lower the wing on a mobile jaw crusher.

Figure 1: Arrow pointing to the hydraulic ram that normally raises and lowers the wing of the crusher.

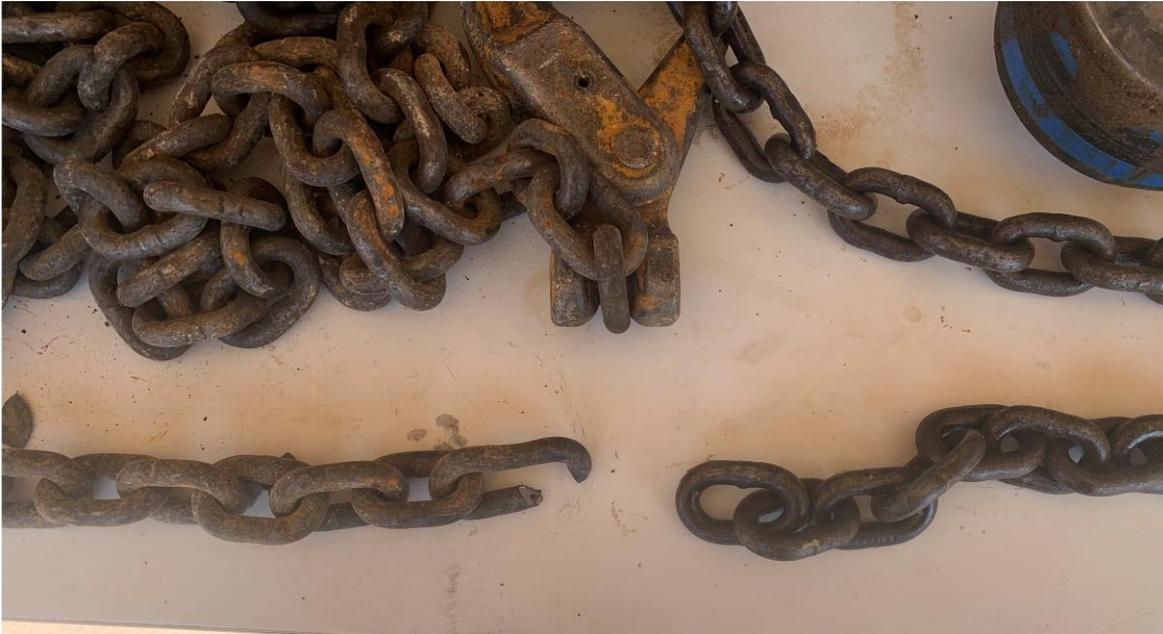
The workers connected an 8-millimetre alloy sling grade T80 chain assembly (WLL rated at 3.5 tonne in straight lift) between the excavator and components of the hydraulic ram on the crusher wing. During the task, the excavator was used to apply a sideways pull force to components of the hydraulic ram.

An uncontrolled release of energy occurred causing the chain assembly and components of the hydraulic ram to fail and a worker to sustain a serious injury.

Figure 2: Failed chain components of the chain assembly used

When planning tasks involving lifting equipment, the WLL rating of the chain assembly and maximum pull/lift force (including potential for shock loading forces) that could be applied to the chain assembly, including selection of connection points, must be considered in a pull/lift system design.

Mine operators and workers must ensure safe standing zones are identified and established to account for potential component failure in the work system.
