**NSW
Resources
Regulator**

INVESTIGATION REPORT

REPORT INTO THE SERIOUS INJURY OF A WORKER AT APPIN NORTH MINE

8 June 2019

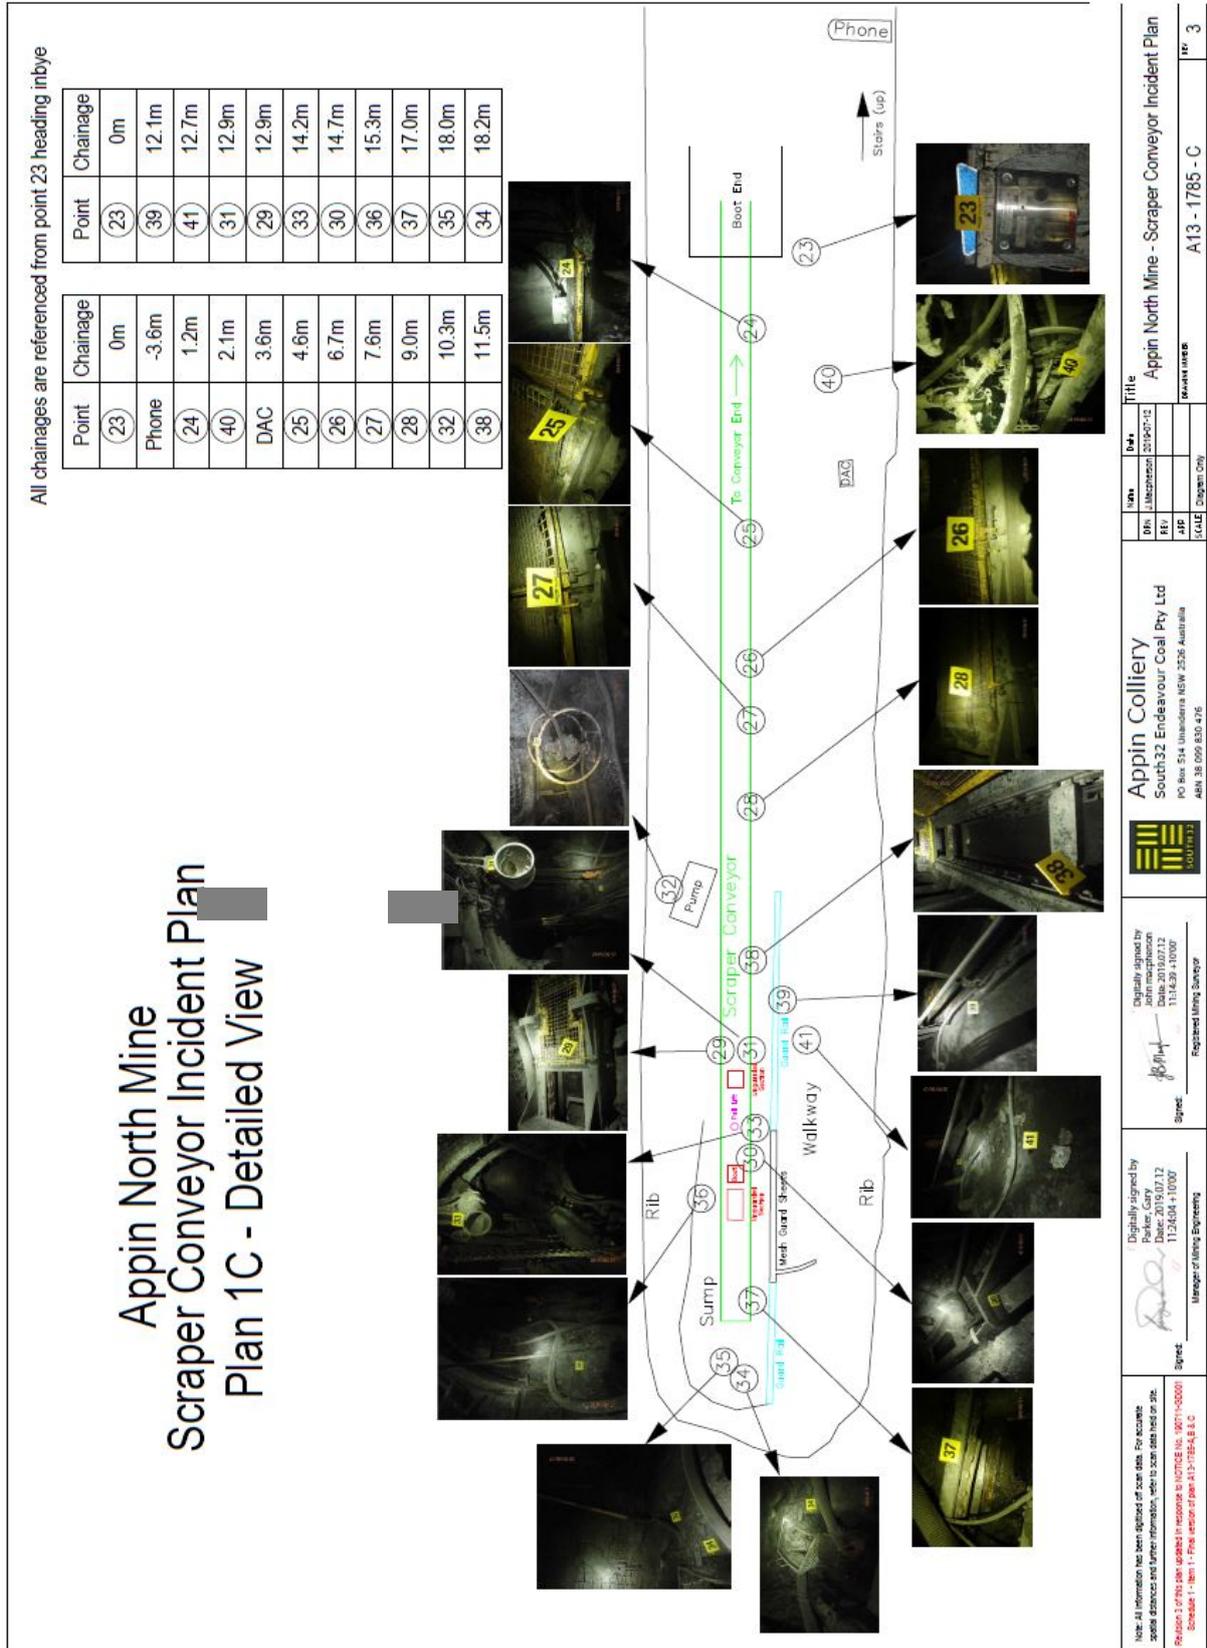
Figure 6. Survey plan of the scene

As the worker continued to use the hose, he walked toward the concrete sump end of the scraper conveyor. He approached a lift point section on the conveyor, installed to allow the conveyor to be lifted with a chain block (refer to figure 6 Survey Plan – location 29).

There was a section in the scraper conveyor that measured 270 millimetres in width and 290 millimetres in length adjacent to the lift point (refer to figure 6 Survey plan – location 29) that was not covered by the yellow steel guard.

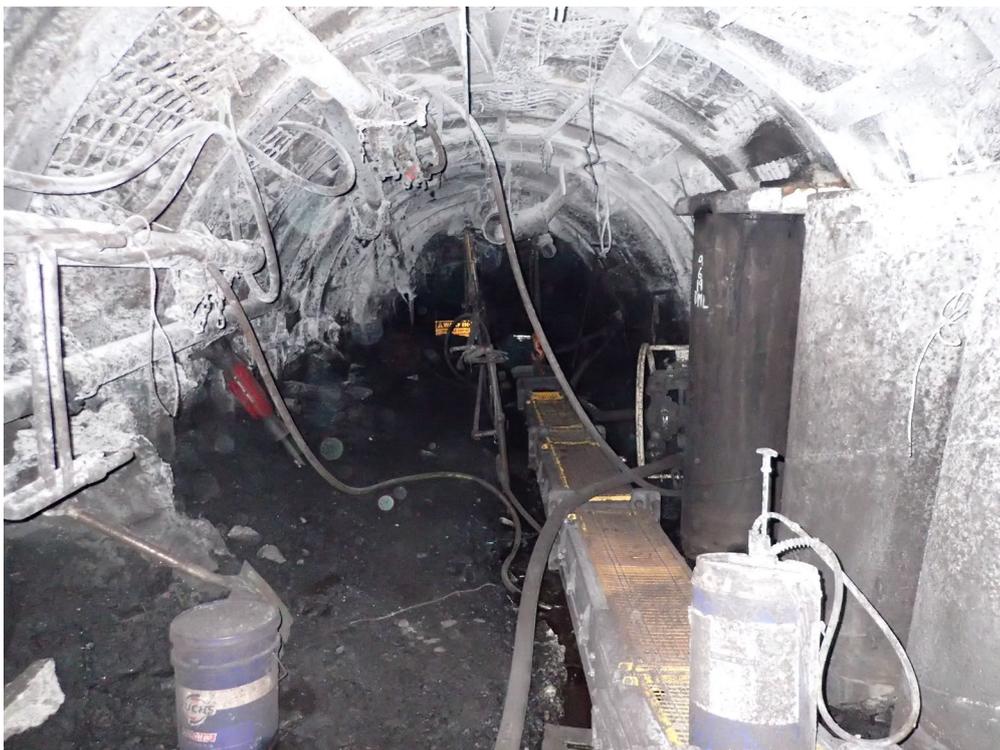
As the drift floor adjacent to the conveyor, that was normally used as a walkway, was covered in coal debris, as shown in figure 7, the worker used the steel covered conveyor as a walkway, as it was a safer option, being flat and sturdy.

Figure 7. Walkway covered in material

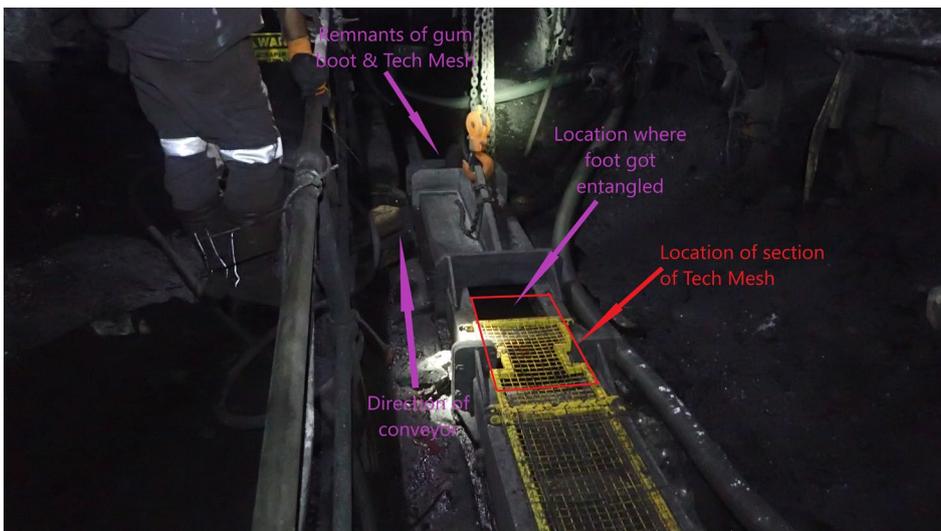
The worker was unable to see that there was a void underneath the tech mesh, when he placed his foot on this section and commenced to place weight on the foot the tech mesh bent down. Both the workers foot and the section of tech mesh became entangled with the flight bars of the moving scraper conveyor as shown in figures 9 and 10.

Figure 9. Location where the workers foot got entangled

The worker partially covered the open section with the tech mesh, leaving a small gap closest to the lift point. The location of the gap can be seen in figures 9 and 10.

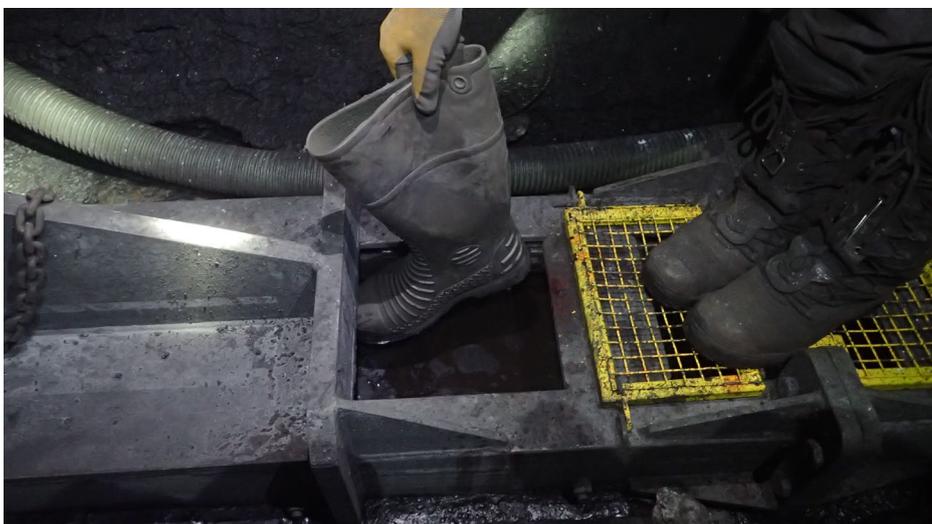
Figure 10. The void post-incident

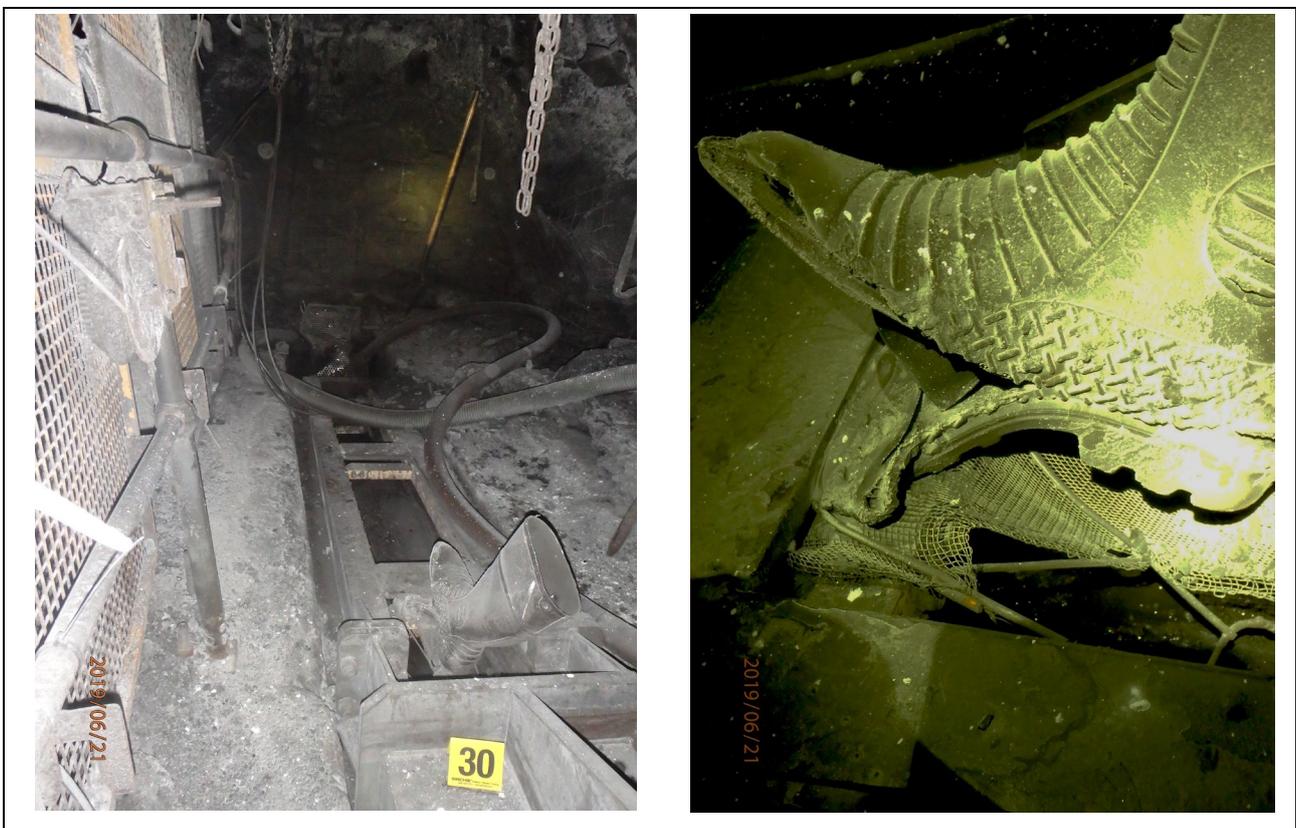
The scraper conveyor's motion then dragged the worker's foot and tech mesh towards the lift point. The worker had to forcibly remove his foot from the conveyor. The worker was able to remove his foot in part due to the fact he was wearing gumboots and not lace up safety boots.

Figure 11. Gumboot and mesh entangled in conveyor flight bar

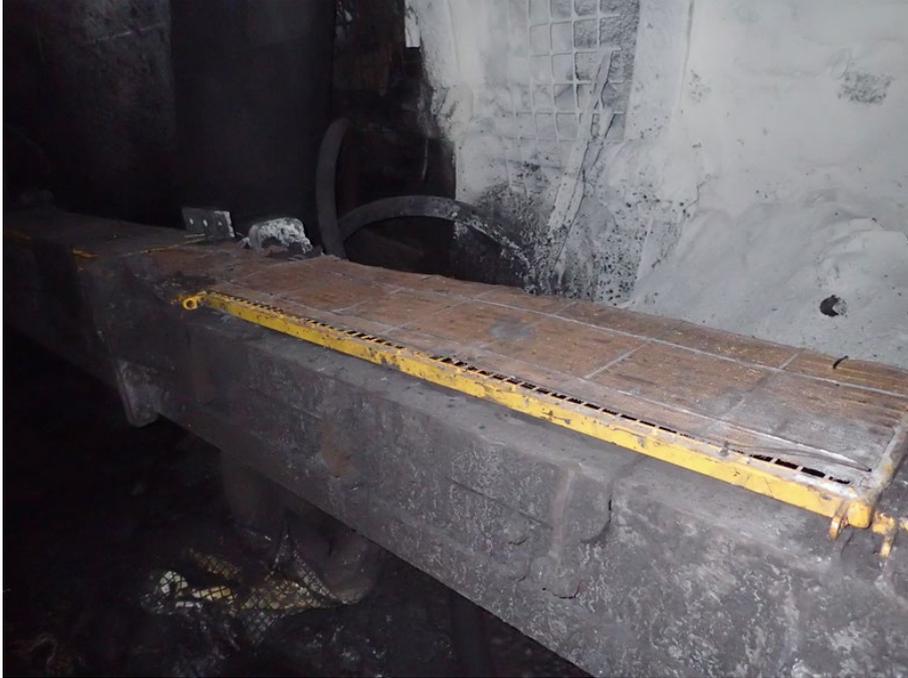
There was little planning and only a general instruction to fit the tech mesh to the top of the yellow steel guard using plastic cable ties, as shown in figure 13.

Figure 13. Tech mesh fitted to the top of the yellow guard on the scraper conveyor

The mine confirmed that there was no authorisation to fit the tech mesh, nor was there any documents to establish that there had been an assessment of hazards in relation to fitting the tech mesh.

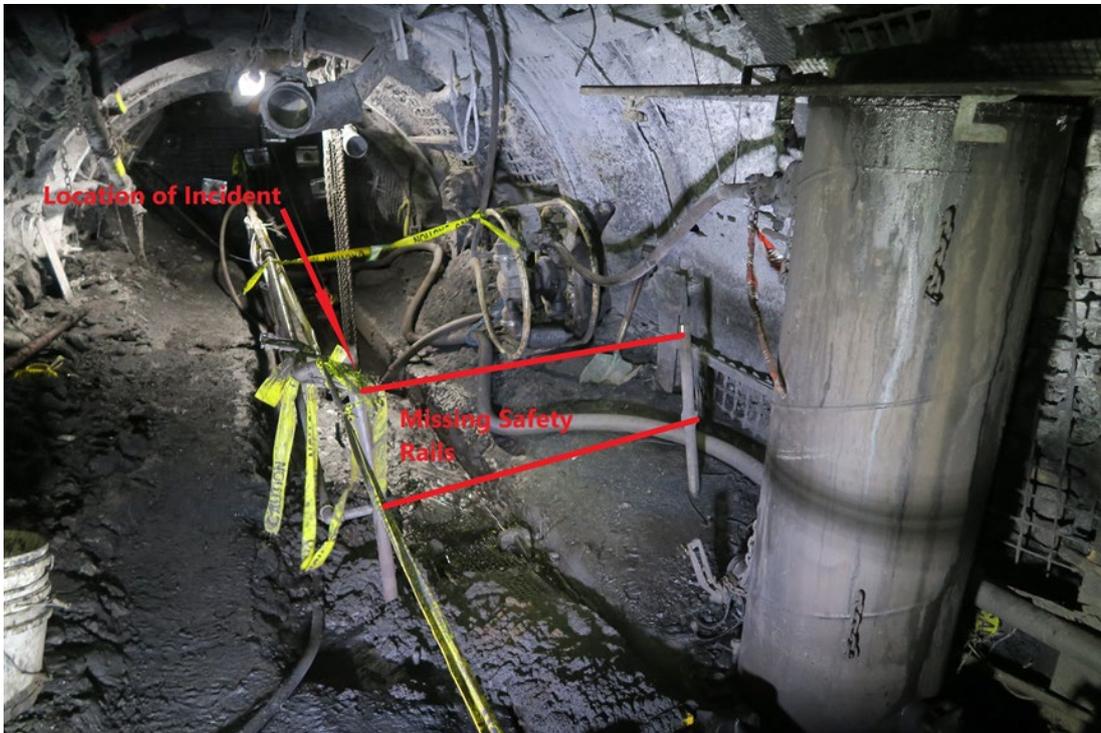
Safety controls that were compromised at the time included the missing safety rail (figure 14), the missing emergency lanyard (figure 15), the drift being non-compliant with the standard AS/NZ4024 (Safety of Machinery) (figure 16), a lack of mechanical commissioning and non-operational lighting in the drift.

Figure 14. Missing safety rail

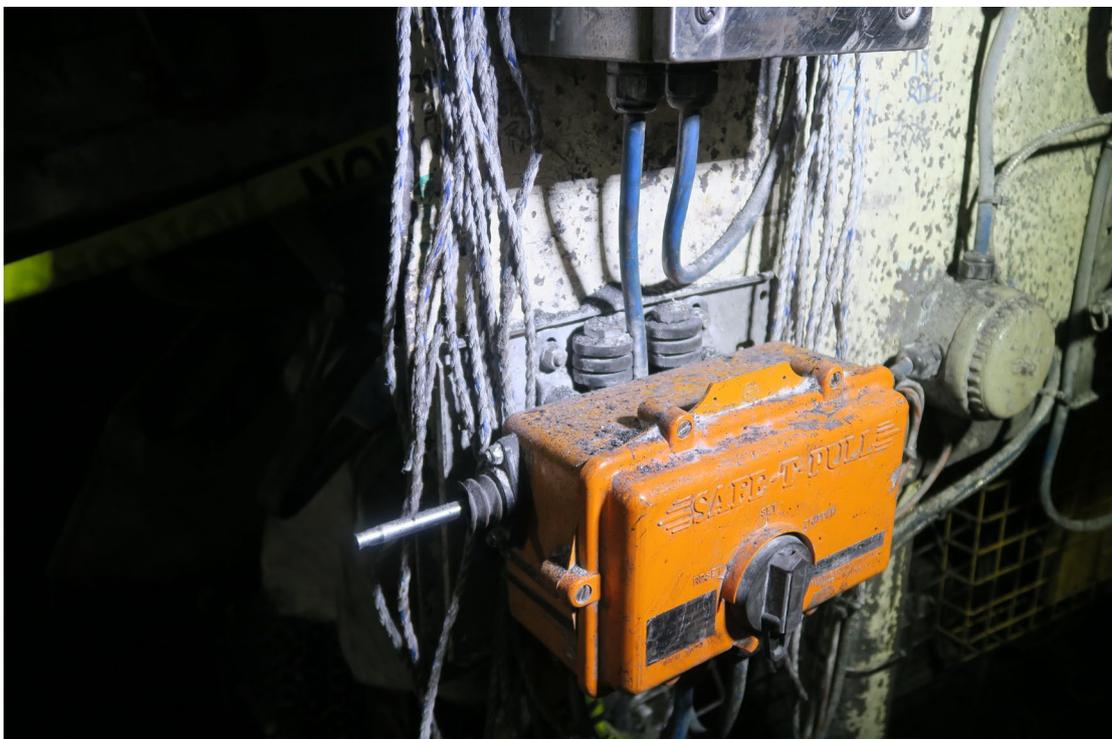
The emergency stop lanyard, which previously ran parallel to the conveyor, had not yet been re-installed.

Figure 15. Emergency lanyard control box with missing lanyard

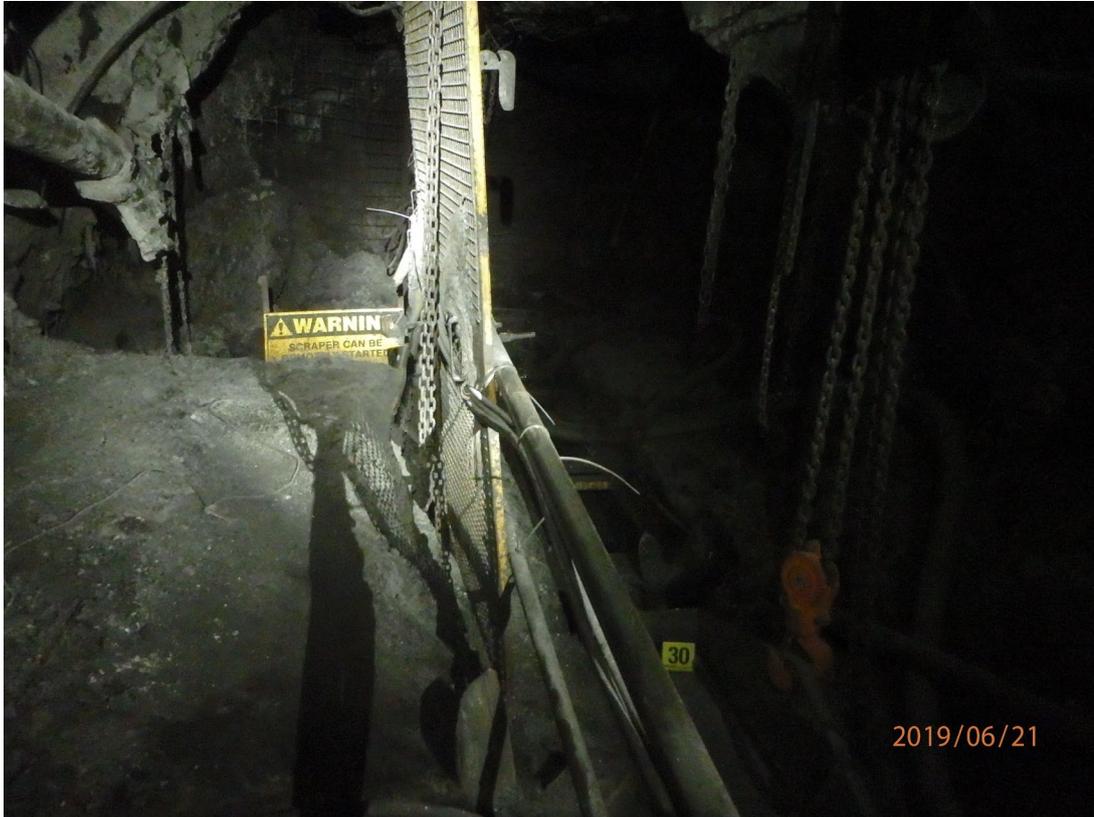
Figure 16. The compromised safety rail height and warning sign partially covered
