INVESTIGATION REPORT

# SERIOUS INJURY

Unexpected movement of Powered Roof Support  
Ulan Underground Mine

7 December 2019

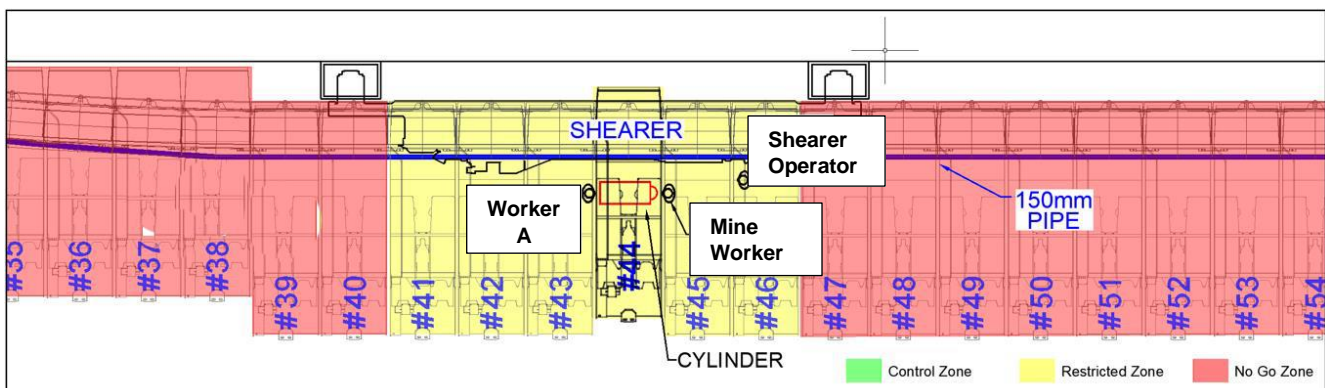
Figure 4 Position of workers in relation to longwall equipment immediately prior to the incident

The PRS leg cylinder was lowered from the shearer carry arm into a horizontal resting position across the pontoon of PRS44 where Worker A began to secure it onto PRS44 using a chain block. At this time a mine worker arrived at PRS44 and assisted with securing the PRS leg cylinder. Worker A was positioned on the maingate side of the PRS leg cylinder and the mine worker was positioned on the tailgate side, with both individuals straddling the PRS leg cylinder on the pontoon of PRS44.

The initial movement of the shearer placed Worker A and the mine worker in a permitted location called the 'Restricted Zone' (Refer to Figure 4- Yellow coloured zone).

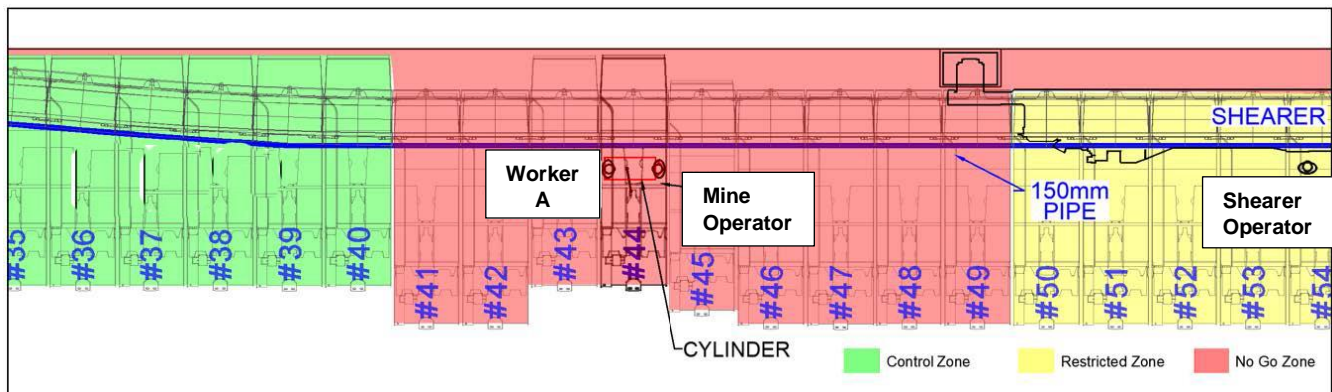
Figure 5 Position of workers in relation to longwall equipment at the time of the incident

The shearer continued to move a distance of four PRSs (about 8m) towards the tailgate. As the shearer maingate drum passed PRS44, Worker A and the mine worker were now located in the shearer 'No-Go Zone' which is located between the last advanced PRS and the trailing drum of the shearer (Refer to Figure 5- Red coloured zone).

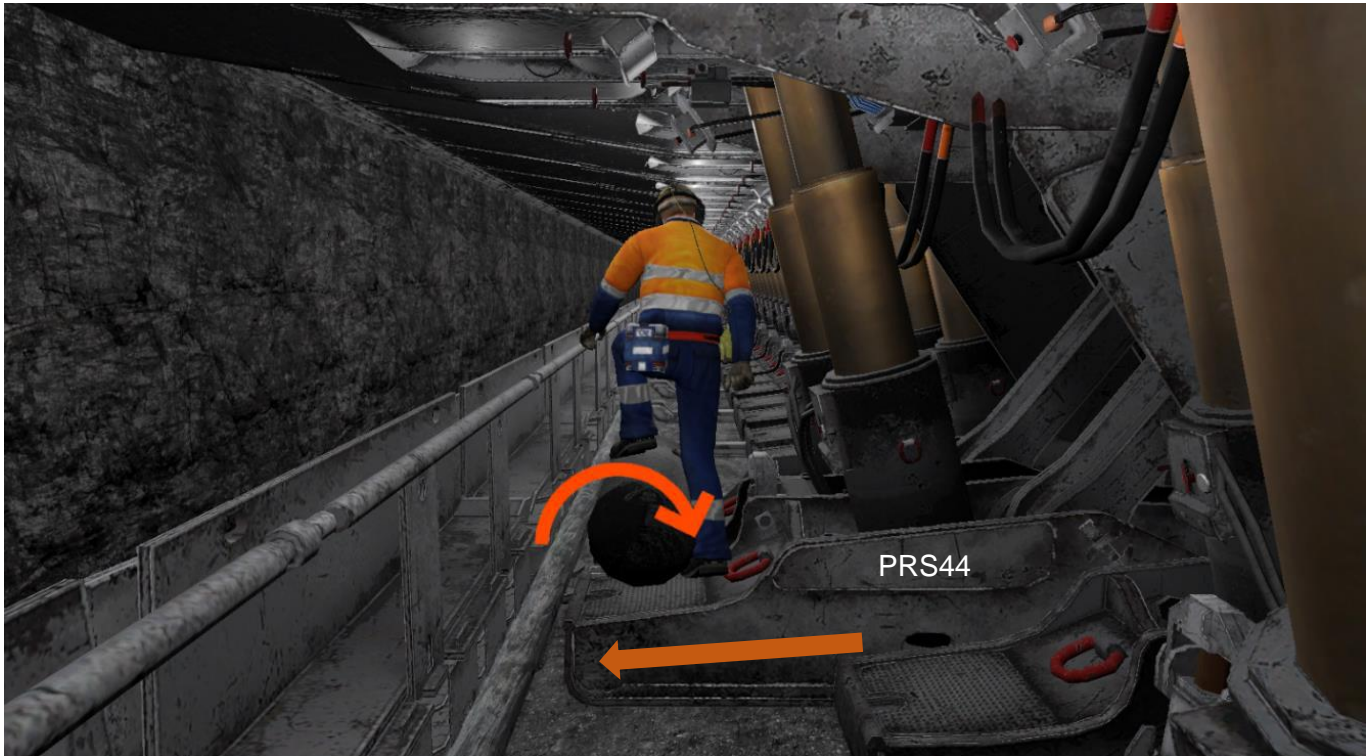
Figure 6 VR Still Animation showing Worker A's positioning relative to the replacement PRS leg cylinder on PRS44 pontoon with arrows indicating movement of PRS44 and PRS leg cylinder (respectively)

The shearer operator noticed that PRS44 lowered as he continued to operate the shearer which caused him surprise as, thinking that it was it was fully advanced, he did not expect PRS44 to move.

The PRS leg cylinder, weighing 1972 kg, caused a traumatic crush injury to Worker A's right foot and ankle.
