LIEBHERR R9250 RISER DETACHMENT FAILURE AT GLENCORE MANGOOLA MINE

Report No: MTI/DS/694

Maintenance Technology Institute Department of Mechanical and Aerospace Engineering Monash University (Clayton Campus) PO Box 31 Clayton, Victoria 3800, Australia Telephone: +61 3 9903 1985 Facsimile: + 61 3 9903 2076 http://www.eng.monash.edu.au/mti/	Document No:	MTI/DS/693
	Title:	Liebherr R9250 Riser Detachment Failure at Glencore Mangoola Mine
	Client:	Glencore Mangoola Mine

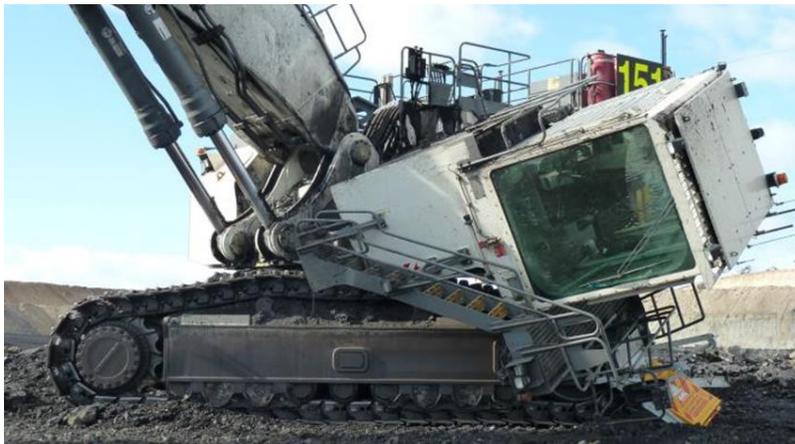
The main reason for the failure was the fracture of the bolts that attach the riser to the chassis. These bolts had failed in a sequence over a period of approximately 5 months leading to the final complete detachment of the riser from the chassis.

Figure 1-1: Riser and Cabin Detachment of Liebherr R9250 Excavator (unit EX151) at Mangoola Mine

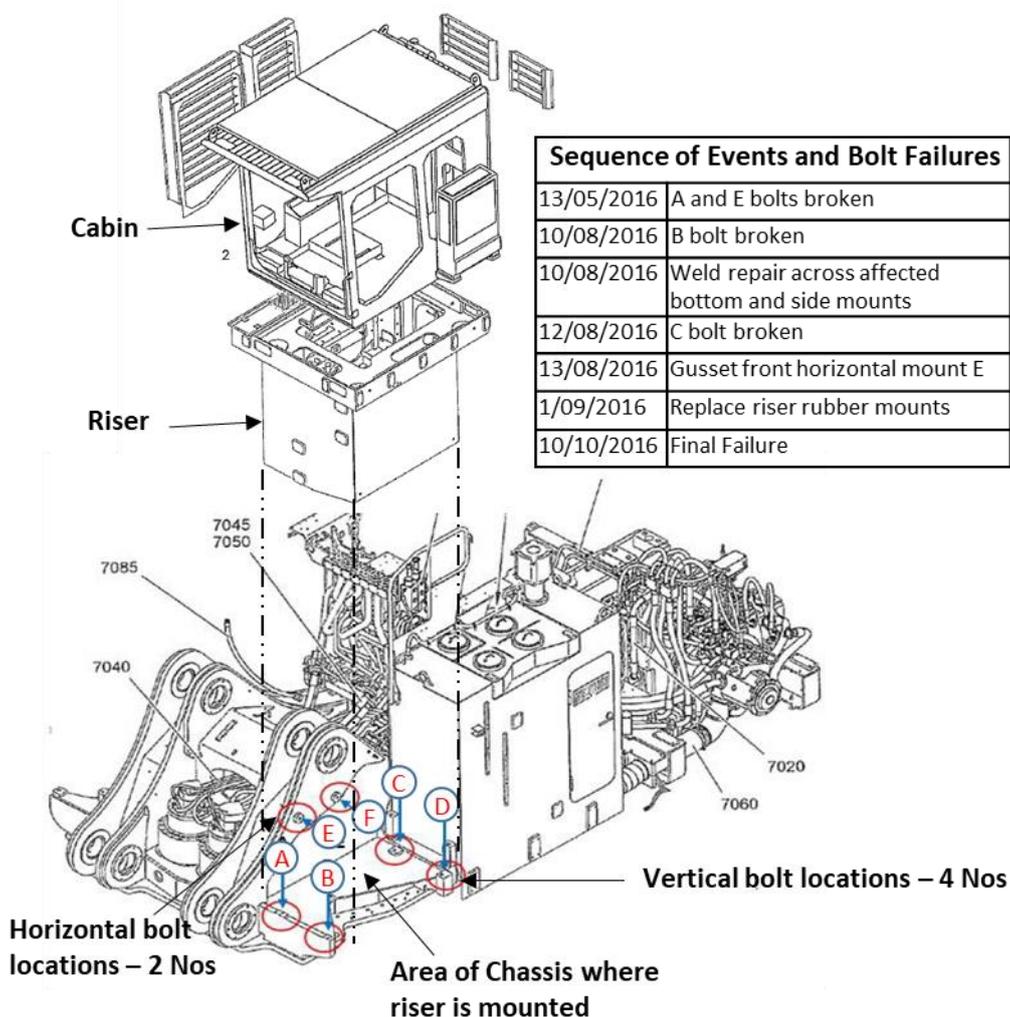
The sequence of bolt failures, as given in the incident report [1], is also shown in Figure 2-1. The sequence of failure given in [2] is slightly different.

Figure 2-1: Chassis, Riser and Cabin General Arrangement

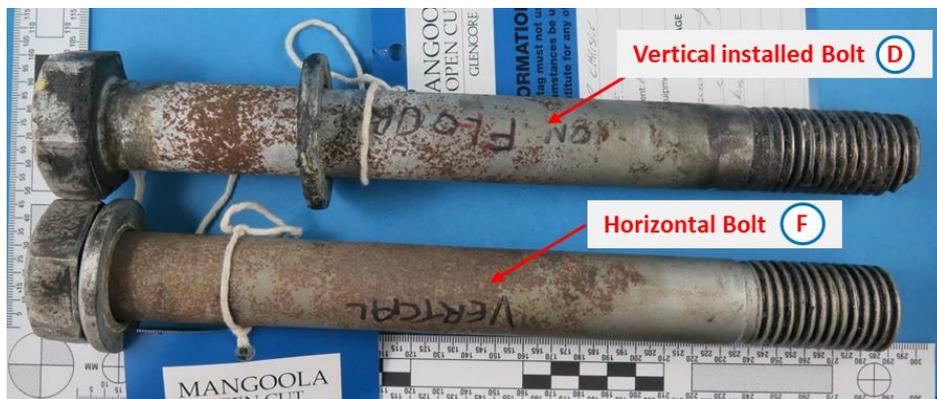
- (h) The report concluded that the failure was attributable to fatigue.
- (i) In addition to the stated discussions and conclusions in the report, the photographs given in the report provide many other important information regarding the failure.

Figure 4-1: Two Bolts Examined by BV

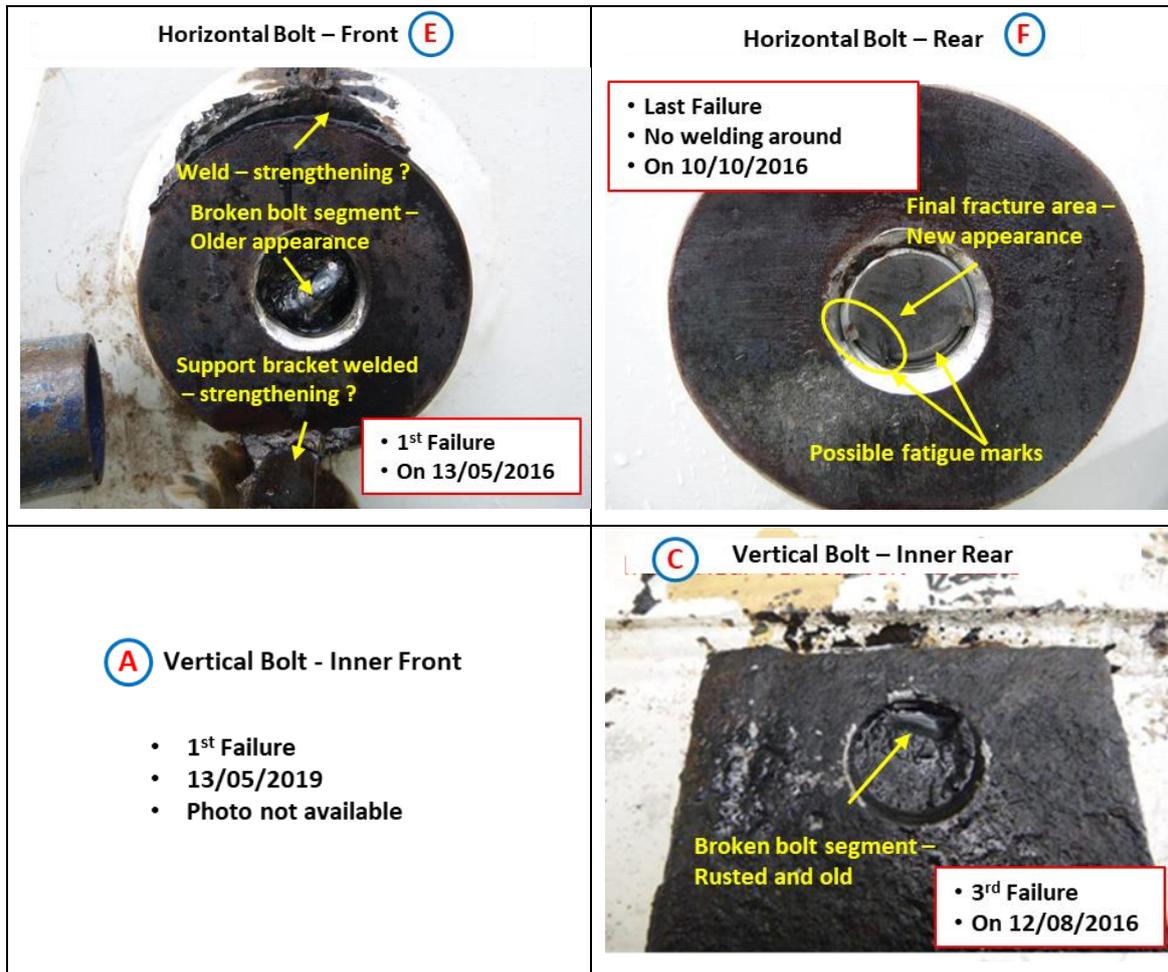
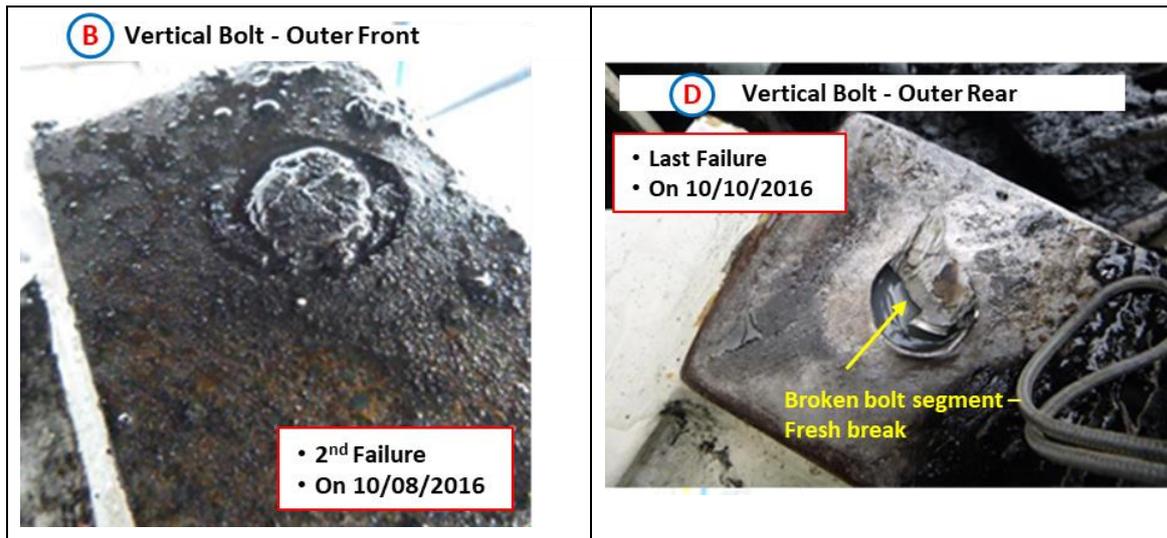
- (v) One very significant conclusion that can be made from these photos is that the attachment arrangement of the riser to the chassis did not facilitate replacement of the previously failed four bolts (i.e. bolts A, E, C and B) unless the whole riser and the cabin was taken off to remove the bolt segments left behind inside the chassis mounts. The corrosion and oil on mounts particularly on B and C clearly show that the two bolts that were broken in August 2016 could not be replaced until the final failure happened in October 2016. If the failed bolts could be replaced, this failure could have been prevented.

Figure 4-2: Bolt Segments Left in Chassis Mounts

- (vi) Therefore, changing the attachment arrangement to facilitate easy replacement of any broken bolts should be considered.
- (vii) At the mount of front horizontal bolt E, there are some remnants of welds around the circular mount. Further, there is an additional bracket welded below the mount as shown in Figure 4-3. These appeared to be attempts by the maintenance staff to temporarily strengthen the riser attachment to the chassis after the first two bolts were broken in May 2016. Considering the axial and shear capacities of a 30 mm diameter Grade 10.9 bolt, these welds and the bracket are grossly inadequate to replace the attachment strength of the bolt.

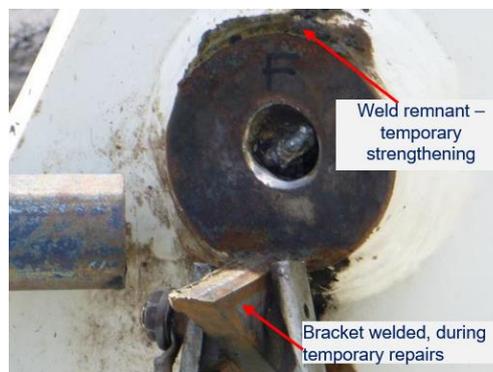
Figure 4-3: Temporary Repairs at Front Horizontal Bolt E

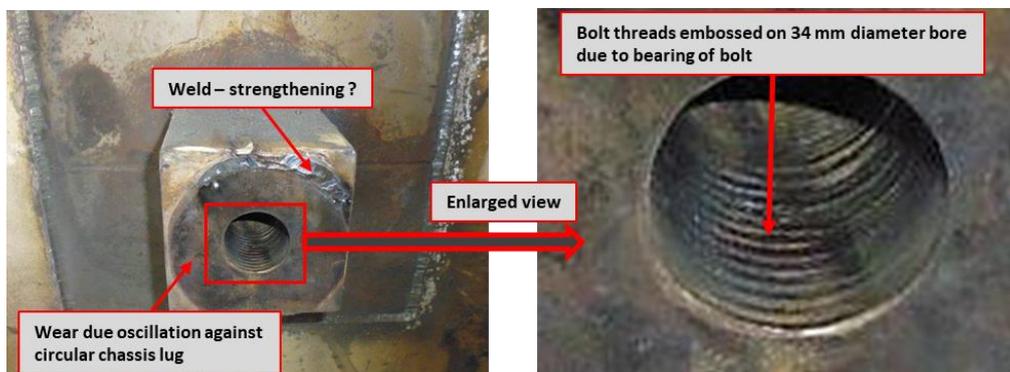
Back of Riser at Front Horizontal Bolt (E)

Figure 4-4: Thread Indentation Marks inside Bolt Attachment Bores

Images of the failed horizontal bolts shown in Figure 4-4 indicate indentation of the bolt threads on the inside surface of the attachment block bore, which suggests that a slip between the interface of the attachment block and chassis mount of the horizontal bolts occurred. As discussed in Section 4.2.2, the riser would have had to be displaced more than 2.5mm to impact or have sufficient contact with the bolt threads. The loss of interface friction could be due to loss in pretension in the horizontal bolts, causing a large displacement compared to that measured by the SMS. The current pretension applied to both the horizontal bolts (SG03 and SG04) is shown in Table 5-1. This further places the importance in maintaining pretension in all bolts in the riser to avoid loss of interface friction which may result in fatigue crack propagation or failure of the attachment bolts.

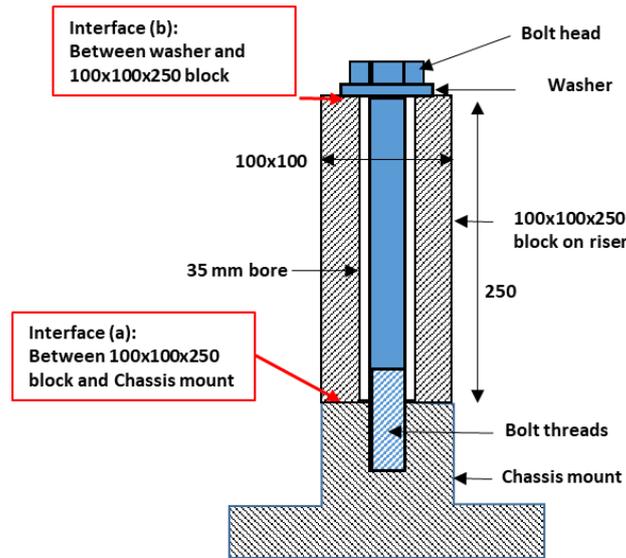
Figure 4-5: Possible Slip Interfaces at Bolted Attachments

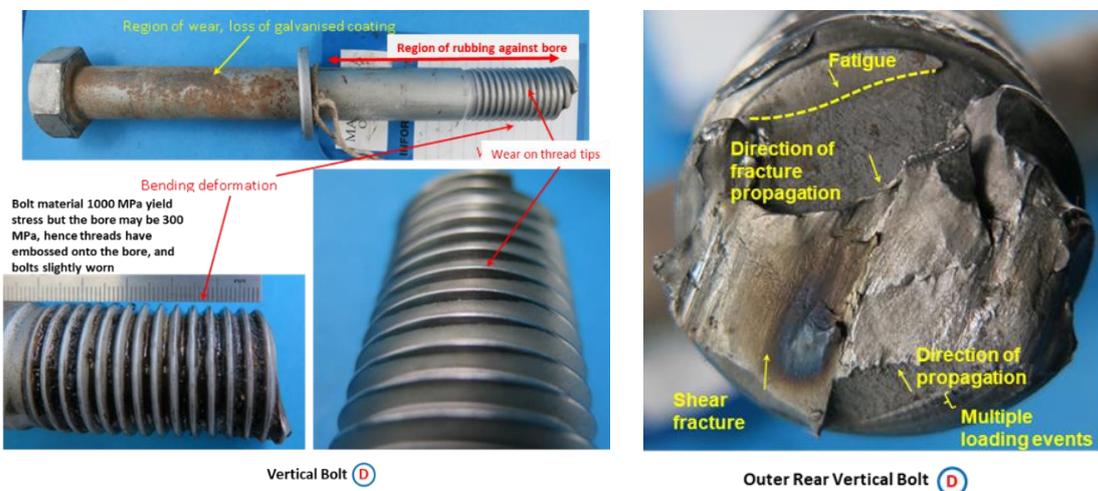
- (i) The threads of Bolt D had badly worn out just above the failure point. This is due to the movement of the riser relative to the chassis.
- (ii) Bolt E has a much large fatigue crack propagation area whereas Bolt F has a relatively larger brittle fracture area in the failure cross-section. Therefore, it is very likely that the last bolt to fail was Bolt D. In the final hours of operations prior to final failure, the Bolt F would have failed in fatigue, and soon after that Bolt D would have fractured mainly due to overload.
- (iii) Failure cross section of Bolt F shows some mechanical damage due to contact with the attachment block of the riser. Two fatigue cracks appeared to have initiated from this mechanical damage area. Later on these two cracks seem to have merged into one crack. This crack grew until it covered almost the entire bolt cross section.

Figure 4-6: Thread Wear on Rear Outer Bolt D

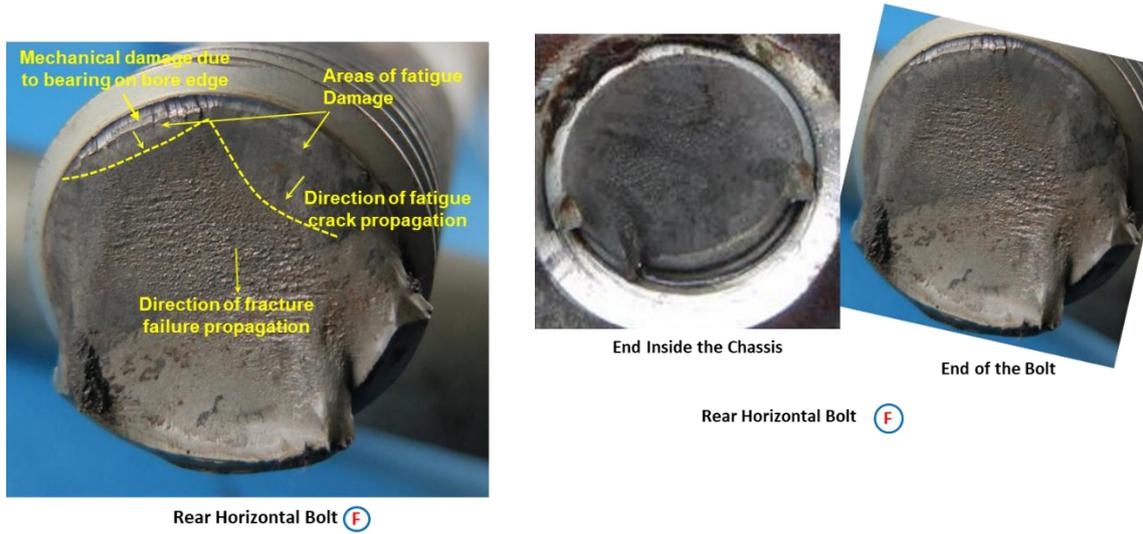
Figure 4-7: Fracture Surface of Rear Horizontal Bolt F

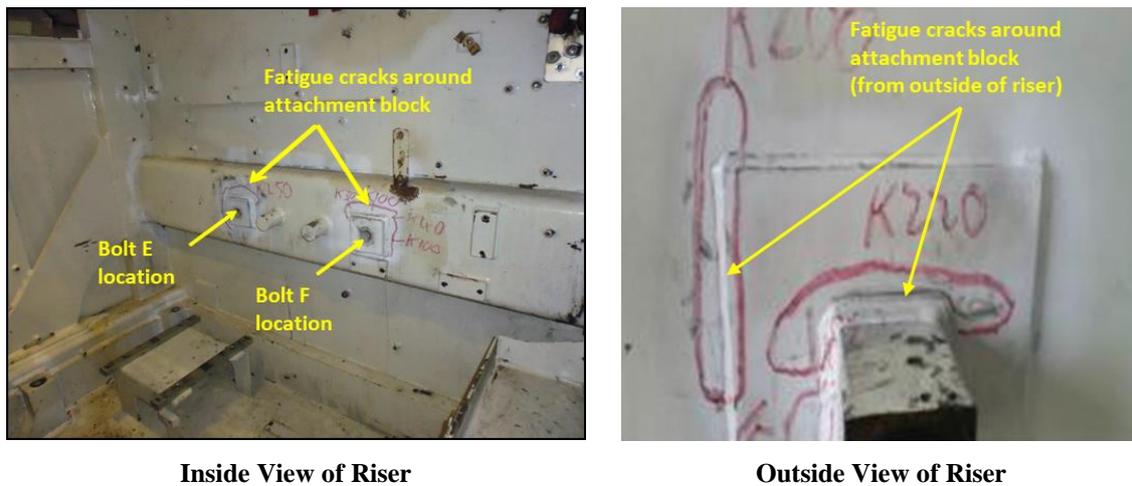
There had been some fatigue cracks in the riser body as well (see Figure 4-8), but these cracks have had no influence on the riser detachment. However, these cracks indicate that the structure has been experiencing vibrations.

Figure 4-8: Cracks in Riser Body

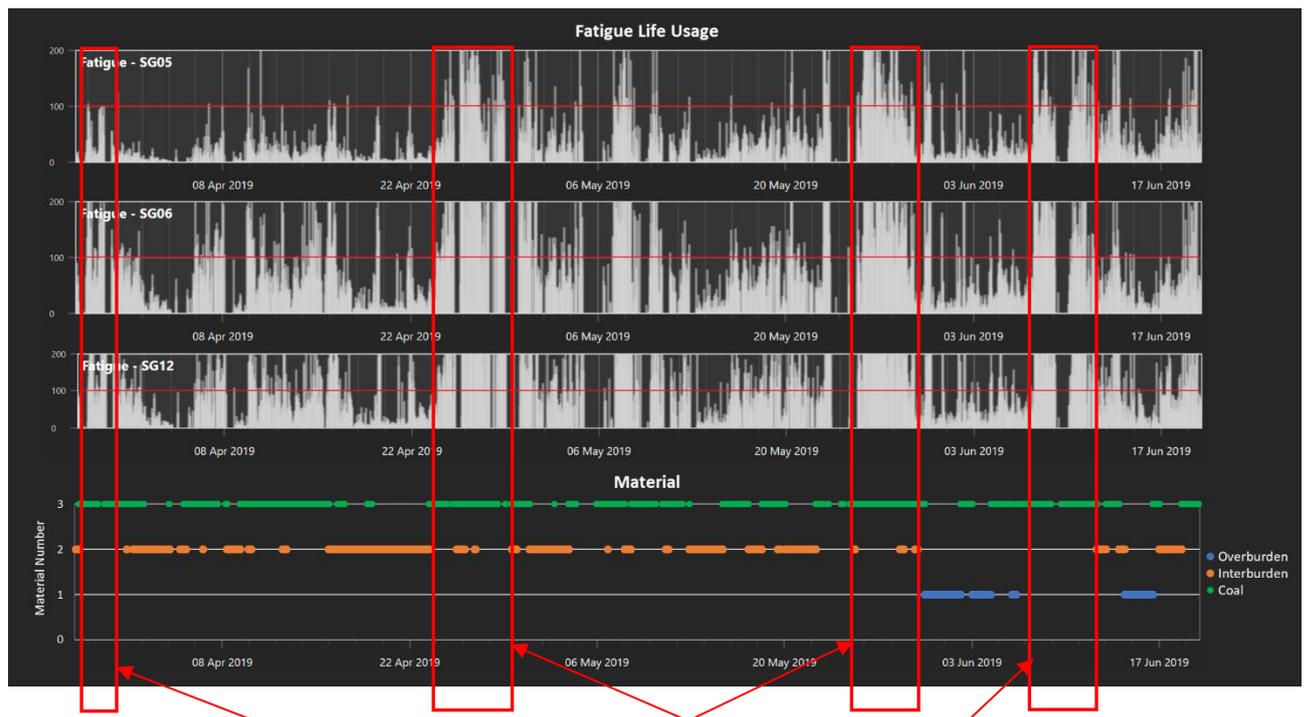
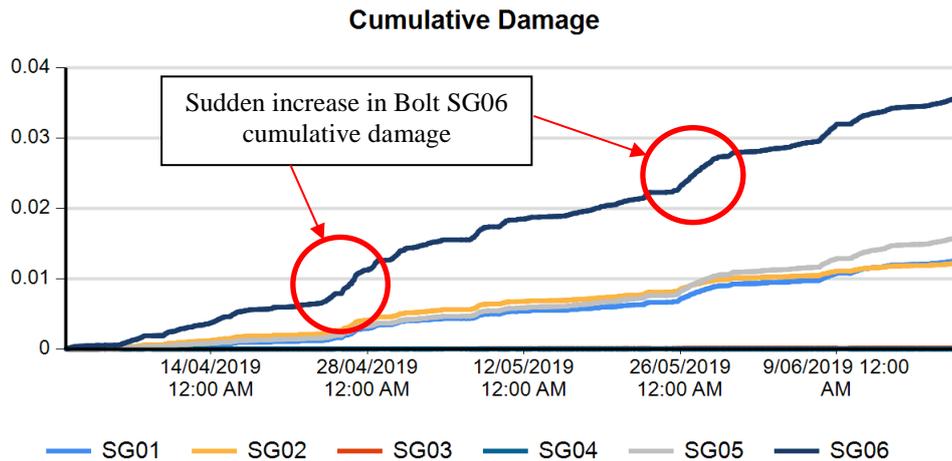
The SMS data trends for the period between 28th March and 20th June 2019 are illustrated in Figure 5-2. Highlighted regions show high fatigue life usage in both the rear vertical bolts SG05 and SG06 and in gauge SG12 located adjacent to horizontal bolt SG03 on the attachment block. MTI has obtained Fleet Management System (FMS) data from Mangoola site to further investigate periods of high fatigue life usage and the sudden increase in the cumulative damage in the rear vertical bolt. It can be observed that the regions with high fatigue life usage and the sudden increase in cumulative damage of the bolts coincide with periods where mostly coal was dug. Based on the measured data collected throughout the investigation period, the fatigue life when digging coal is reduced by 74% compared to when digging other materials. This is potentially due to the coal not being ripped to aid the dig process. Consequently, operators are inclined to exert more force to dig ground; increasing the fatigue life usage of the machine. The sudden increases in cumulative damage of the gauges in the boom structure also coincide well with periods when coal is dug. The SMS has been designed to monitor dig conditions and machine performance and provide real-time feedback to the operator.

Highlighted regions show high fatigue life usage in both the rear vertical bolts SG05 and SG06 and in gauge SG12 located adjacent to horizontal bolt SG03 on the attachment block which coincide with periods when coal was dug

Figure 5-2: Fatigue life usage and cumulative damage of SMS instrumented bolts for the period 28th March to 20th June 2019.

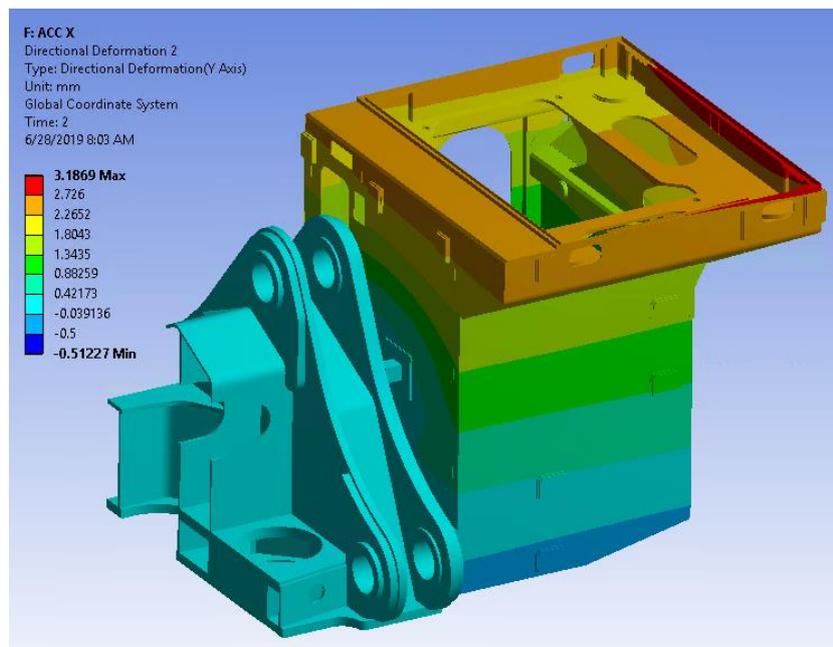
Figure 6-7: Deformation of the cabin riser in the transverse direction

Results from the FE model when an acceleration is applied in the transverse (horizontal) direction shown in the figure above show that there is some deflection in the cabin riser wall adjacent to the chassis. The deformation in the FE model (at the location where the displacement transducer was installed) was compared against the measured value recorded by the displacement transducer. It was observed that under the same loads, the ratio of deformation obtained from the FE model to measured data in the horizontal direction is approximately 34%. Meaning that 34% of the measured displacements are due to the deflection of the riser body and the remaining 66% is due to the riser sliding with respect to the chassis.

The operating practices of the machine which cause a transverse acceleration to the structure has resulted in a deflection of the riser wall adjacent to the chassis, and has additionally also forced bending of the vertical bolts. It should be noted that although it appears that bending is present in the vertical bolts, it is difficult to quantify the amount of bending present in the individual vertical bolts. The sudden acceleration in the transverse direction also causes axial stress reversals in the horizontal bolts, which are directly measured by the strain gauges. However, the effect of the axial stress reversals on the fatigue life usage of the horizontal bolts are not significant compared to the effect of bending stress on the fatigue life usage of the vertical bolts.

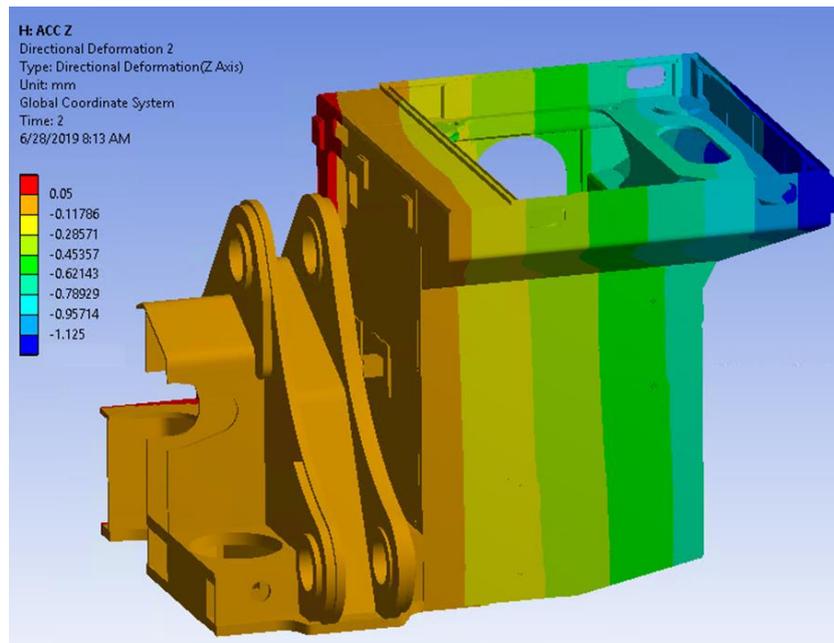
Vertical displacement of the structure when an acceleration is applied in the vertical direction are shown Figure 6-9 below. Similar to the results obtained when the longitudinal acceleration is applied to the model in Figure 6-8, there is very minimal deflection present in the cabin riser wall adjacent to the chassis. Once again, the deformation in the FE model (at the location where the displacement transducer was installed) was compared against the measured value recorded by the displacement transducer on the machine. The displacement recorded by the transducer is larger than that observed in the FE model. This implies that the movement of the riser is taken by the horizontal bolts, forcing the bolts to bend.

Figure 6-9: Deformation of the cabin riser in the vertical direction

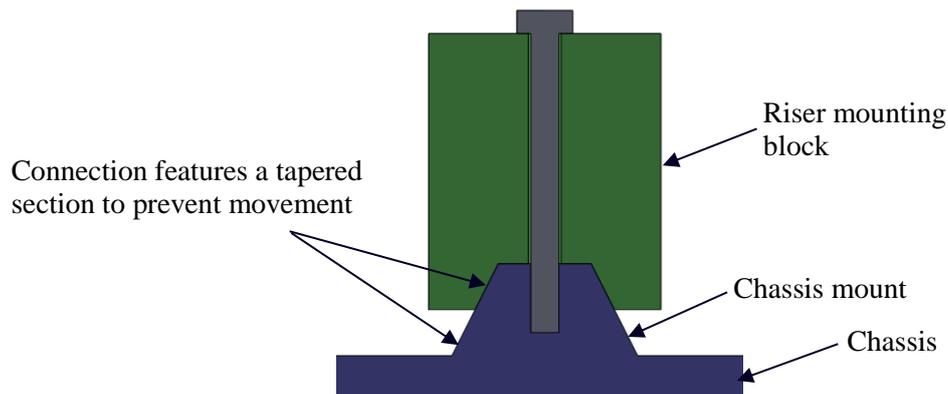
The sliding movement of the riser is the main cause of bending in the bolts which accounts for 85% of the fatigue life usage. Ideally, the bolted connections should have been designed with a mechanism to lock the riser onto the chassis to prevent movement and reduce or eliminate bending in the bolts. A combination of improved operator practices and the suggested locking mechanism will result in a significant improve to the fatigue life of the attachment bolts and eliminate bolt failure. An example of the type of mechanism that could be used is shown below.

Figure 8-1: The configuration above prevents sliding movement in the bolted connection of the riser

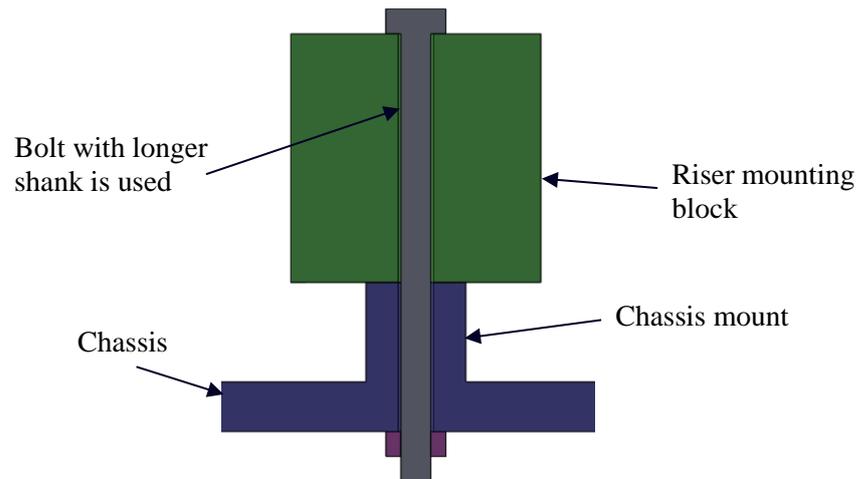
As discussed in Section 4.2.2 of this report, investigations determined that the attachment arrangement of the riser to the chassis prevented replacement of four bolts that had already failed (i.e. bolts A, E, C and B). The broken bolt segments which remained inside the chassis mounts could not be extracted without detaching the entire cabin from the chassis, which would result in major down-time and loss of production. To avoid another potentially catastrophic failure, a bolt and nut arrangement should be considered to ease replacement of the bolts if needed. However, this may not be practical for all six bolts.

Figure 8-2: Bolt and nut arrangement above would ease replacement of bolts in the occurrence of a failure
