CHAPTER 8

CASE STUDIES

8.1 INTRODUCTION

In this chapter case studies are presented on accidents that have occurred recently in New South Wales underground coal mines.

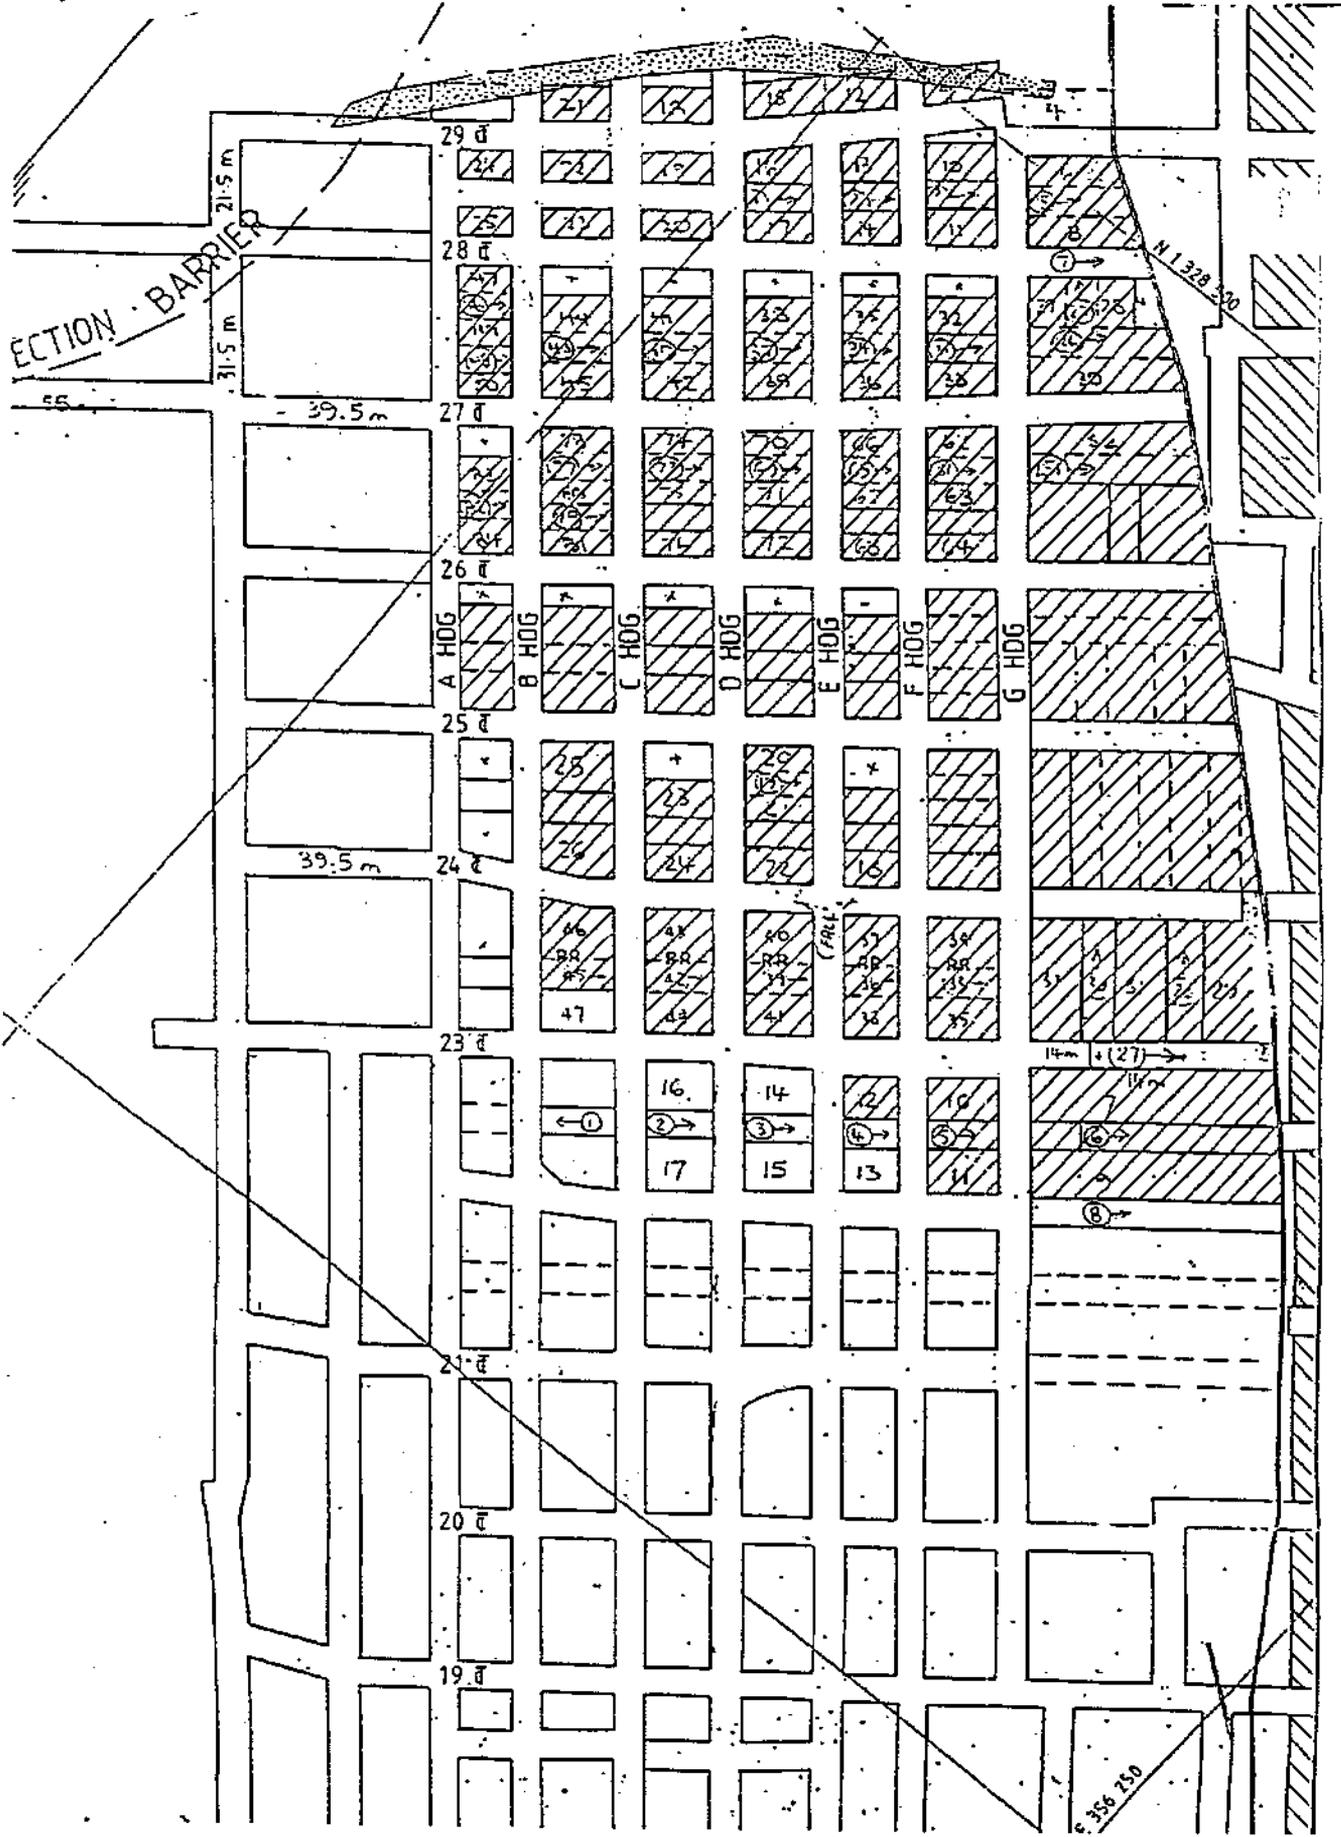
Reference to plan 8.2 shows that the panel was started adjacent to a geological weakness, (a large dyke), to help induce a quick cave. Also the plan of extraction allowed for the extension of an existing goaf, to further assist in creating an early cave and maintain goaf continuity.

Plan 8.2 indicates that the row of pillars at the goaf edge was pre - split across the full width of the panel, thus the size of pillar cores was markedly reduced. This loss of core led to greater pillar compression, more strata movement and thus a reduction in strata integrity at the goaf edge.

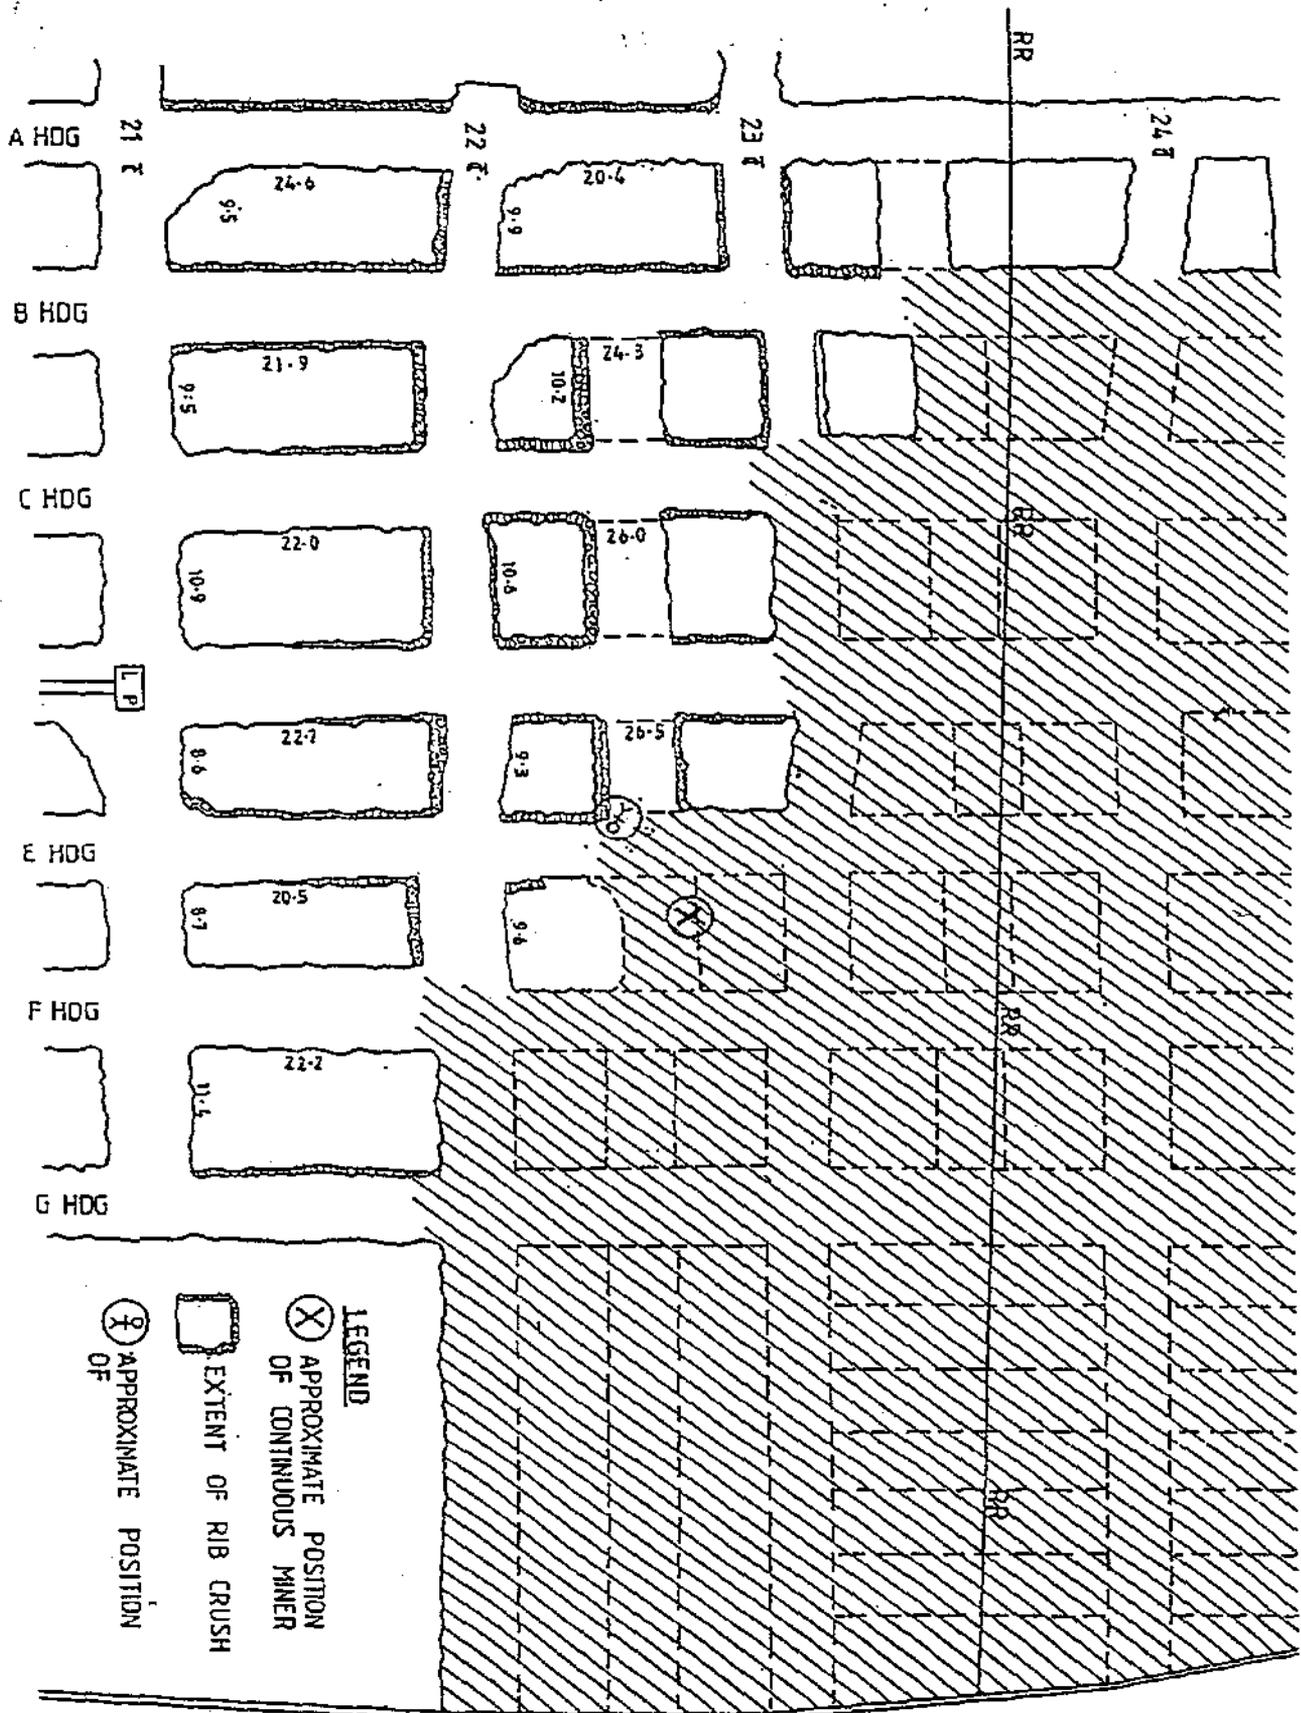
Rib crush shown on plan 8.3 was caused by pillar compression and roadway strata movement (i.e. floor heave).

Whilst plan 8.3 appears to show a regular pillar layout, in fact there were variation in pillar dimensions, intersection size and roadway widths. An accurate plan is essential for careful design and controlled extraction.

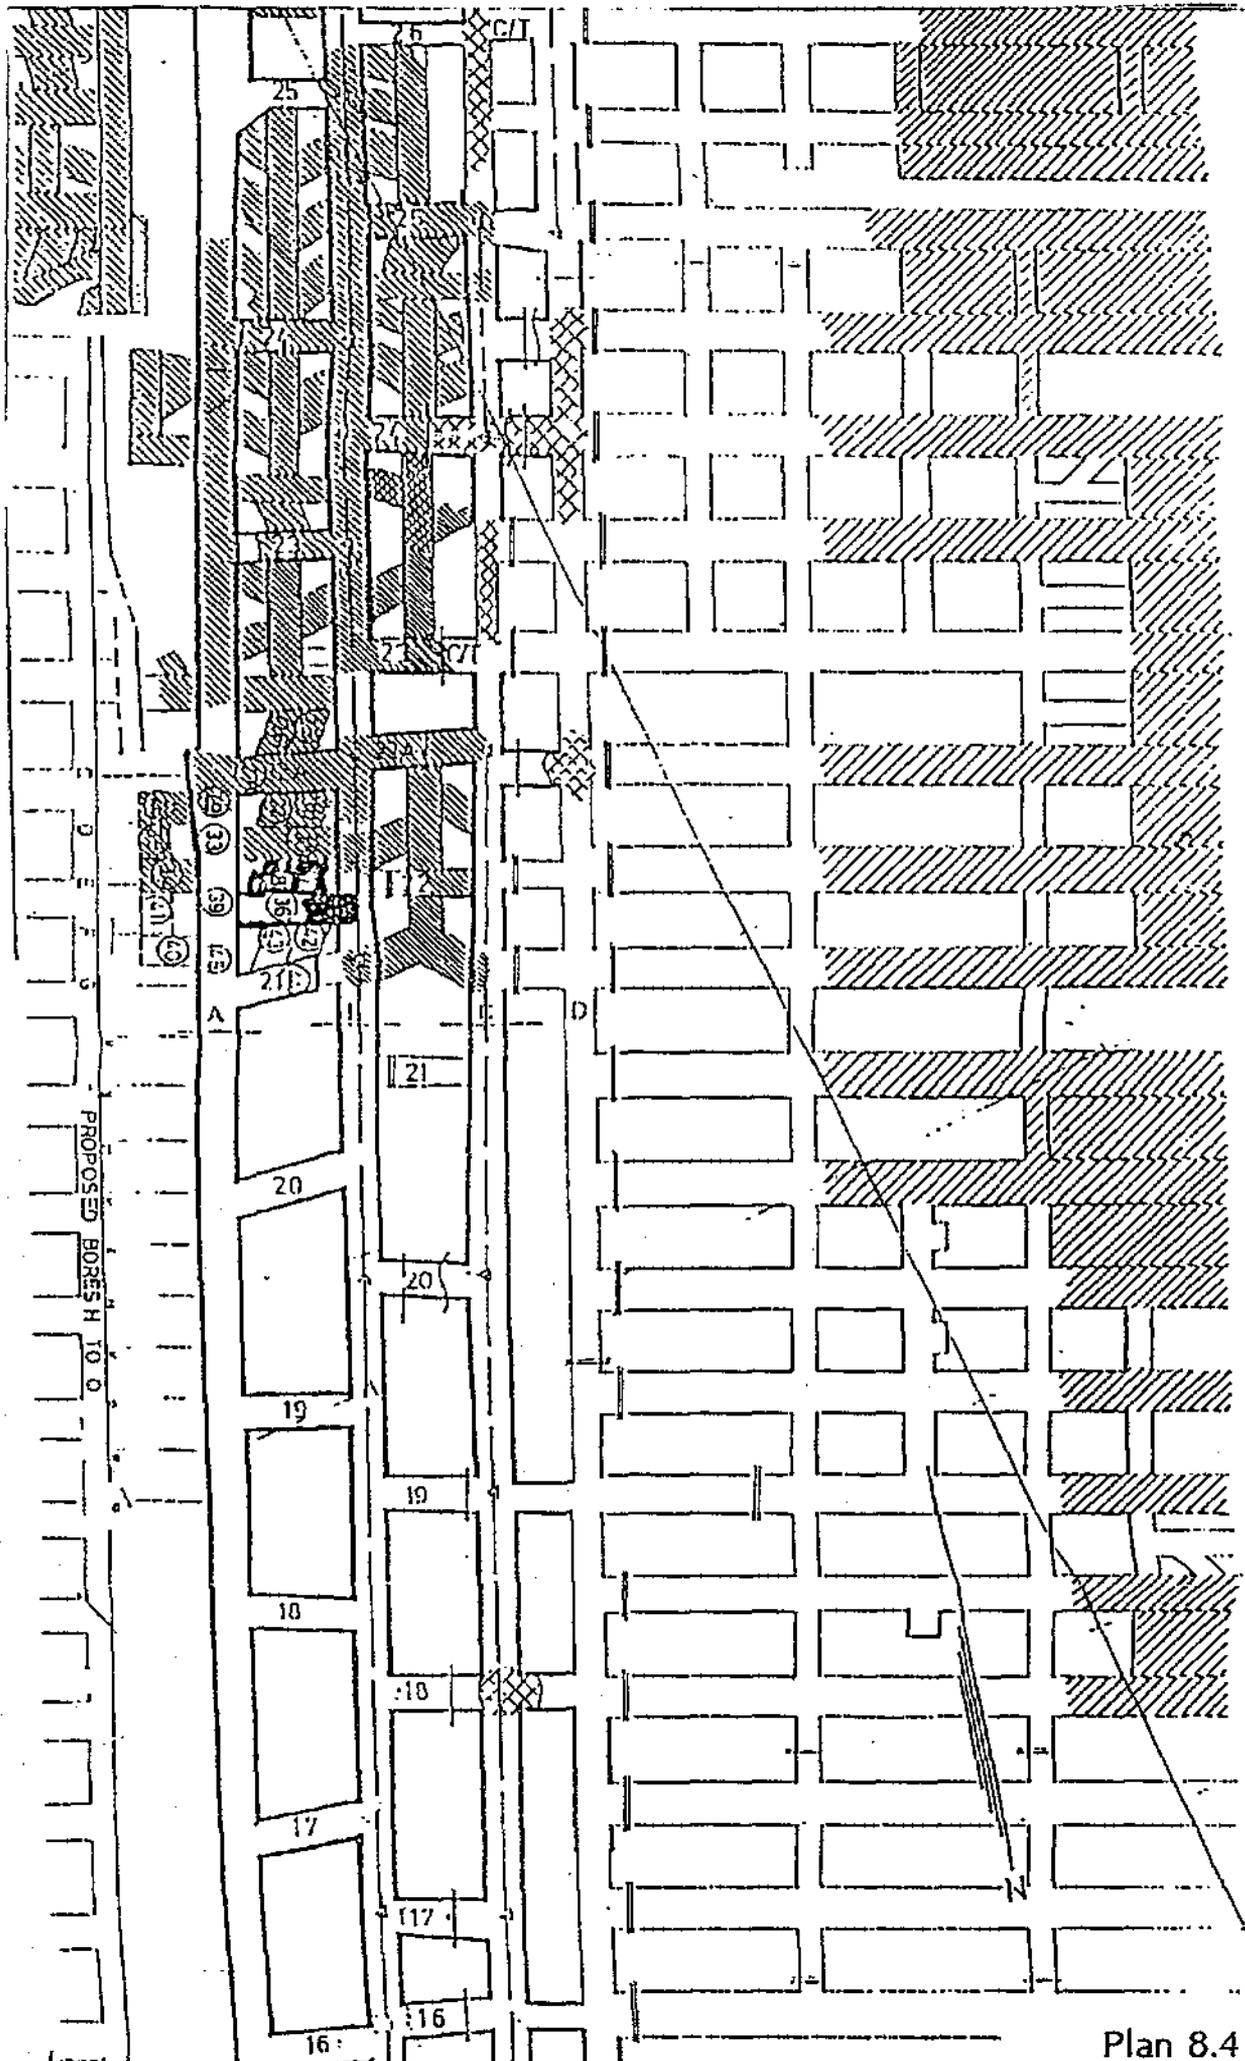
Plan 8.4

The pillars being recovered, shown on plan 8.4, were over 60 years old. To control spontaneous combustion the goaf being formed was kept separate from old adjacent goaves. This separation was achieved on one side by a solid barrier and on the other by a double row of seals.

Shortly after production re-commenced, following a Christmas shutdown, the final stook in a fender (stook X) suddenly collapsed fatally injuring one workman and burying the continuous miner and shuttle car.

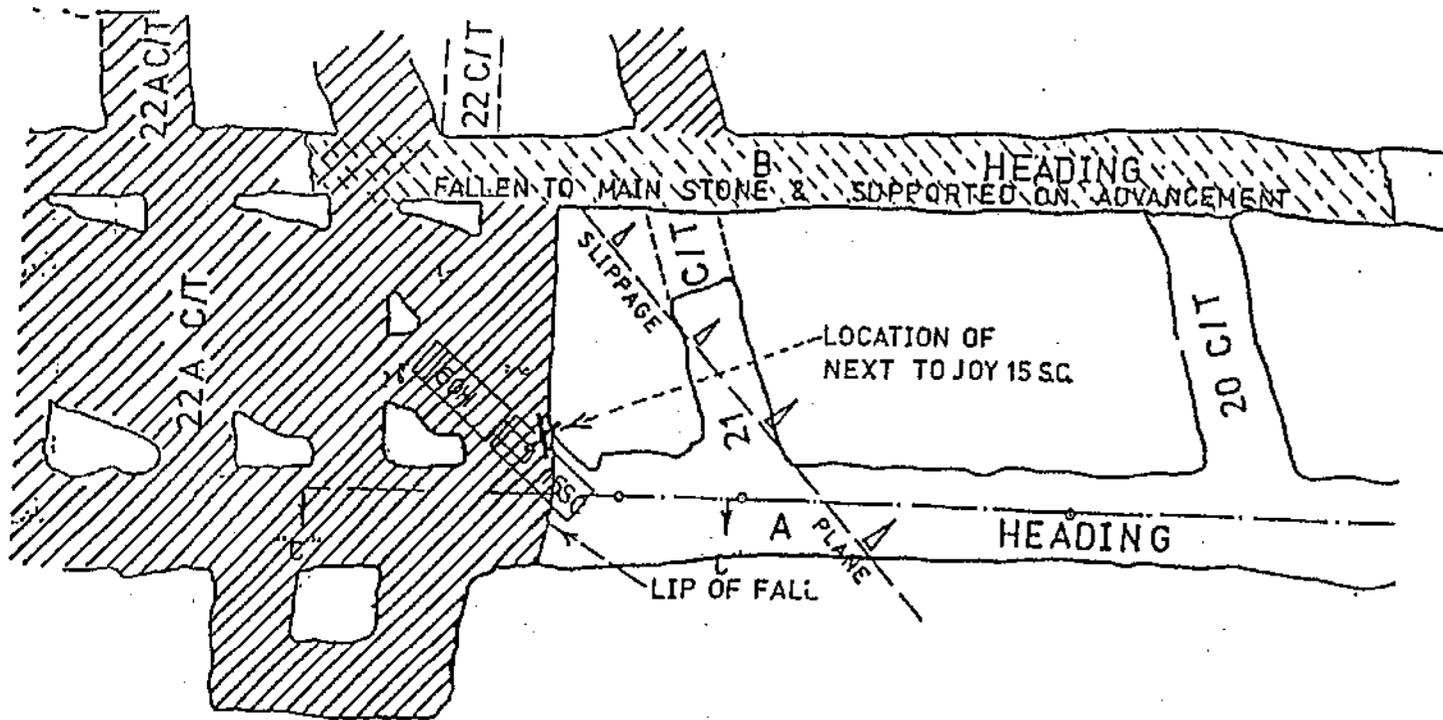
SECTION "C-C" SHOWING LIP AREA, MACHINES AND EXTENT OF FALL
REDUCTION RATIO 1:100

PLAN VIEW OF WORKING AREA WHERE FATAL ACCIDENT OCCURRED
REDUCTION RATIO 1:400

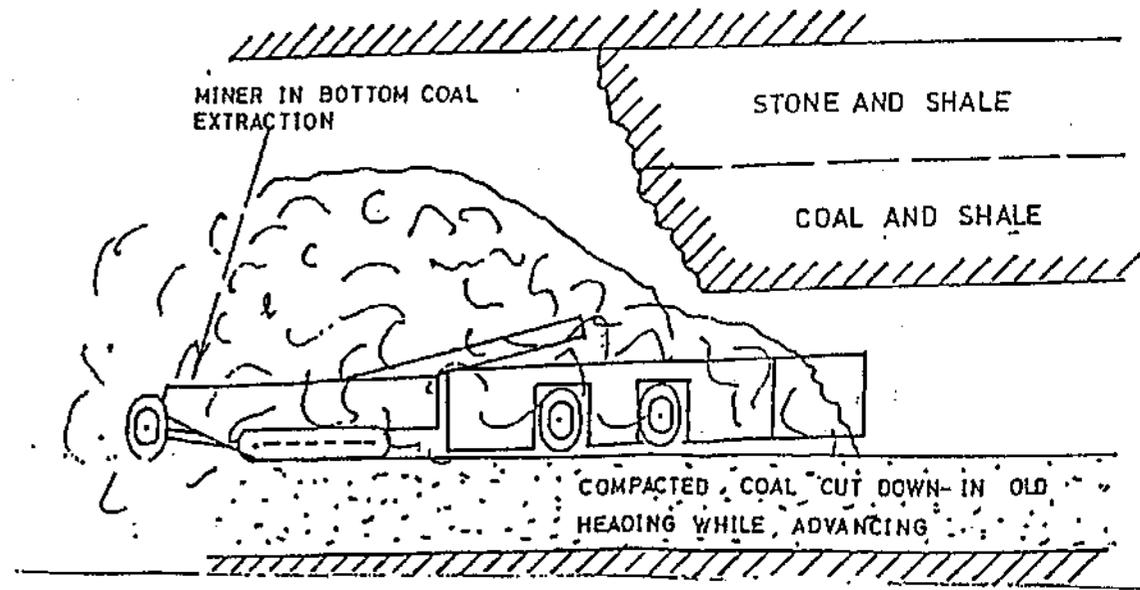
Plan 8.5

Formation of the pillar (5.5 - 6.0m high) in the barrier, adjacent and prior to, the extraction of the roadway pillar, as shown on plan 8.5 effectively resulted in stook X having goaf on 3 sides. The security of the continuous miner whilst extracting the fender was dependent on a stable stook X.

Removing bottom coal reduced the w/h ratio of stook X to less than 1. Further the activity of removing bottom coal increased the length of time workman were at any one place, therefore increasing their exposure to potential hazards.
