SAFETY ALERT

Serious potential incident: underground loader collides with light vehicle

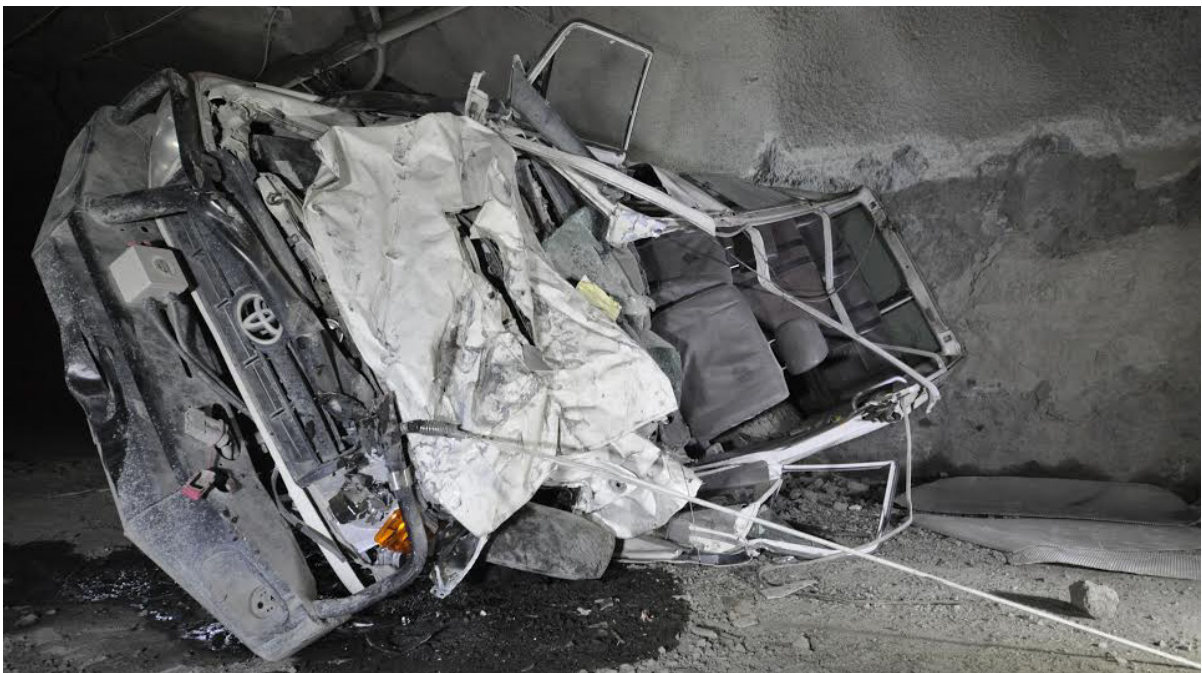
An underground loader (LHD) operating between an ore pass and a crusher tippie collided with a light vehicle.

The two occupants of the light vehicle suffered minor injuries however there was a potential for serious or fatal injuries to occur. The light vehicle sustained extensive damage.

- Mine management should review risk assessments, operating procedures and training material for suitability of fit-for-purpose controls relating to the interaction between mobile machinery (heavy and light) and personnel.

- controls that rely on human intervention.
 - Mine management should investigate and consider proximity detection/collision avoidance systems appropriate to the level of identified residual risk, where reasonably practicable. MDG 2007 provides guidance on selection and implementation of different proximity detection and awareness technologies.
