## SAFETY ALERT

# Structural failure and collapse of drill rig mast

Mine Safety Report No: SA09-07 File No:08/2492 Comet ID:317568027001 Prepared by: G Johnston Phone: 02 4222 8307 Date Created: 28 April 2009

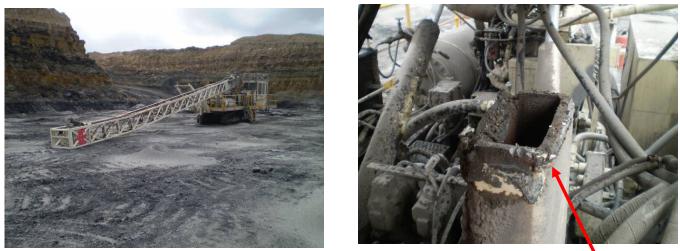
An onsite inspection concluded that the mast pivot points had failed where the bearing blocks were welded onto two RHS (rectangular hollow support) vertical supports. Further visual inspection of the drill rig identified additional cracking at the base of the bearing block support steel work.

The collapsed drill rig mast (left) and the drill rig's failed pivot point (right) on the RHS tubing.

- 1. Include, as part of the operator's pre-operational checks, a visual inspection of the mast pivot points, pivot shaft and supporting structure for any visual signs of cracking or component failure.

- 2. Include more detailed visual inspections on all critical elements as part of all periodic maintenance checks.
- 3. Consult with the plant original equipment manufacturer (OEM) about the frequency of non-destructive testing (NDT) of all critical structural elements to include, but not be limited to, mast pivot points, pivot shafts, locking devices and supporting structures.

- 5. Develop 'exclusion zones' around the plant whenever the mast is being raised or lowered before tramming or servicing.
- Consult with the plant OEM to ensure the mast pivot points, pivot shaft and supporting structure are of the latest design. Should the plant require modification, this should be carried out in consultation with the plant OEM.

- 7. Where modifications have been made, or are required to be made, ensure design changes are assessed by the plant OEM or a suitably qualified person.
