Underground mine fire initiates emergency response

Incident date: 23 June 2018

Event: Fire at an underground metalliferous mine

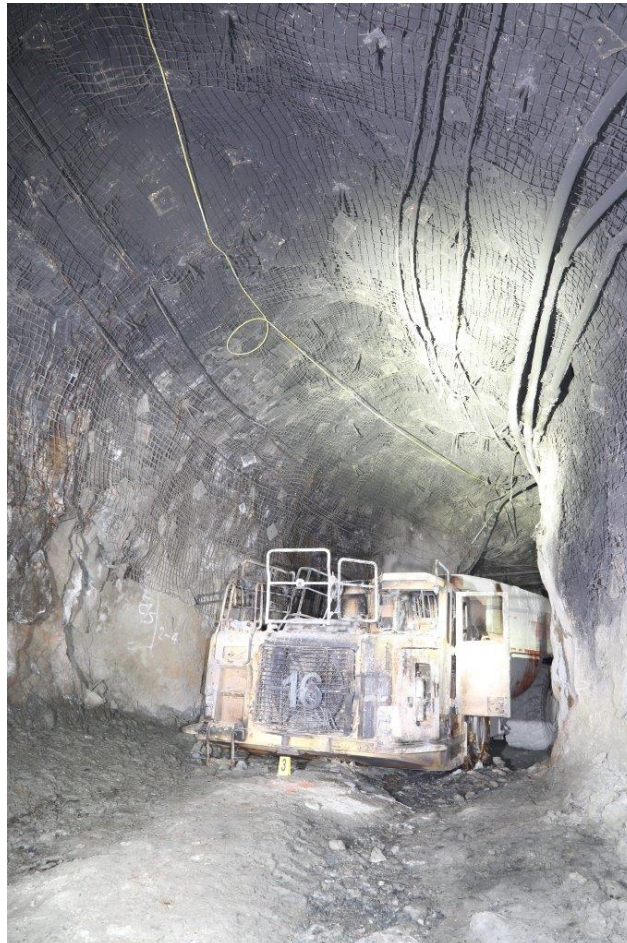
A 60 tonne underground mine dump truck caught fire, blocking a main decline and contaminating the ventilation in the mine. This resulted in an emergency evacuation and mines rescue response.

Photograph 1: Dump truck after the fire. Photo by Resources Regulator

The operator of the dump truck saw the orange glow of a fire coming from the right side of the truck as he was travelling down the decline. The operator started to turn off the main decline but when he realized that he was entering a refuelling bay, he steered the truck back into the main decline and stopped it just past the intersection.

He manually initiated the fire suppression system, which appeared to initially extinguish the fire. The operator then called an emergency alert from the truck and retreated to the rear of the machine. When he looked back, the fire appeared to have gone out. He heard voices over the radio in his truck and went back to the cab and found that the fire had reignited. He then left the truck, walking up the decline.

The cause of the fire had not been identified at the time of writing. The incident is now the subject of an investigation by the Resource Regulator's Major Investigation Unit.

Mine operators must ensure their mechanical engineering control plan sets out the control measures to manage risks to health and safety arising from uncontrolled fires being initiated or fueled by plant. In developing these control measure mine operators must also take into account the identification, assessment, management and rectification of defects that affect the safety of plant.

All isolation points on fresh air supply lines to refuge chambers must be clearly identified.
