SAFETY ALERT

ACCIDENT AND NEAR MISS WITH CEMENT AGITATOR

Report No: SA 01-07

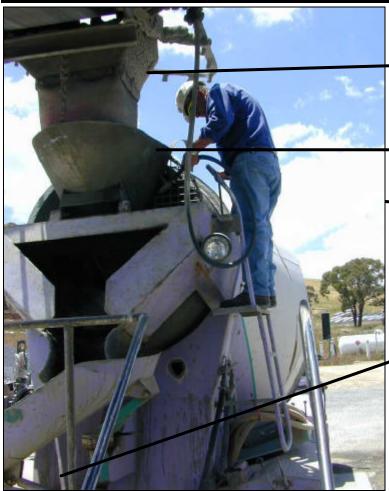
The driver's injuries came from the hose and his hand being pulled into a pinch point by the turning bowl of the agitator. The pinch point area was unguarded. It had not been recognised as a hazard. Putting the hose into the opening beside the loading hopper exposed the driver to the pinch point. A mesh guard was put over the opening (shown on the attached photograph). However, with this type of guarding, a hose and even a finger could still be caught in the pinch point as the bowl turned. A flat steel plate was then put over the opening as guarding. Inspection and hosing can still take place, more safely, through the loading hopper.

Discharge chute from batch plant converyor above loading hopper.

Loading hopper

Area where hosing was taking place (previously unguarded).

Batching platform where hosing normally done on surface.

Adequate guarding should be fitted so that such accidents do not occur.

Consideration should be given to fitting agitator trucks with flat steel plate guarding over the agitating bowl's opening beside the loading hopper. This would prevent access through that opening, but would still enable inspections and hosing of the bowl to be carried out through the loading hopper.

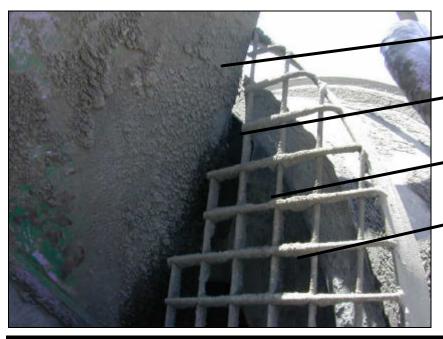
The driver climbed the loading hopper ladder to wash cement from the bowl fins. He put a hose into the agitator bowl. The hose was caught by the fin at the edge of the bowl, which turned upwards. The hose and the driver's fingers were caught in a pinch point between the loading hopper and the rear of the bowl as the bowl's fins turned.

Loading hopper.

Pinch point where fingers caught.

Outer end of bowl fin.

Guard fitted after the accident.
