SAFETY ALERT

COAL MINE SHUTTLE CAR CABLE REEL

Report No: SA 01-10 File No: C00/0276, CM81/16

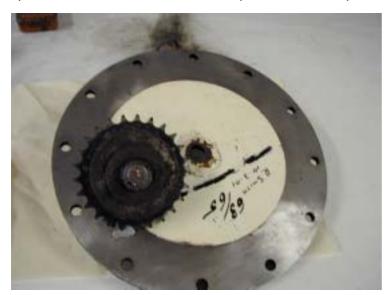
There have been a number of separate incidents of failure of a weld between the slip ring cover and the sprocket shaft. These failures compromised the explosion protected characteristic of the cable-reel slip

ring cover of JOY shuttle cars. In a number of cases the cable reel covers had been inspected by an approved workshop within the previous 12 months.

The picture shows a slip ring cover, internal side up. The sprocket and parallel shaft also shown was able to break free from the centre locating hole because of the lower strength

design. The redesigned shaft with a larger diameter head fully welded to the cover is intended to increase the strength of the assembly.

- As a result of the recent failures, collieries and approved workshops are urged to examine each cable reel cover, and to replace or repair any that do not have the improved sprocket shaft.
 In case of any doubt, the Original Equipment Manufacturer, Joy Mining Machinery Pty Ltd, should be consulted.
- 2. The Department also draws the attention of Mine Managers to the requirements of Clause 51, Coal Mines(General) Regulation 1999.
