SAFETY ALERT

UNSAFE FLAMEPROOF ENCLOSURE OVERHAULED AUXILIARY FAN

SA 05 02
317518395001
09/02/2005
Steve Millington
(02) 65721899

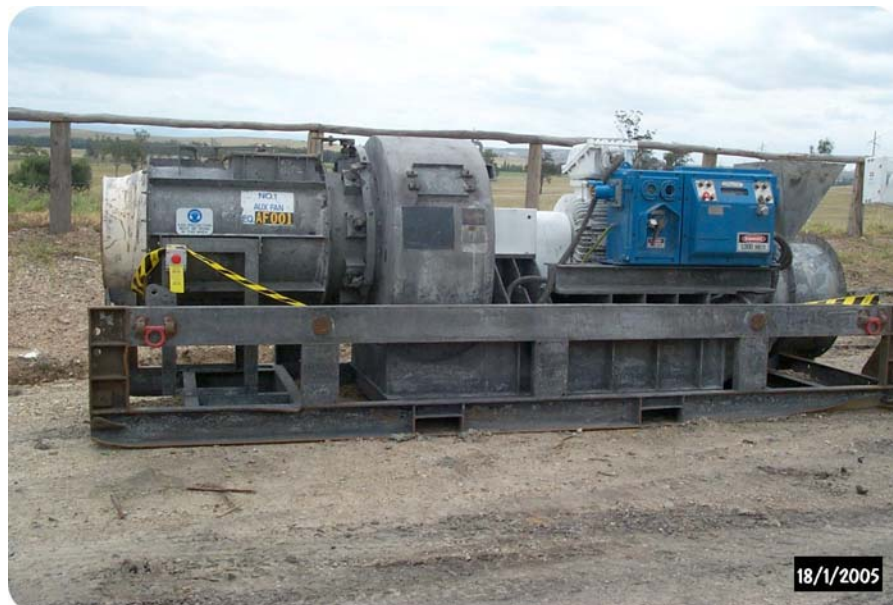
Flameproof Auxiliary Fan

An overhauled auxiliary fan was installed in a hazardous zone in a coal mine while the motor terminal enclosure was not properly flameproof.

After the fan was delivered and installed underground at the mine, it was found that an unused threaded entry in the motor terminal enclosure had a plastic bung rather than a flameproof blanking element.

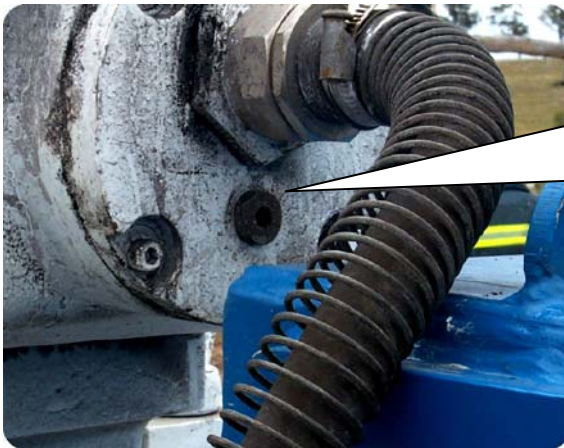
The plastic bung was found by an electrician who was doing diagnostic checks while getting the fan running.

The parts were assembled and test run at the motor overhaul workshop because of the availability of adequate electrical supply for test running. The work and testing was under the control of the accredited repair facility.

A final inspection of the equipment prior to dispatch did not occur.

The mine did not carry out detailed commissioning inspections, relying solely on the quality system and accreditation in place at the repair facility and workshop.

Picture showing plastic bung.

Note: the flameproof blanking element was not fitted when the fan was supplied. The opening was blinded by a plastic cup intended to protect the thread during spray painting.

Mine managers should ensure that standards of electrical engineering practice prepared under Clause 9 Coal Mines (General) Regulation 1999 give effect to those duties.

In particular, standards for overhaul should specify measures to ensure complying product is supplied, and standards for commissioning should include measures for ensuring that plant is safe prior to energising in the hazardous zone.
