SAFETY ALERT

Failure of flameproof enclosure – thread repairs

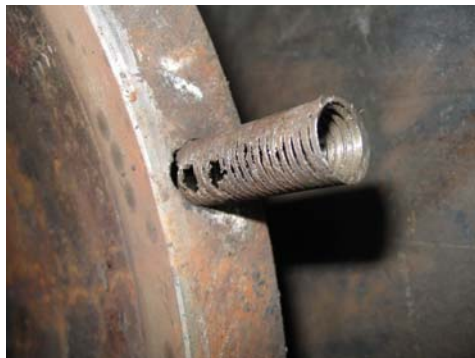
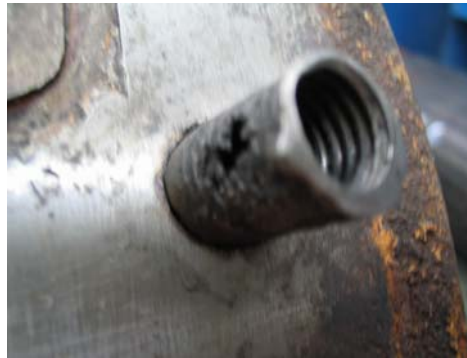
The Department of Primary Industries (DPI) was notified that a number of thread repairs on a flameproof motor had failed.

Figures 1 and 2: Two separate examples of the numerous failed thread repairs on a flameproof motor

The failed repairs on the flameproof motor were located by a workshop that was contracted to overhaul the motor. The Motor had recently been removed from service in a hazardous zone of an underground coal mine.

Underground coal mines and flameproof overhaul workshops that undertake repairs to flameproof apparatus should review the full technical report that is available on the DPI web site, and implement recommendations made in the report. Reports can be located at <http://www.minerals.nsw.gov.au> > Safety > Technical Services > Electrical Engineering Safety > Guidance Material > Technical Papers.
