Failure of explosion-protection characteristics of flameproof equipment

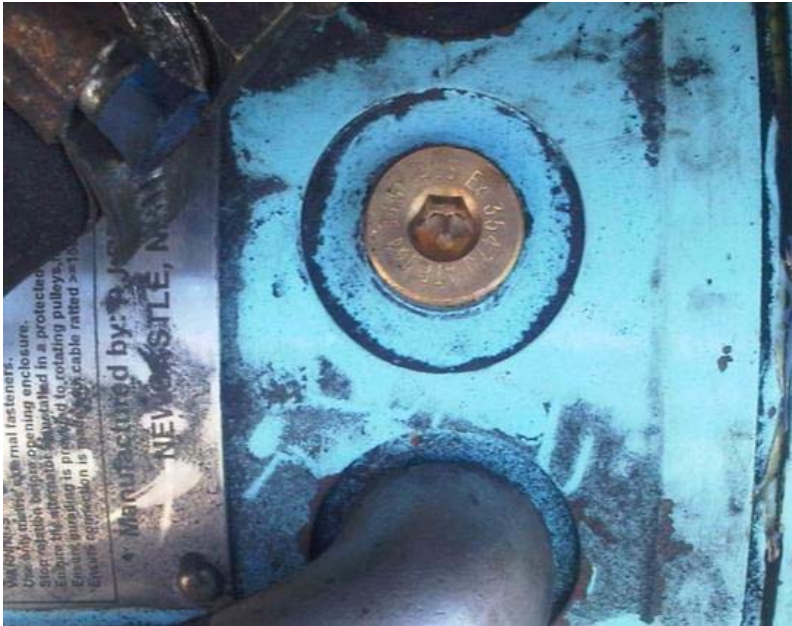
During a routine inspection, the flameproof alternator of a diesel powered personnel transport vehicle was found to be fitted with a plastic blanking plug in an unused gland entry of the alternator. The alternator had been in service for several months prior to identification of this defect.

The alternator has two threaded cable gland entry holes, however only one cable entry hole is used on this vehicle. An electrician found the plastic blanking plug in the unused gland entry during a routine examination.

The alternator was overhauled at a licensed facility for the repair and overhaul of electrical Ex apparatus. It was routine practice at the licensed facility to fit plastic blanking plugs in all threaded gland entry holes of new and repaired alternators prior to painting to prevent ingress of dirt or water during delivery to a customer. The alternators are subsequently supplied to mines with the plastic blanking plugs still fitted.

The alternator was installed on the vehicle as an in-service replacement by mine site personnel and had been in use for several months in a non-Ex condition. The unused gland entry was overlooked during installation at the mine, and by subsequent scheduled examinations.

Photo shows a certified blanking plug in the unused entry hole.

- Mines should review their systems for the introduction of equipment to site and for in-service maintenance activities for electrical equipment and plant. This review should ensure the requirements of Australian Standard AS/NZS 2290.1 '*Electrical equipment for coal mines – Introduction and maintenance*' have been addressed, including requirements for the inspection of Ex areas and component parts that are not readily accessible.
- Training systems for personnel that undertake work on Ex equipment at the mine should be reviewed to ensure periodic review of the competency and standards of workmanship of these personnel.

- Mine operators should implement purchase and supply processes that require all unused cable entries on Ex electrical equipment be fitted with certified blanking elements prior to the supply of the equipment to the mine.
- Suppliers of Ex electrical plant and equipment should only supply Ex electrical plant and equipment with all unused gland entries fitted with suitably certified blanking elements.
- Safety alerts SA04-23 '*Unsafe Flameproof Enclosure*' and SA05-02 '*Unsafe Flameproof Enclosure – Overhauled Auxiliary Fan*' should also be reviewed.

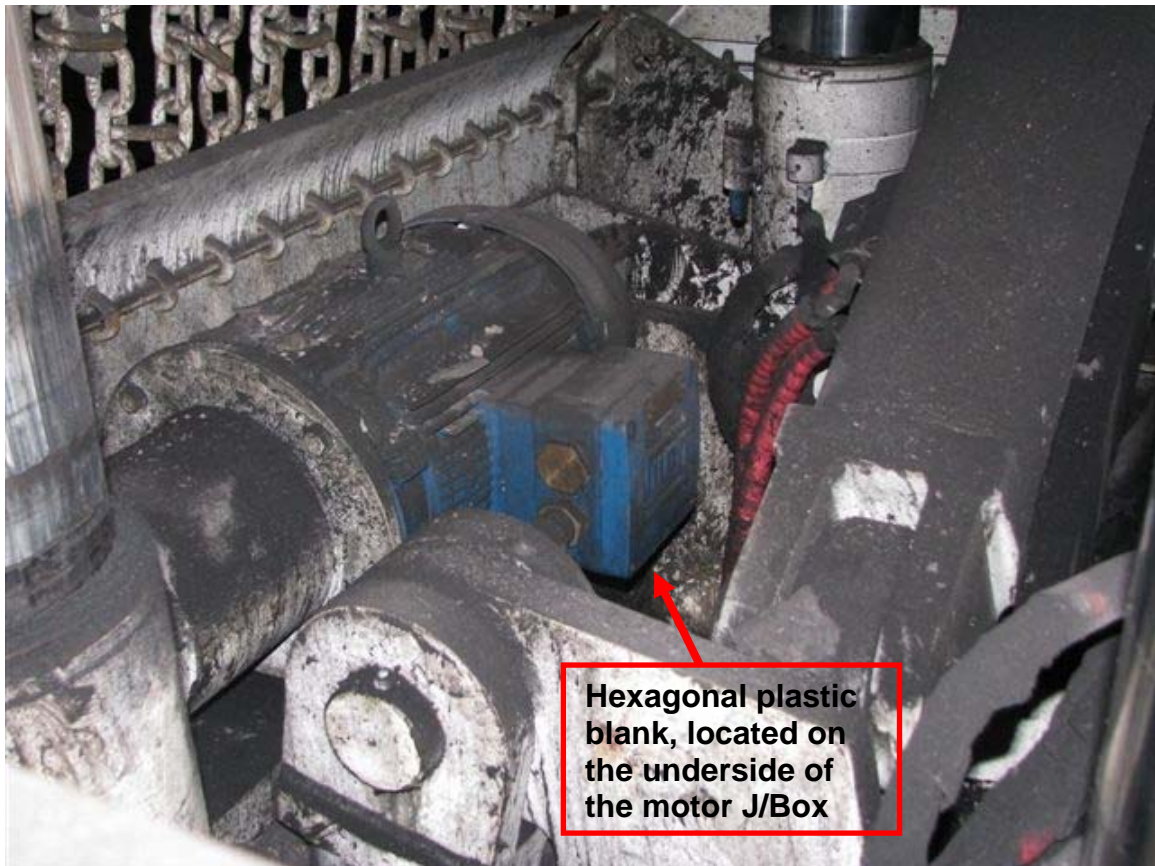
Photo of BLS Motor J/Box

During the replacement of a flameproof motor on a BLS an electrician identified that the newly supplied motor had been fitted with a plastic, non-Ex hexagonal-headed blanking plug. The plastic plug was located on the underside of the motor junction box and had been painted the colour of the motor. This motor was new but had been rewound from 415 to 1000 volts by the motor repair workshop prior to being installed.

The electrician subsequently inspected another BLS that was in service. The in-service BLS had previously been fitted with a replacement motor by a licensed overhaul workshop before delivery to the mine site. The BLS had been in service for 4 weeks within the hazardous zone with Code A inspections being undertaken daily. This motor was also found to be fitted with a plastic hexagonal-headed blanking plug on the bottom side of the motor junction box.

The original motor had been replaced by a licensed electrical workshop prior to the BLS being returned to site. The motor had been fitted by a fourth year apprentice and the paperwork signed off by a tradesman that had not inspected the installation.

The mine had inspected the BLS under the sites 'introduction to site' management system prior to the BLS being placed into service. The inspections which include an internal inspection failed to identify the non-flameproof plastic plug. Several external visual inspections had also failed to identify the plastic plug.
