# SAFETY BULLETIN

**DATE: MARCH 2019**

## Welding-related electric shocks increase

<b>CM9 reference</b>	DOC19/209222
<b>Mine safety reference</b>	SB19-03
<b>Date published</b>	18 March 20192019
<b>Authorised by</b>	Chief Inspector Office of the Chief Inspector

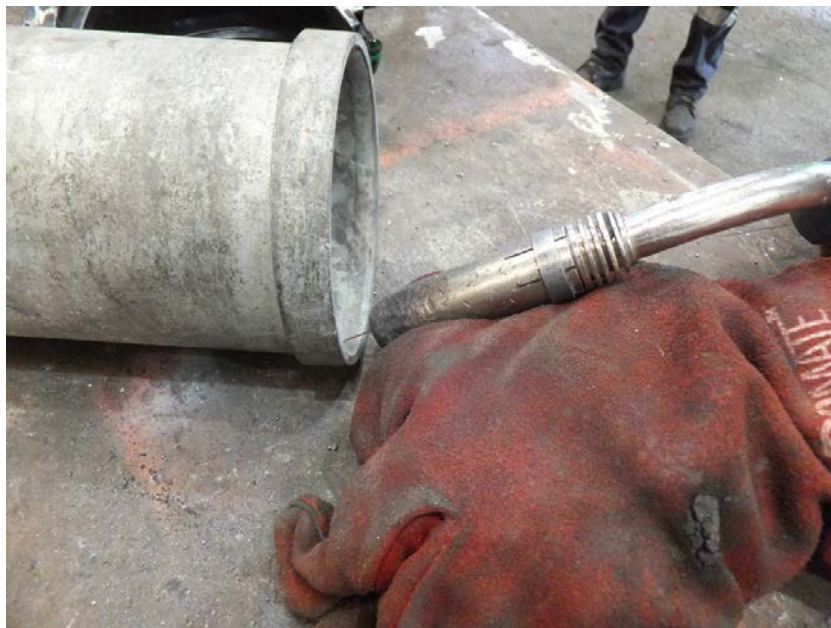
A worker was using a MIG welder in a surface workshop of an underground coal mine. The worker rested the handpiece tip on his gloved hand to steady the handpiece. The worker then felt a shock in his left hand.

*Figure 1: Shock while welding pipe*

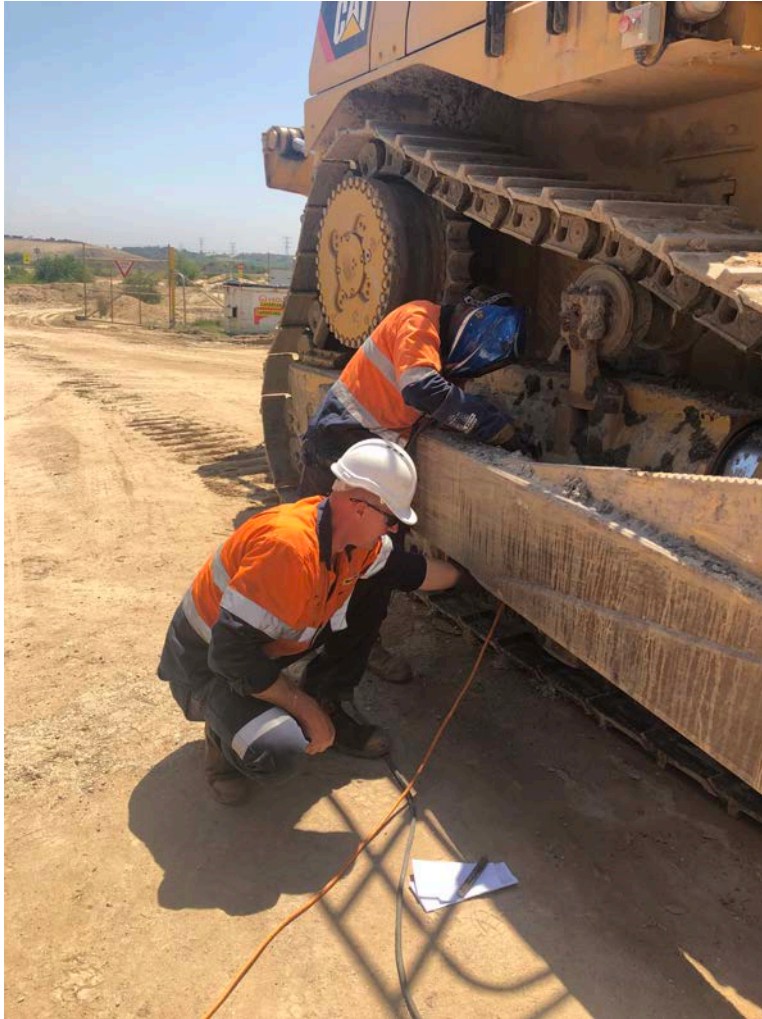
A fitter had washed down a dozer in a sand mine and was preparing to weld. Another worker saw the fitter positioned awkwardly so went to assist. After getting a welding glove, he held a pipe in place. The worker felt a tingle up his arm when the fitter struck the arc.

*Figure 2: Re-enactment of assistant suffering an electric shock*

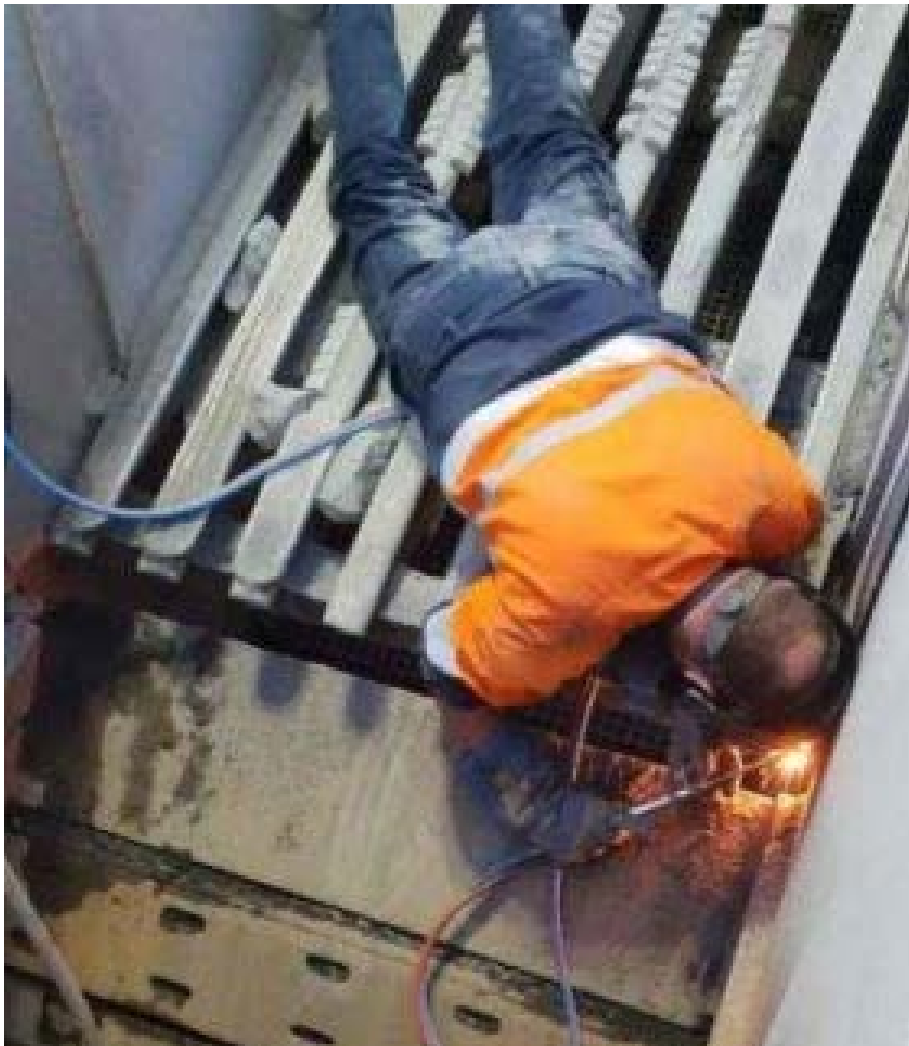
A contractor boilermaker was welding on grizzly panel in a quarry. The earth had been positioned on the opposite side of the grizzly to the area being worked on. The boilermaker was lying on the grizzly. When a programmable logic controller (PLC) code was loaded, a spray bar over the grizzly activated. The arc had already been struck, and welding was underway when the boilermaker suffered the shock.

*Figure 3: The photograph was taken earlier in the day of the incident when the worker was in the same position at the time of the incident*

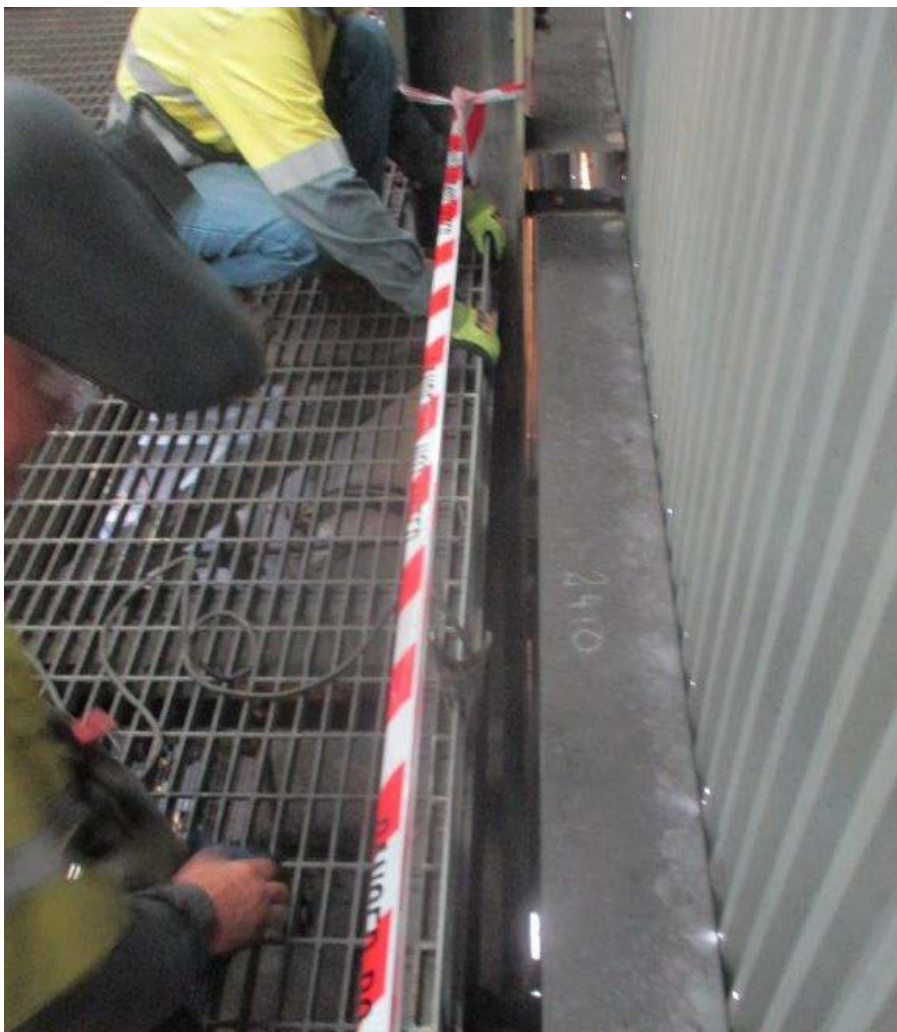
A trades assistant and boilermaker were repairing a walkway. The trades assistant was holding a kick board in position to be welded. As the boilermaker struck the arc, the trades assistant felt an electric shock through the right-hand glove. The trades assistant had his shoulder against a steel column. The boilermaker had the earth return on the opposite side to the trades assistant holding the work piece.

*Figure 4: A re-enactment of the incident on the walkway*
