Week ending 1 November 2017

This incident summary provides information on reportable incidents and safety advice for the NSW mining industry. To report an incident to the NSW Resources Regulator: phone 1300 814 609 24 hours a day, 7 days a week.

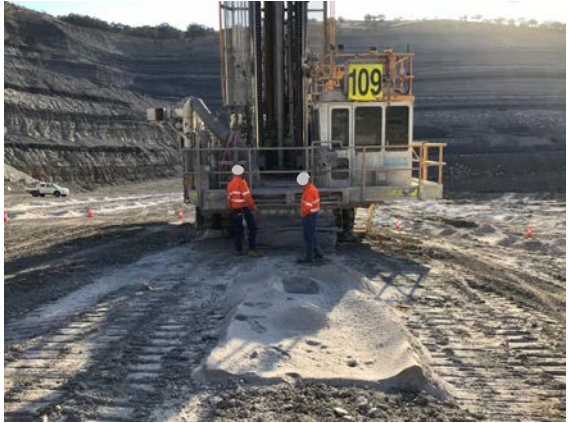
<p>Dangerous incident SInNot-2017/01724</p>	<p>A surface drill was drilling on a pattern in the pit on a slope of approximately 10 degrees. As the operator began tramming, the drill travelled forward down the slope in an uncontrolled movement for approximately 10 metres. The operator parked the drill and put the jacks down to secure the machine.</p> <p>The wiring harness was found to have been rubbing, and was damaged, underneath the operator's seat.</p>	<p>Recommendations:</p> <ul style="list-style-type: none"> • Maintenance strategies for braking systems on mobile plant should consider all potential failure modes of the braking system, including faults on on wiring systems • Braking systems should be inspected, tested and maintained in accordance with the original equipment manufacturer's recommendations. • Wiring systems must be fitted with short circuit protection and over current protection (refer to clause 32(2)(n) WHS(MPS) Reg) • Safety critical electrical wiring systems should be designed so faults, including short circuits between different circuits, do not cause unintended operation of machine functions. <p>Refer to:</p>

<p>Hazard¹: Kinetic energy – Velocity/inertia of vehicle. Risk: Harm to people from unexpected movement of mobile plant.</p>	<p>SB10-03 Mobile plant - safety critical systems SA06-12 Maintenance of Safety Critical Systems - Braking, Steering & Warning Systems MDG 15 – <i>Guideline for mobile and transportable equipment for use in mines</i></p>
<p>Serious injury SInNot-2017/01717</p>	<p>A deputy has stepped into a pumping auger hole while hanging a pump line along the rib. The auger hole was below the surface of the water and was not visible. The hole was about 300 mm in diameter. The deputy's entire leg went into the hole.</p>

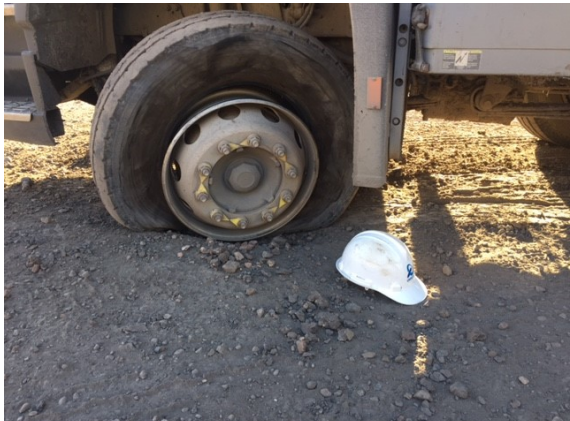
<p>Dangerous incident SInNot-2017/01700</p>	<p>A tyre on a road-registered truck blew out while reversing. This caused debris to be ejected from the area around the tyre blowout towards another road-registered truck that was parked alongside the area where the truck was reversing. The operator was sitting in the parked truck with the window down.</p>

<p>Recommendations:</p> <ul style="list-style-type: none"> • Tyre manufacturers should be engaged to assist with identification of causes of tyre failure. • Regular visual inspections of tyre sidewalls should be done to identify bulges, bubbles, cuts or other damage to ensure risk from tyre failure or blowouts is minimised. <p>Refer to: <i>AS 4457.2-2008 : Earth-moving machinery - Off-the-road wheels, rims and tyres - Maintenance and repair - tyres</i></p>

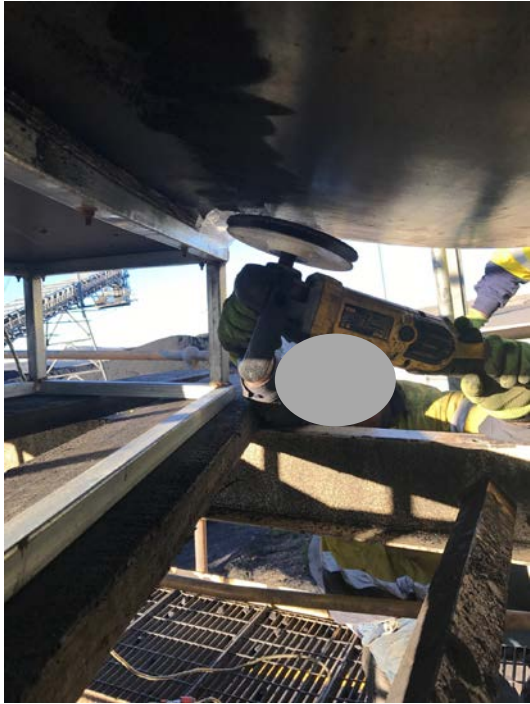
<p>Hazard¹: Pressurised fluids – compressed air</p> <p>Risk:</p> <ul style="list-style-type: none"> • Harm to people from the uncontrolled release of compressed air. • Harm to people from flying debris. 	
<p>Medical treatment injury SInNot-2017/01699</p>	<p>Repairs were being carried out on a product conveyor. A hot splice was completed earlier in the day with the belt technician finalising the splice using a 180 mm polisher with a tungsten carbide buffing disc.</p> <p>While operating the polisher, the belt technician made contact with the table supporting the conveyor in the area of splice. As the polisher wheel made contact with the table it has changed direction and hit the technician's face, moving across his safety glasses and causing a laceration to his nose. The technician received five stitches to his nose and bruising to his forehead.</p>

<p>Hazard¹: Kinetic energy – moving parts.</p> <p>Risk: Harm to people from friction of abrasion.</p>	<p>Recommendations:</p> <ul style="list-style-type: none"> • Before using hand-held grinders and polishers, where possible consideration should be given to using alternative tools. • Workers who use hand-held grinders and polishers need to be trained in their correct use and in the potential risks. • Appropriate personal protective equipment should always be worn. Consideration should be given to full face masks. • Hazard identification should be routinely performed before starting work. • Mines should periodically check contractor's tools and work practices • Adequate supervision should be provided for contractors.
