COMPLIANCE AUDIT PROGRAM

WOODLAWN MINE

Tarago Operations Pty Ltd

Title: Compliance audit program: Woodlawn Mine, Tarago Operations Pty Ltd

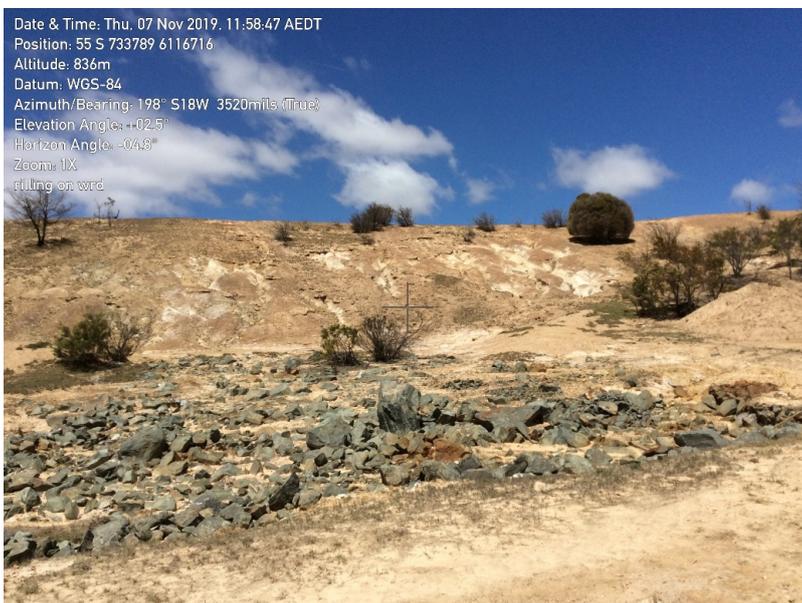
During the site inspection, it was noted that there were areas of active erosion and vegetation failure on parts of the WRD, particularly the western face (Figure 1). Section 5.1.1 of the approved MOP identified

that Tarago Operations would monitor erosion and vegetation on the surface of the waste rock dump and undertake maintenance as required to ensure that the vegetation cover was maintained. It was observed that Tarago Operations had dumped additional soil material to be respread over the failed eroding areas. However, the Regulator's auditor identified a concern that the slope was too steep and may require additional stabilisation (e.g. jute mesh, bitumen emulsion or similar) until vegetation could be established. Otherwise, the newly placed soil could wash off at the first rain event. This was raised as **observation of concern no. 2**.

Figure 1 Vegetation failure and erosion on the western face of the waste rock emplacement

OBSERVATION OF CONCERN NO.	DESCRIPTION OF ISSUE	RECOMMENDATION
	<p><i>rehabilitation monitoring program.</i> Landscape function analysis (LFA) baseline monitoring was completed in October 2018. Although discussion with Woodlawn staff indicated that LFA was planned to be undertaken on a quarterly basis, this had not yet commenced (but was not a MOP commitment).</p>	<p>basis to monitor rehabilitation progress.</p>
<p>2</p>	<p>During the site inspection, it was noted that there were areas of active erosion and vegetation failure on parts of the WRD, particularly the western face. Section 5.1.1 of the approved MOP identified that Tarago Operations would monitor erosion and vegetation on the surface of the waste rock dump and undertake maintenance as required to ensure that the vegetation cover is maintained. It was observed that Tarago Operations had dumped additional soil material to be respread over the failed eroding areas. However, the Regulator’s auditor identified a concern that the slope was too steep and may require additional stabilisation (e.g. jute mesh, bitumen emulsion or similar) until vegetation can be established, otherwise, the newly placed soil could wash off at the first rain event.</p>	<p>Tarago Operations should consider additional stabilisation on the western slope of the waste rock emplacement.</p>

3. **Observation of Concern no. 2. Erosion and vegetation failure on the rehabilitated waste rock dump.** Erosion across the rehabilitated waste rock dump is in need of stabilisation and rehabilitation. Initially, it was anticipated that Mixed Waste Organic Output (MWOO) material produced on site by Veolia would be used for the erosion rehabilitation. However, in view of the removal by the EPA of the Exemption allowing use of MWOO, other material for the rehabilitation of the WRD will be required. A stockpile of topsoil has been placed adjacent to the erosion in preparation for the rehabilitation activities. The suggestion from the Auditors that additional measures, including jute mesh or other materials will be required to stabilize the erosion on the steep western slopes is agreed and a range of appropriate materials and strategies will be utilised. A works program to commence rehabilitation of the erosion on the rehabilitated WRD will be initiated during Quarter 3, 2019/2020.

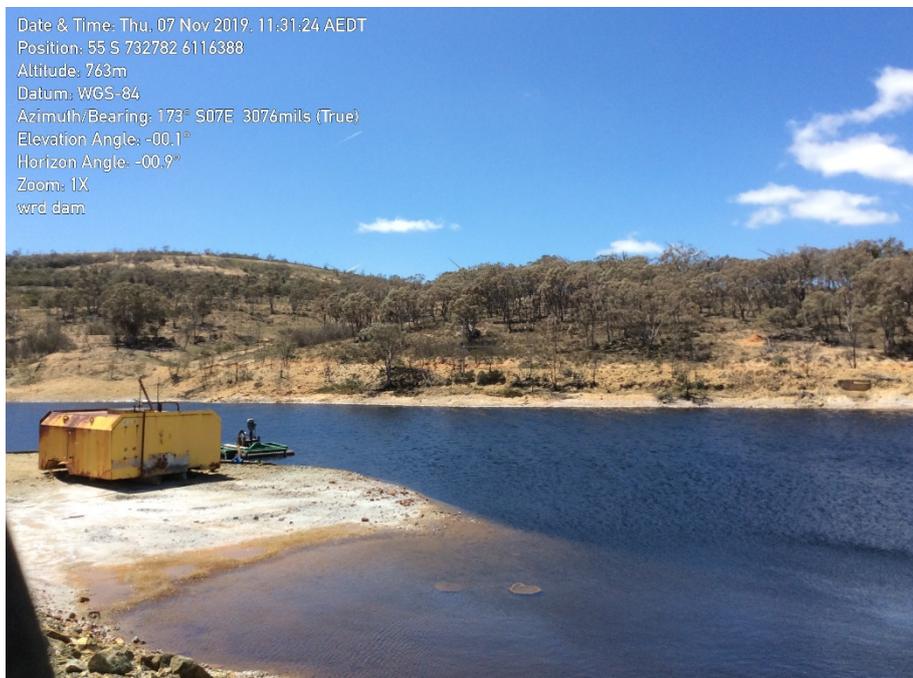
For the phase of 'Rehabilitation of other domain areas', the completion criteria for the waste rock dump was '*water quality contained in dam suitable for discharge or recycling*'. Water quality in the waste rock dump dam (Figure 2) had been monitored over a 15 to 20-year period and records were available to verify this. However, waterflow from the waste rock dump had not been routinely monitored. Tarago Operations had recently installed monitoring equipment so that flows from the waste rock dump were now being measured. Collection of the flow monitoring data was necessary for the design of a passive treatment system for the poor quality seepage from the waste rock dump.

Figure 2 Waste rock emplacement seepage dam

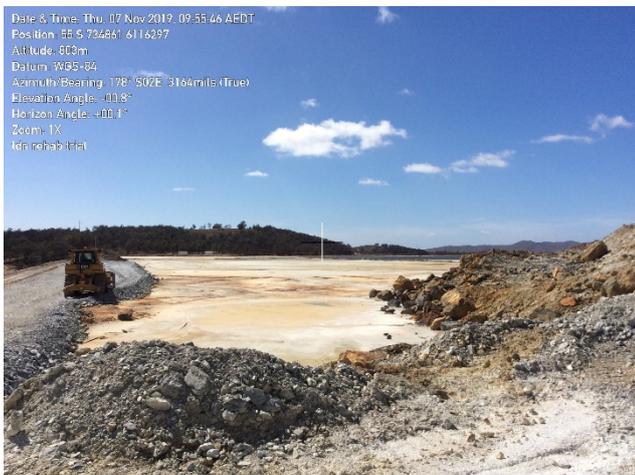
Section 5.1.2 broadly discussed the rehabilitation program for Domain 2 Tailings storage facilities. This described two options for capping and rehabilitation of the tailings dams. During the audit, Tarago Operations advised that a capping trial using Option 1 was about to begin on a five-hectare area of Tailings Dam North (Figure 3). The trial was planned to be conducted over five years, and the results would be used to refine the capping design for use in rehabilitation of the other TSFs on site. The trial was proposing to use the processed pulp material as one of the neutralising layers for the acidic nature of the tailings (Figure 4).

Figure 3 Area of capping trial on TD North

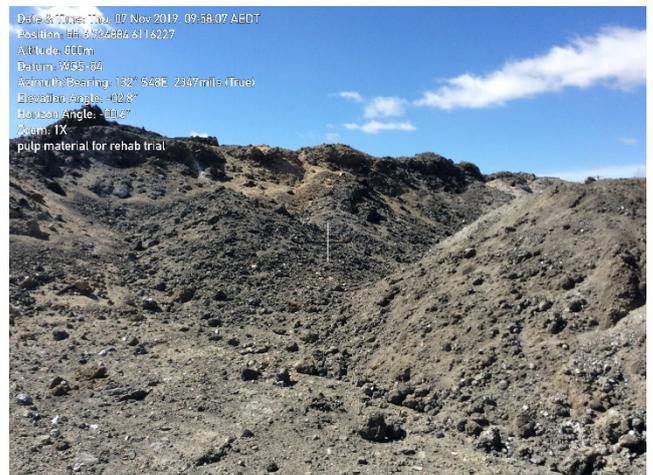
Figure 4 Processed pulp material at TD North

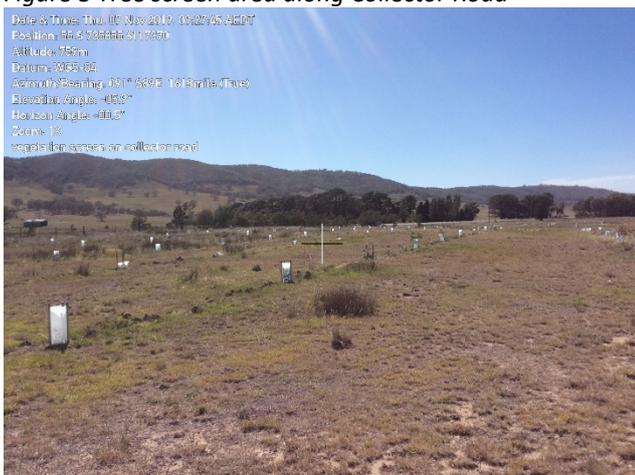
Section 5.1.5 of the approved MOP described the proposed rehabilitation for Domain 5 - Remaining Site Areas. During the site inspection, the tree screen area along Collector Road was inspected (figure 5). This area was noted to be included in the biodiversity offset area proposed as part of the project development consent. Tree development was observed to be quite successful, with monitoring data detailing survivability rates of about 80% (figure 6). Tarago Operations advised that the tree screen area was being used as a pilot study to assess controls aimed at increasing the survival ability of the vegetation in this area. Detailed records of the species planted, ameliorants added, when trees were watered and assessments of the health and growth of each species, have been maintained. A photographic record was also reported to have been maintained.

Figure 5 Tree screen area along Collector Road

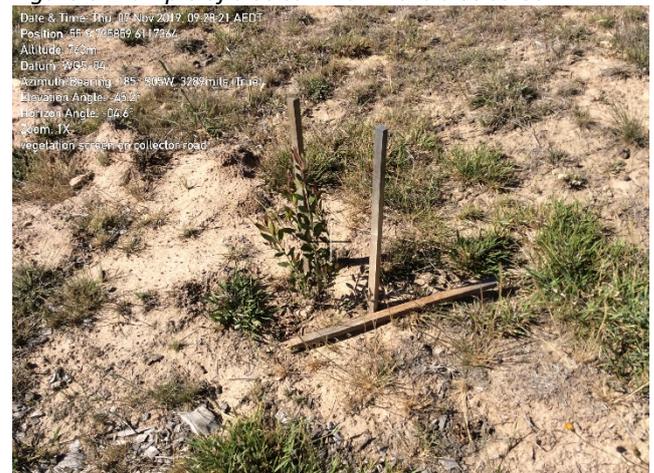
Figure 6 Example of tree survival in the tree screen

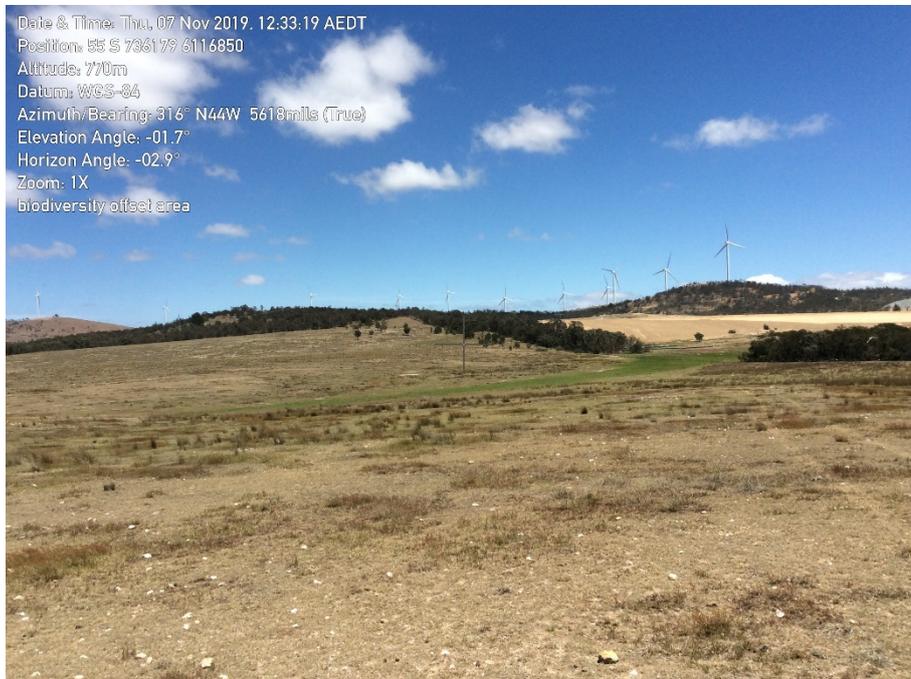
The remainder of the biodiversity offset area was observed to be left as is, generally not disturbed by mining activities (figure 7). The area had been subject to ongoing grazing but did not appear to be degrading at the time of the inspection. Tarago Operations reported that seed collection was proposed from the treed area on the ridgeline with these species used to revegetate similar areas in the biodiversity offset area.

Figure 7 Biodiversity offset area

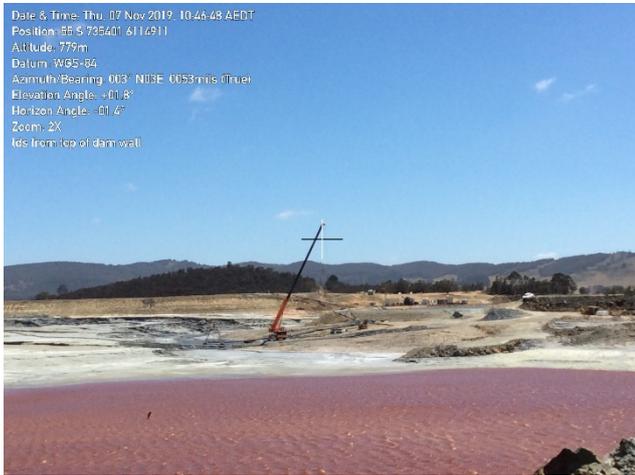
Figure 8 Tailings Dam South - reprocessing in progress

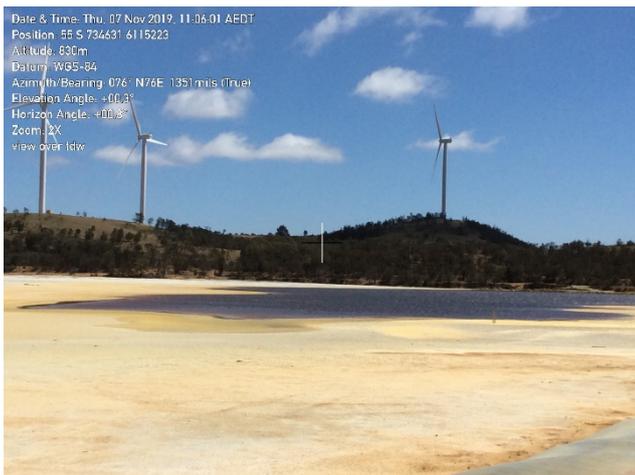
Figure 9 View over TD West

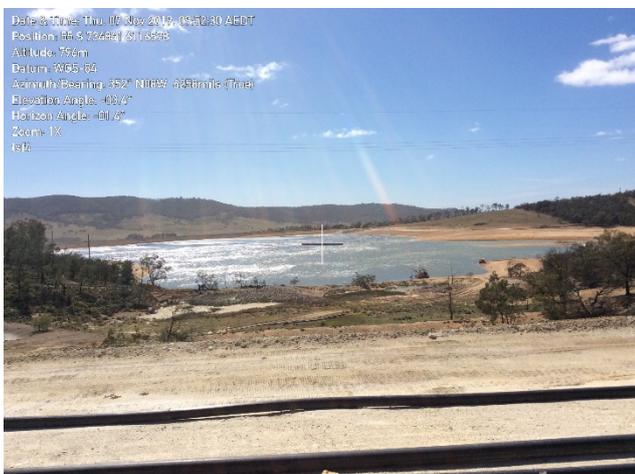
To facilitate the reprocessing activities, tailings storage facility TSF4 was constructed in 2018 (Figure 10). Engineering consultant Coffey International prepared the Woodlawn Project – Tarago Construction Report TSF4 in September 2018 at the completion of construction to confirm that the TSF was constructed according to the design.

Figure 10 View over TSF4

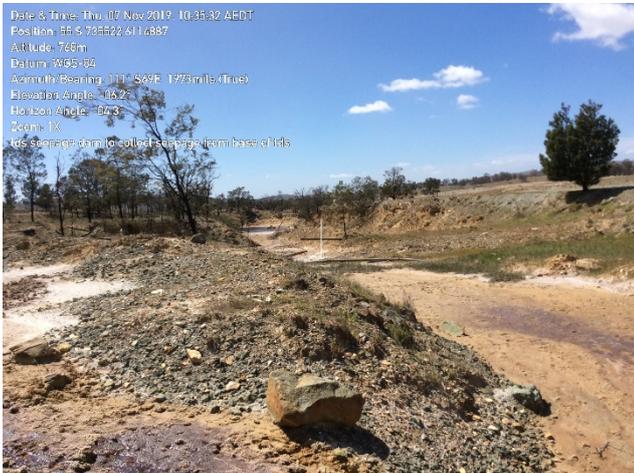
Figure 11 Seepage collection dam below TD South

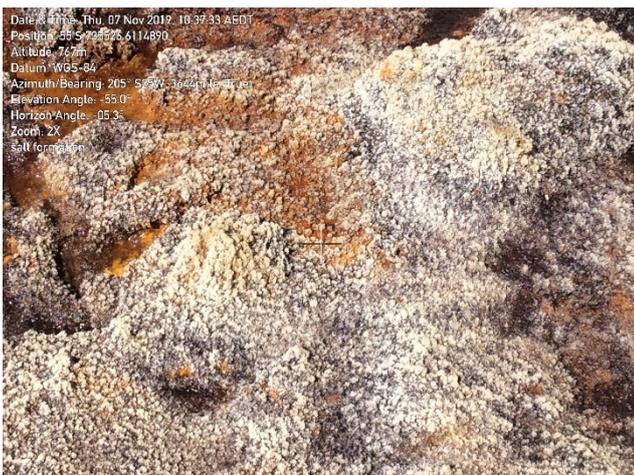
The monitoring program for the TSFs included groundwater monitoring using a network of piezometers. Tarago Operations reported that quotes had been obtained for the installation of additional piezometers downstream of TSF4. Data provided in the annual review indicated that no significant issues were identified to-date from this monitoring. There is a known seepage issue from Tailings Dam South. However, this seepage issue was planned to be addressed once tailings reprocessing in TD South has been completed, and before depositing further tailings. The seepage area was inspected during the audit (Figure 11) and salt formation was observed over a small area (Figure 12). No additional issues were identified.

Figure 12 Salt formation in seepage area

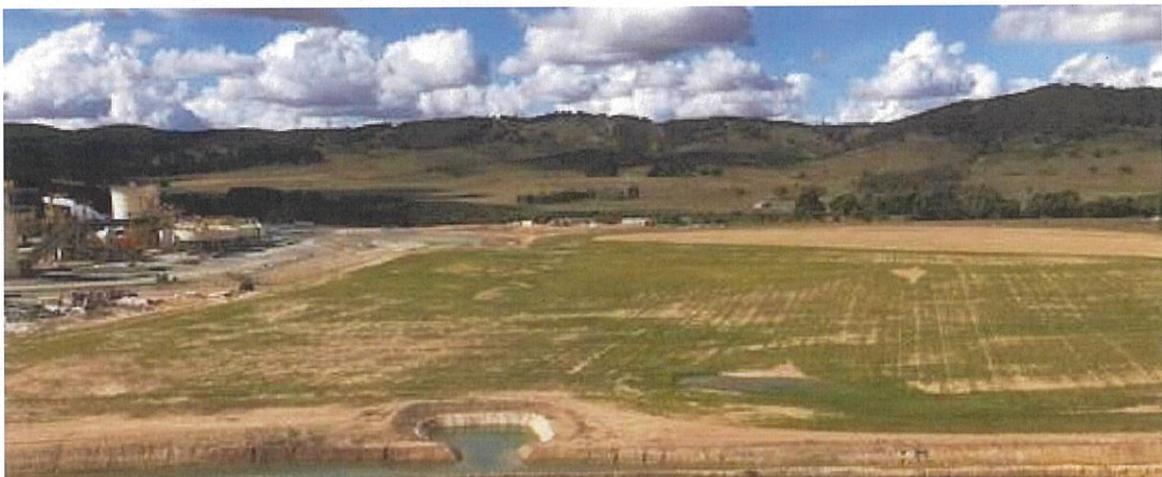
Figure 1. Overview of Hickorys Paddock rehabilitation, millet crop (March 2019)

5. **Observation of Concern no. 4. Rehabilitation of Domain 4 - Hickory's Paddock.** During the site inspection the auditors were shown an area below TSF4 that was in the process of being rehabilitated following construction of TSF4. Rehabilitation of the site is relatively advanced having first been sown with millet in December 2018 (Figure 1). Millet, was used as the initial vegetation cover as it is a summer crop useful for reducing erosion, improving water infiltration and soil nutrient cycling. The high above ground biomass grown desiccated over winter and contributed organic matter to the soil. A second crop comprising brassica and millet was sown, using a direct drilling technique, on the day prior to the Audit inspection (6 November 2019), explaining the limited vegetation observed on the ground during the inspection. There has been no rainfall recorded on site since the crop was sown, consequently there has been negligible germination of the crop to date. Presently, it is planned that a permanent pasture be sown during Autumn 2020 as the definitive understory ground cover. However, should the extreme drought conditions persist it may be necessary to revise the schedule. LFA will be used to monitor the rehabilitation within Hickory's Paddock.
