MINE SAFETY DIVISION, DEPARTMENT OF PRIMARY INDUSTRIES

REVIEW OF FAILURES OF BOLTHOLE REPAIRS TO FLAMEPROOF MOTORS

ON BEHALF OF: Mine Safety Division, Department of Primary Industries Review of failures of bolthole repairs to flameproof motors		DOCUMENT NO: 9.4.6_MIN_DPI_28/01/05
		REVISION NO: 3
		PAGES: 22
		DATE: 28 th January 2005
COMPILED BY: G. ALLAN	RECOMMENDED BY: C. SMALLBONE	AUTHORISED BY: C. SMALLBONE

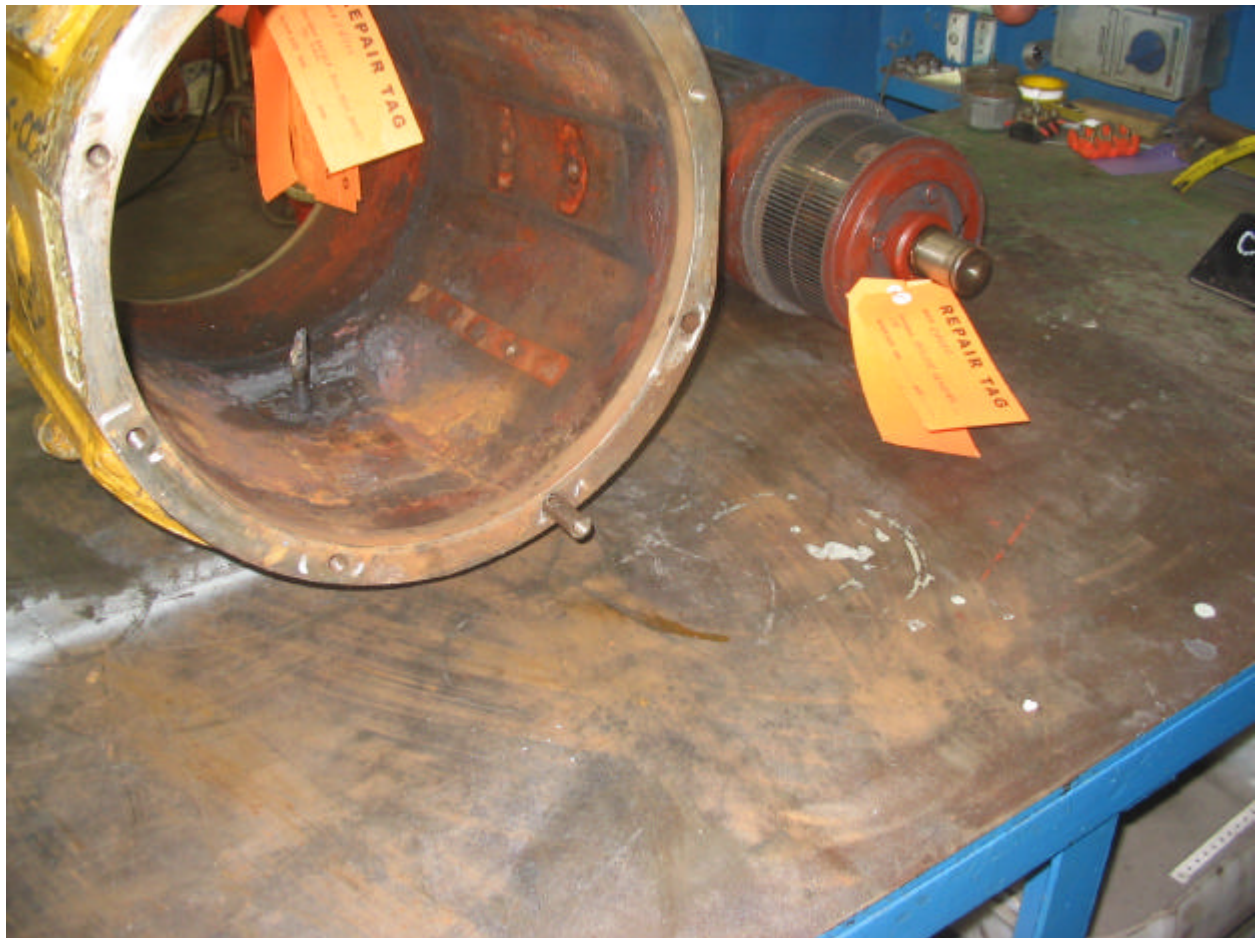
On the motor examined at the MinePro workshop, boltholes had been repaired on the frame ends and on the hand access hole on the stator frame. See Figures 1 & 2.

Figure 1. General view of the stator frame end face of Motor A. An insert has been partially removed.

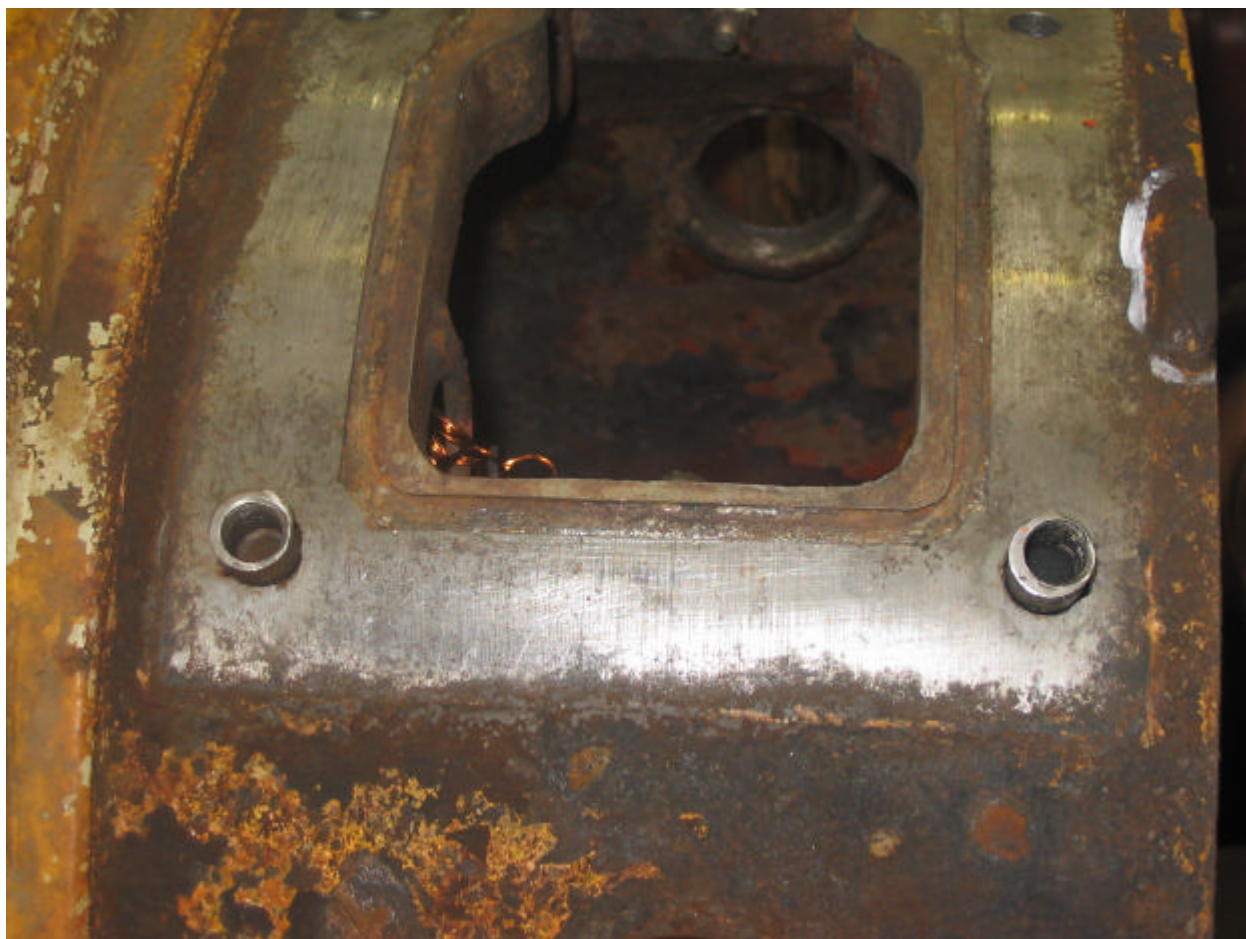
Figure 2. General view of side cover of Motor A showing partially removed inserts.

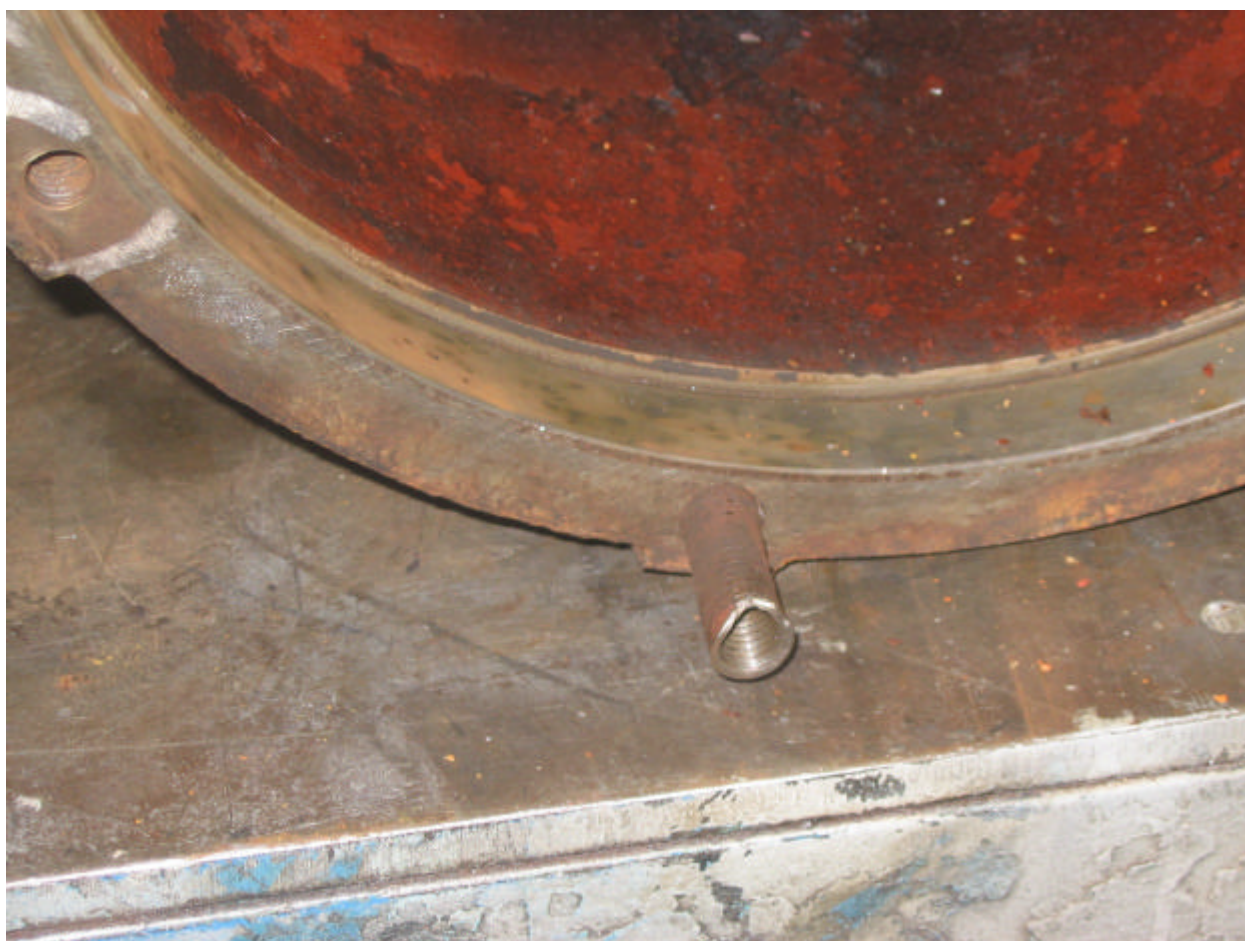
All six bolthole inserts had failed at the hand access hole. At least 13 of the 16 boltholes on the stator frame end faces had been repaired with inserts. There was evidence of insert failure on a number of those repaired holes. See Figure 3.

Figure 3. Detail of the partially extracted insert from Motor A.

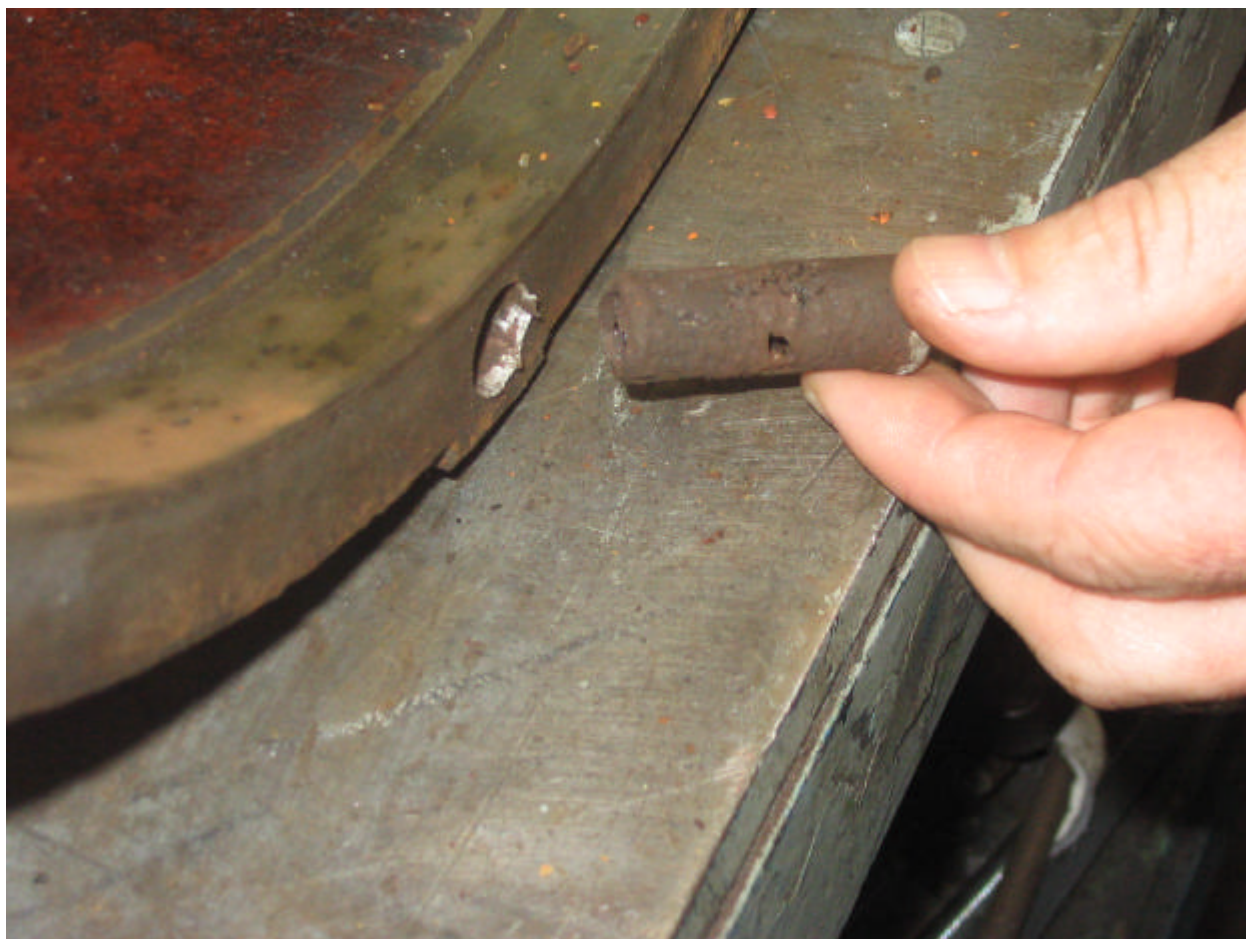
Very little force was required to remove the inserts in some cases. Some inserts could be dislodged with hand force only. See Figure 4.

Figure 4. Insert easily removed by hand.

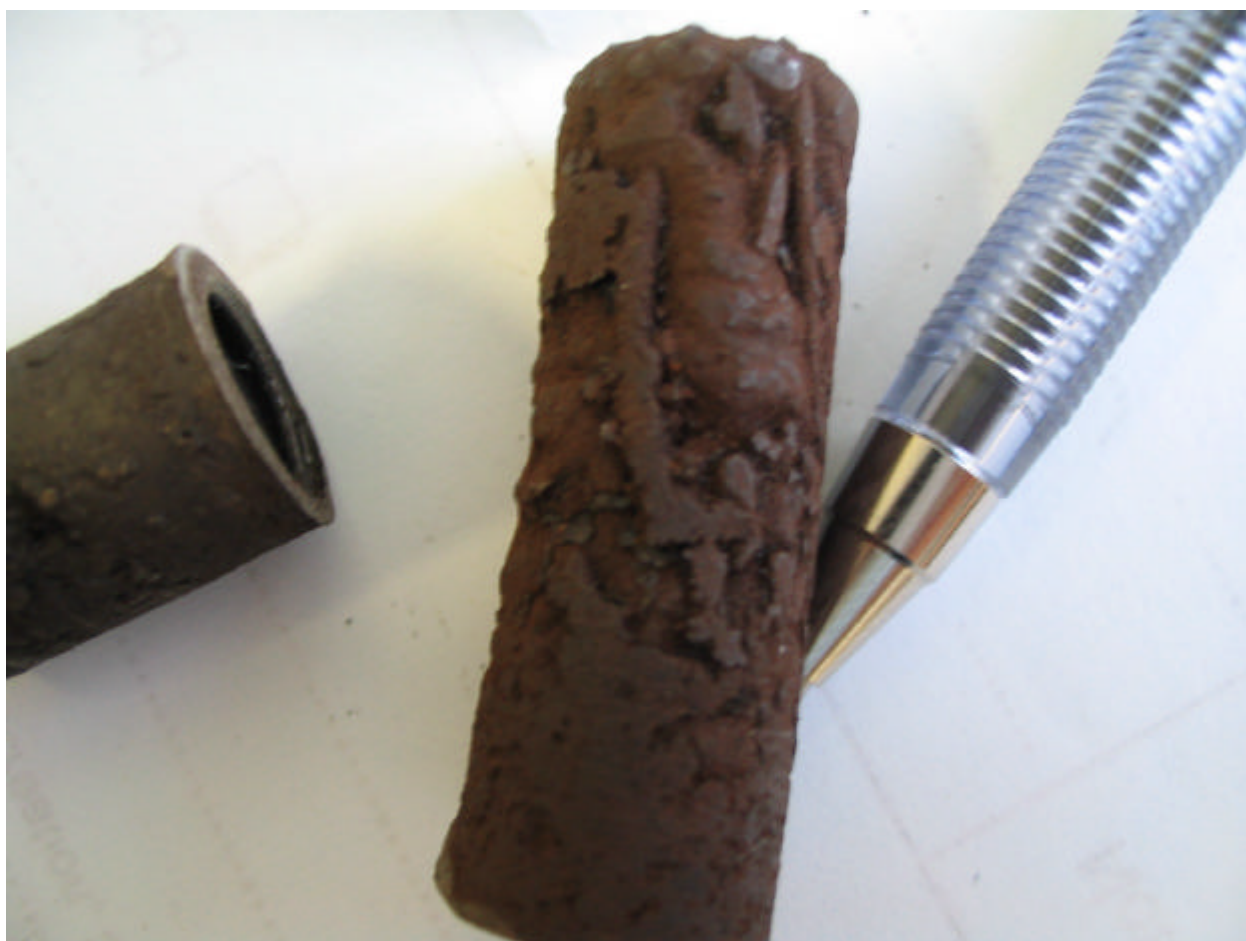
Insert material that had been removed from failed repairs was examined. The specimens were approximately 14mm diameter and up to 45mm in length. See Figure 5. The boltholes for the hand access hole were blanked on the inside with a cover that was welded in place.

Figure 5. Inserts after extraction from Motor A.

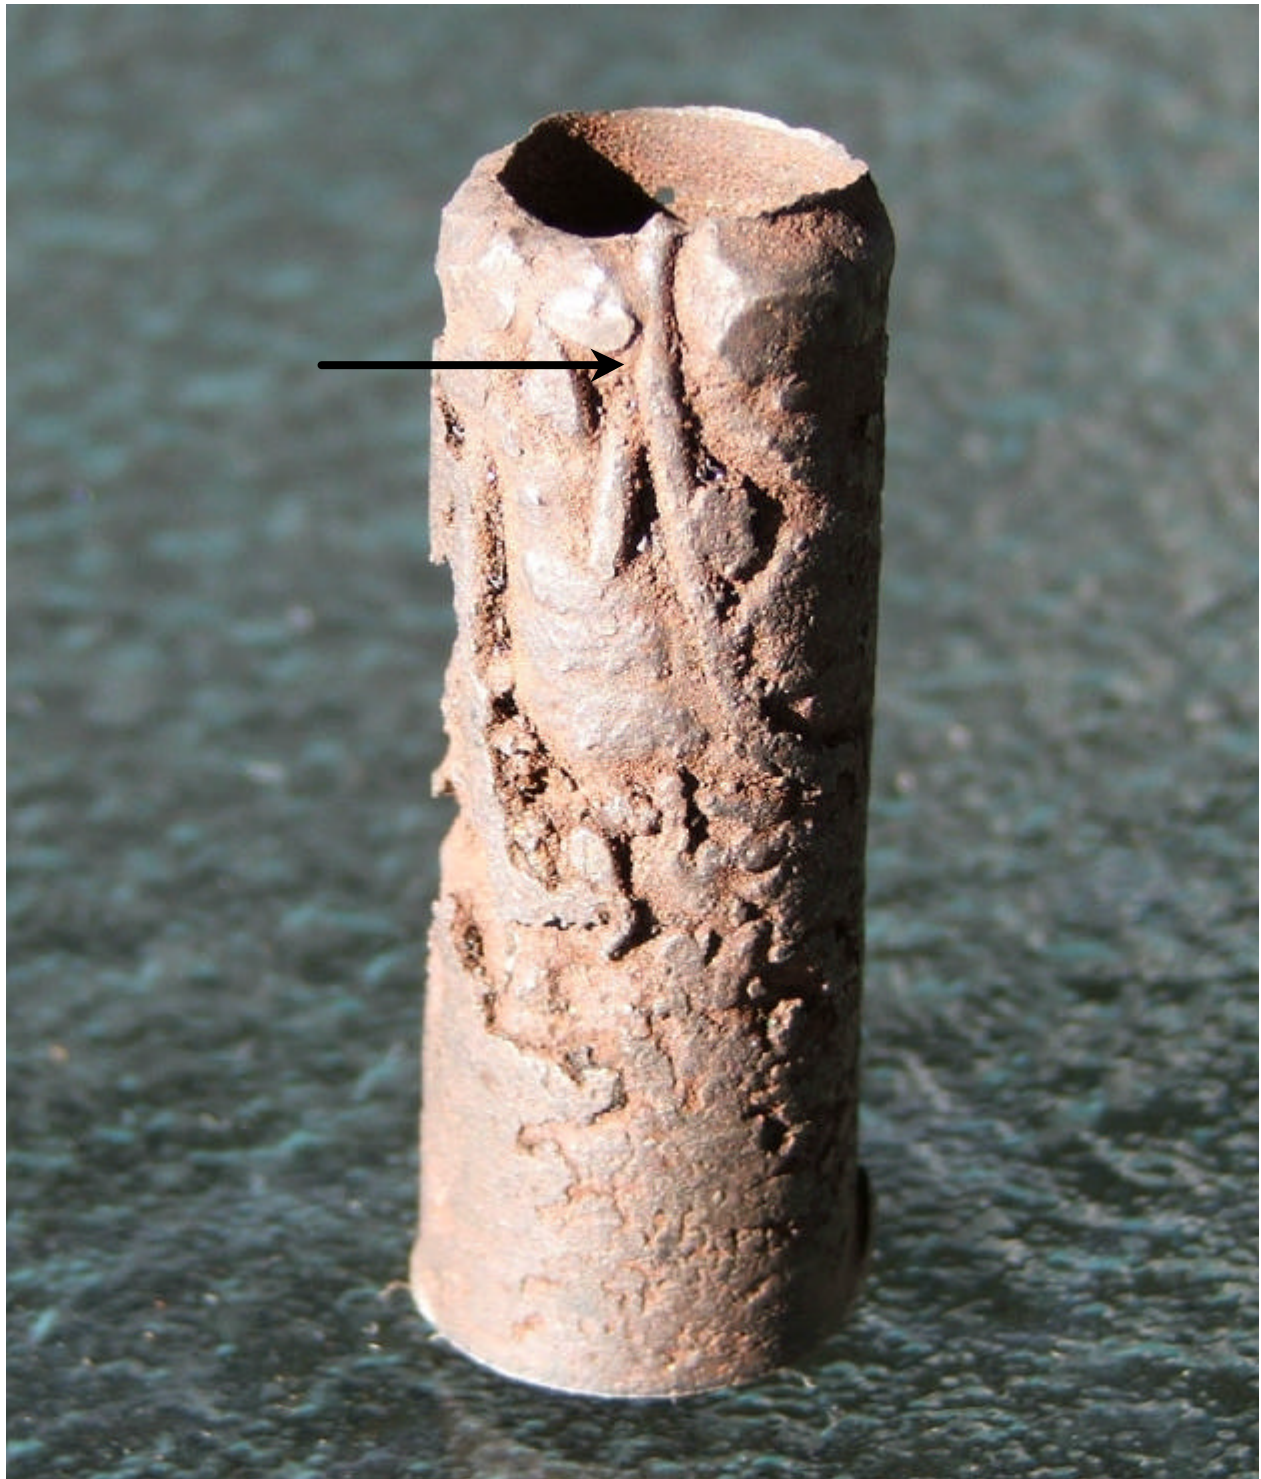
All failed insert specimens were oxidised and had a rough outside surface appearance. There were features on the outside surface of the inserts that were consistent with GMAW wire and weld spatter. See Figure 6.

A section was taken through the point indicated by the arrow on the failed insert shown in Figure 6.

Figure 6. Closer view of insert material after removal from the bolthole (Motor A). Partially melted welding wire is evident.

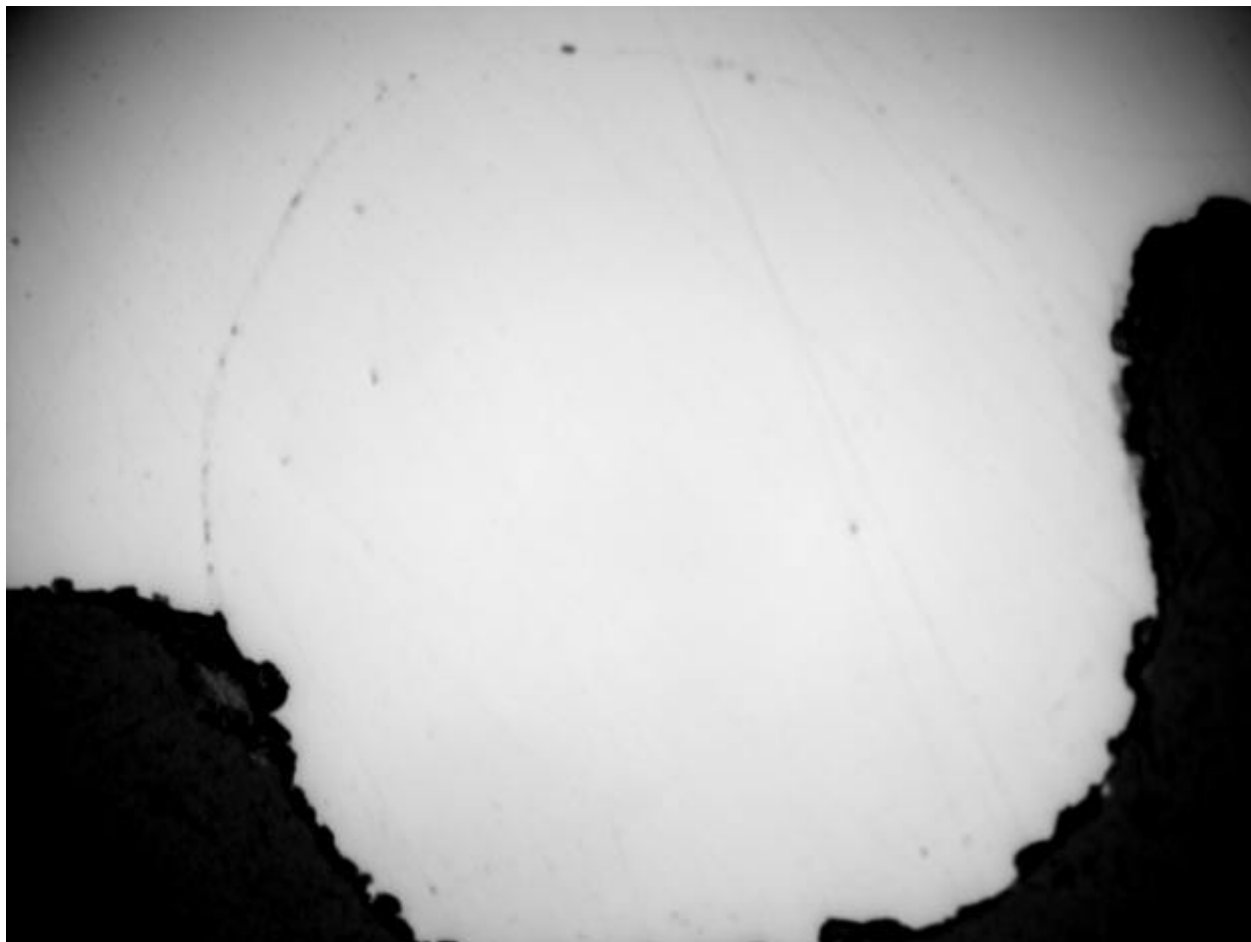
Figure 7. X 100 - Unetched

The specimen was examined in the polished condition. There was a circular form with half of the circle protruding from the body of metal. See Figure 7. The diameter of the circle was measured at approximately 1mm. The form was consistent with a GMAW solid wire consumable.

The photomicrograph was sectioned at the position indicated by the arrow in Figure 6. There is a semi-circular form in the upper part of the field.

The circle was measured at 1.0mm diameter.

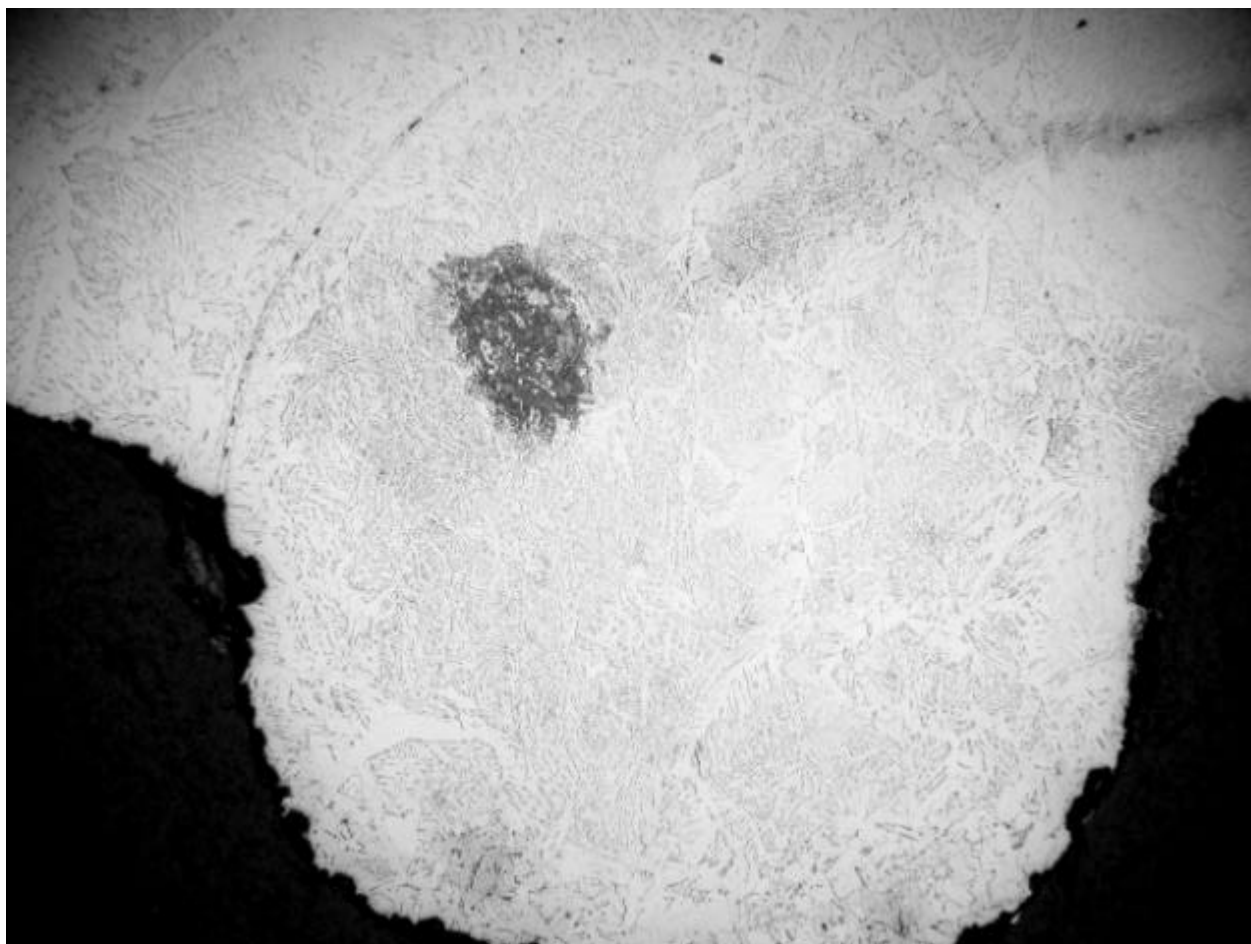
Figure 8. X 100 – 2% Nital etch

The specimen was etched and the microstructures were examined. There was partial fusion of the wire to the body of weld metal. There was a network of fine oxide inclusions and porosity around the circumference of the wire. See Figure 8. This is consistent with molten metal coming in contact with the wire but with insufficient temperature at the boundary for complete fusion.

The same photomicrograph as shown in Figure 7, sectioned at the position indicated by the arrow in Figure 6. A partially unfused boundary can be seen.

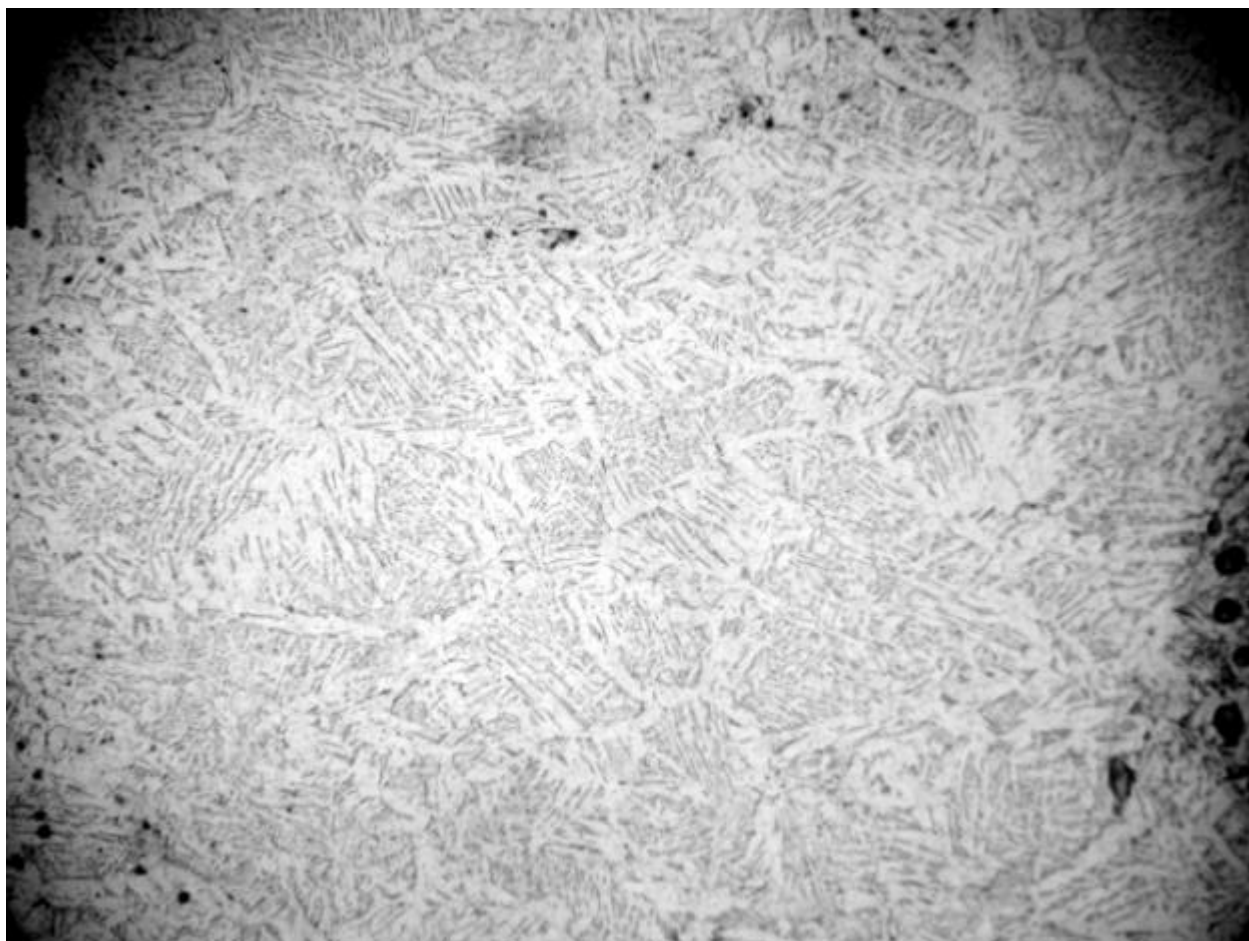
Figure 9. X 200 – 2% Nital etch

A longitudinal section was taken through a failed insert from Motor A. The microstructure was consistent with low carbon steel weld metal. See Figure 9.

Insert material from Motor A. the microstructure is consistent with a low carbon steel weld deposit.

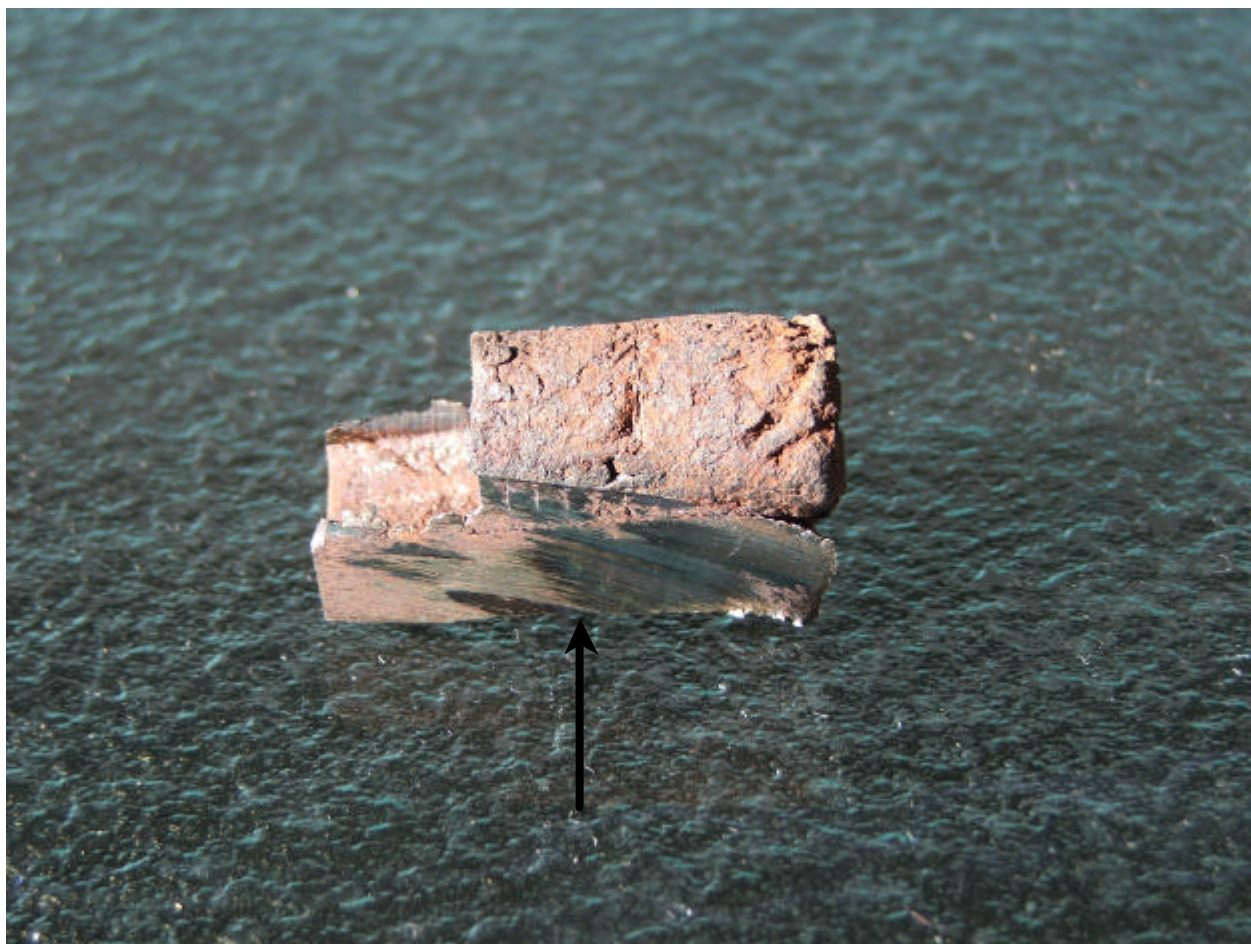
A section was taken through the point indicated by the arrow in Figure 10. The section contained parent metal and insert material.

The polished specimen was examined in the polished condition. There was a gap between the parent metal and insert material. There was no evidence of fusion of the insert material with the parent metal.

Figure 10. General view of a sample from Motor B.

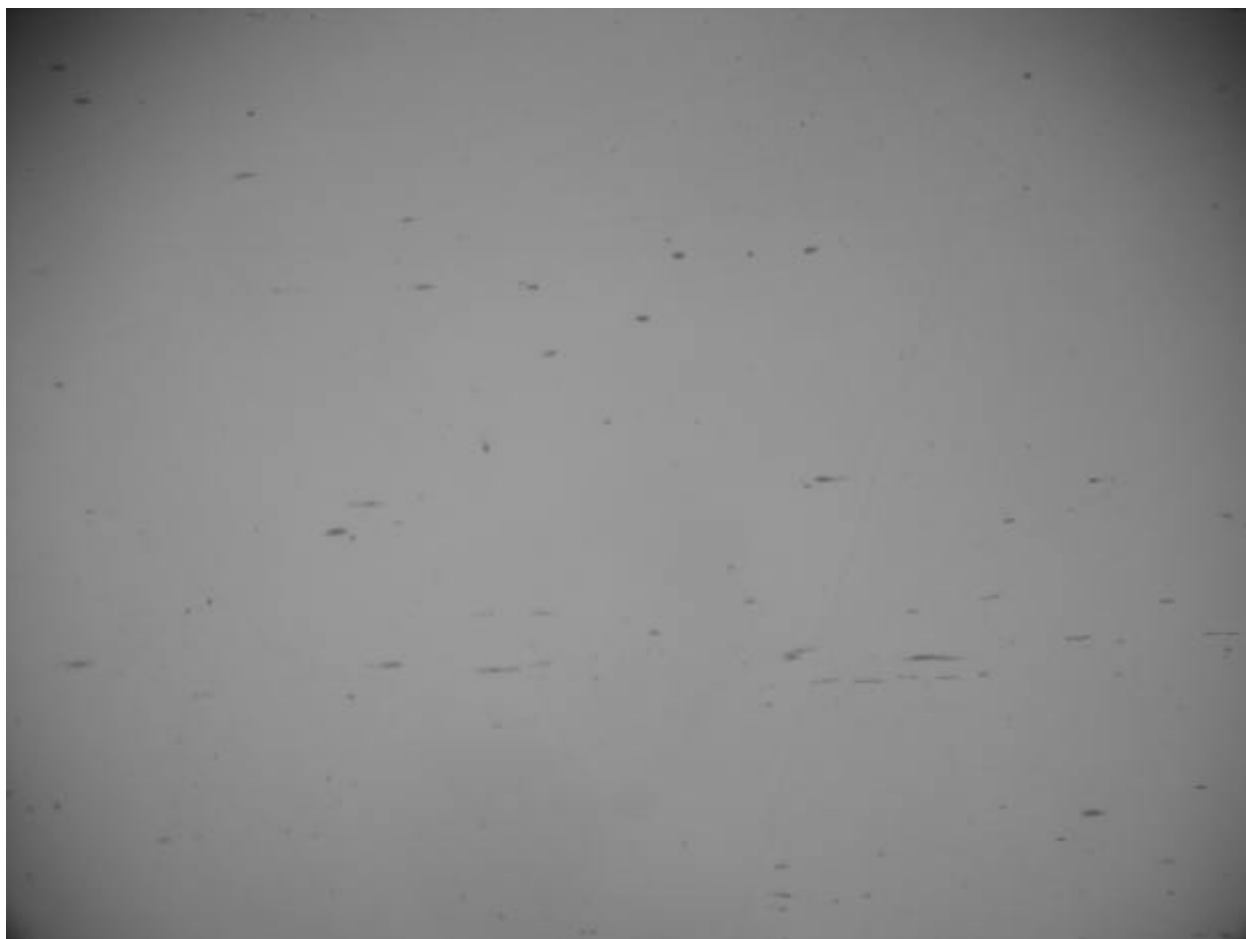
Figure 11. X 200 Unetched.

The parent metal had a significant number of elongated manganese sulphide inclusions. See Figure 11. This feature is consistent with hot rolled steel produced by the ingot route.

Stator frame parent metal sectioned adjacent to a repaired hole from Motor B. Elongated manganese sulphide (MnS) inclusions are evident. The inclusion morphology is typical of wrought steel made by ingot route.

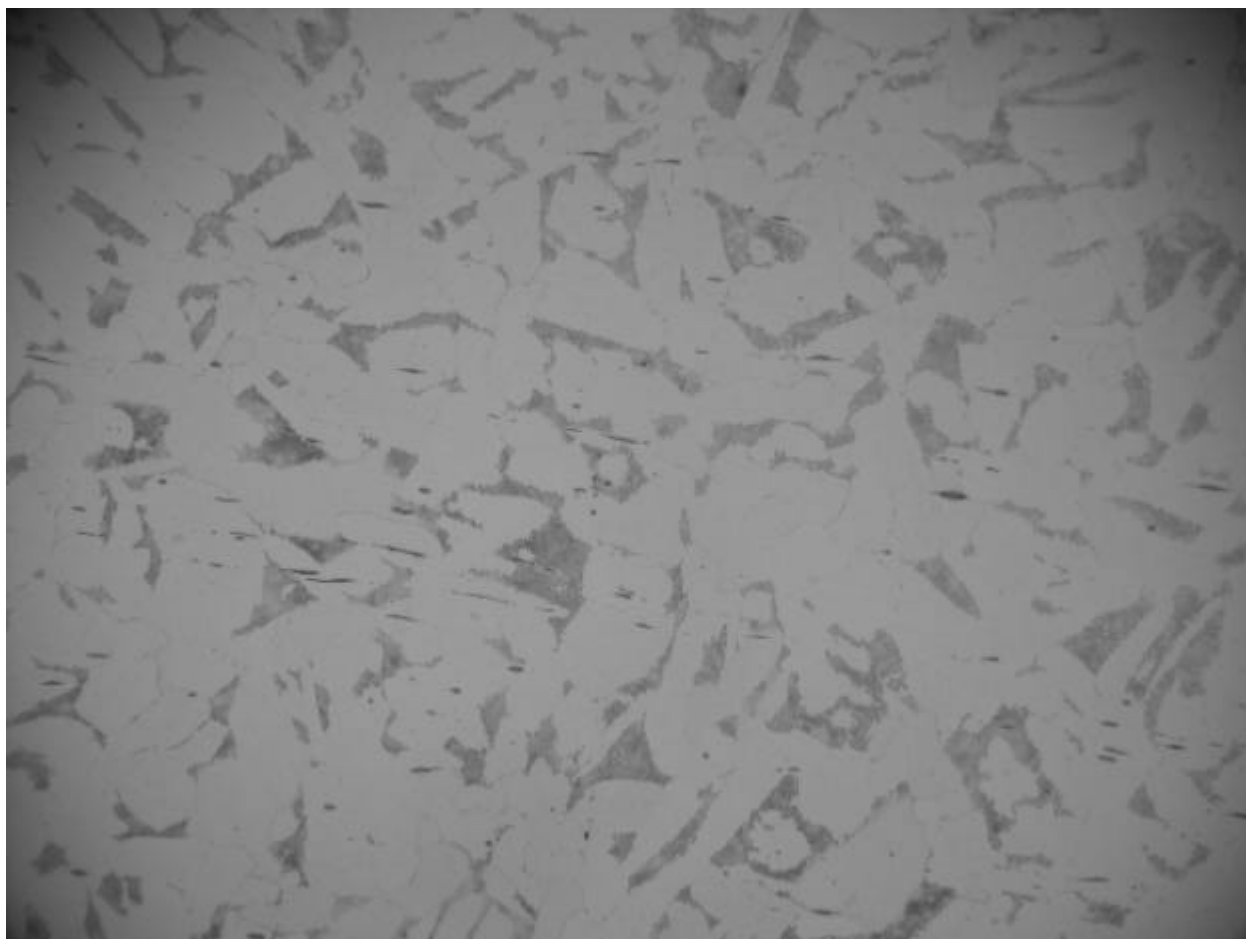
Figure 12. Magnification X 200, Etched in 2% Nital.

The specimen was etched and the microstructures examined. The parent metal was a relatively coarse-grained low carbon steel in the normalised condition. See Figure 12.

Stator frame parent metal sectioned adjacent to a repaired hole from Motor B. The microstructure is consistent with wrought steel produced by conventional hot rolling.
