**NSW  
Resources  
Regulator**

# **Quarterly safety report**

July to September 2021

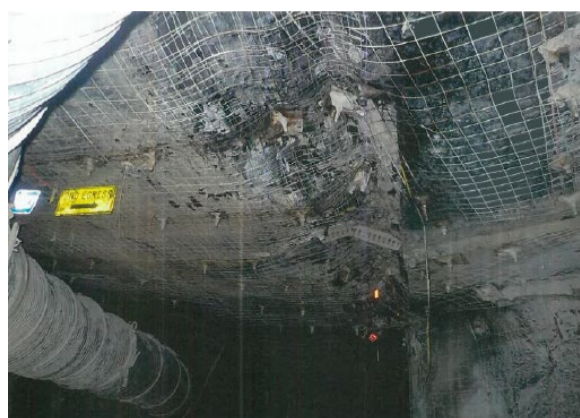
A roof fall occurred in an underground coal mine. The fall was the full width of the roadway and extended 15 to 20 metres. It occurred as workers were in the crib room preparing to start work in the area where the fall occurred. Monitoring in the intersection showed 31 millimetres total displacement leading up to the fall. Initial investigations suggest it was a stress related roof fall.

*Above: Fallen section, spread across roadway.*

Underground mine operators should review the adequacy of their strata monitoring arrangements and associated trigger action response plans to ensure that workers are not exposed to unacceptable risks associated with strata failure.

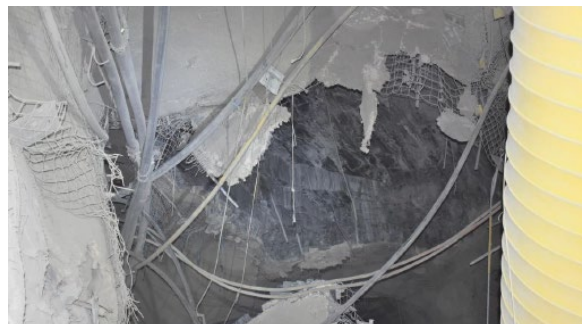
*Above: Fall of ground at intersection.*

Underground mine operators should review the adequacy of their strata monitoring arrangements and associated trigger action response plans to ensure that workers are not exposed to unacceptable risks associated with strata failure.

Strata monitoring should be increased in areas of geological structures or where other mining operations may influence strata stability.

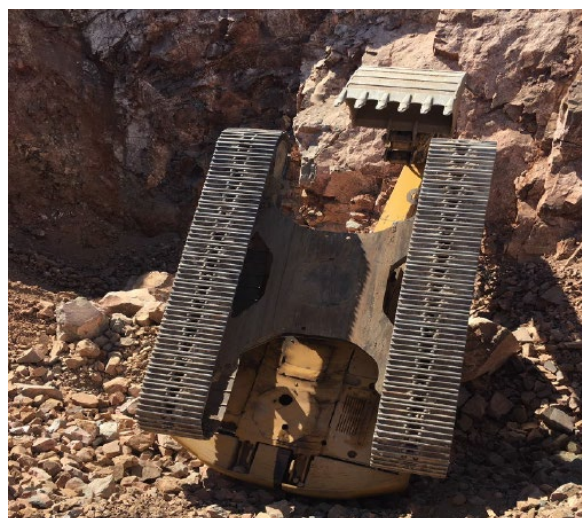
A 50-tonne excavator was operating on a pad of material that was being fed into a mobile crusher when the air conditioner failed. Consequently, the operator swapped to a 20-tonne excavator. While setting up to cut down the pad, the operator reversed off the edge of the pad, rolling backwards down the 3.5 metres face.

*Right: The excavator came to rest on its roof.*

When equipment is changed out, the operator and supervisor should review the hazards and controls for the task.

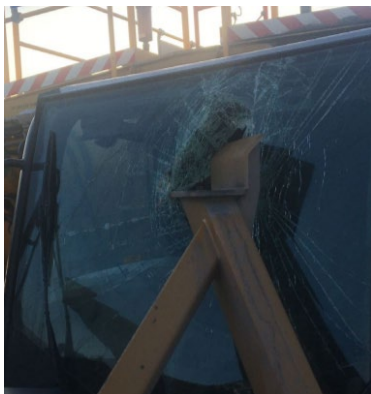
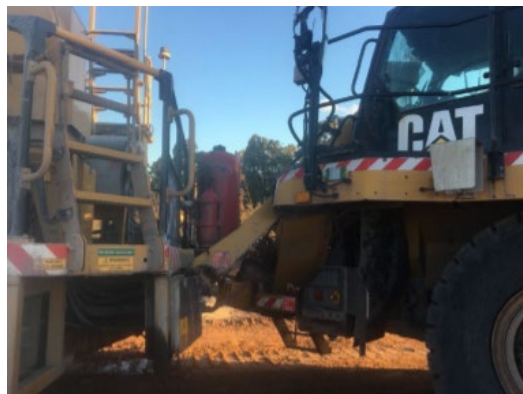
*Far left: Cradle arm damage to windscreen.*

Operators of plant must establish positive communications before entering the work area of other mobile plant. All mine operators must have well established procedures for such communications and workers have a legal obligation to follow those procedures. Our recent campaign focused on the risk of collisions involving heavy mining equipment. Refer to [Vehicle incidents - heading in the wrong direction](#).

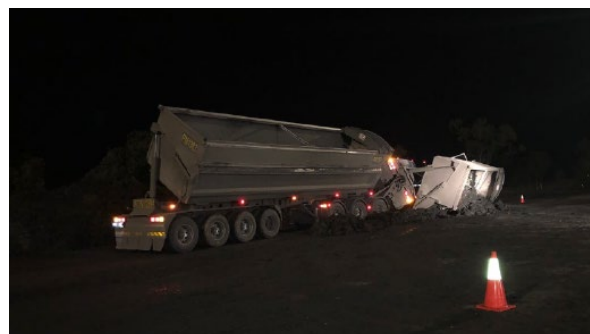
*Above: An overturned prime mover.*

Mine operators should consider the most appropriate truck type for the material being transported. Workers should monitor for material hang up and should report unsafe conditions to their supervisor.

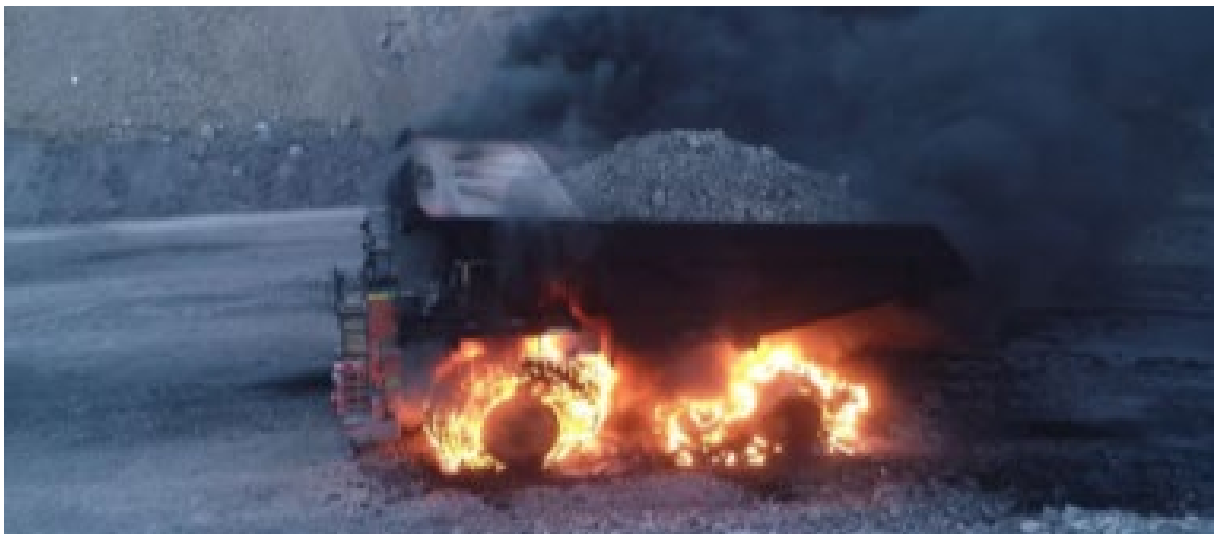
The cause of the fire is being investigated. Further information may be published later.

Above: Haul truck fire incident.

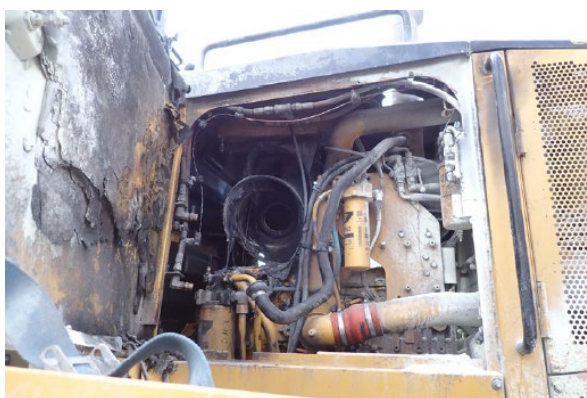
A grader caught on fire while being refuelled. Diesel fuel escaped from a crack in the weld between the tank and the inlet pipe. The fuel ignited when it contacted a hot surface within the engine compartment.

Above: The burnt engine compartment of the grader.

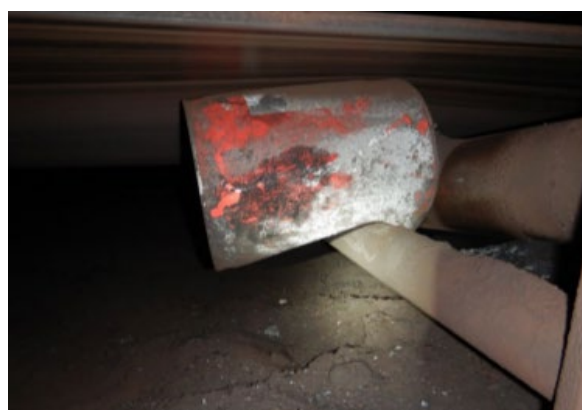
A deputy, carrying out underground conveyor belt inspection, found hot embers and a small flame caused by an empty 20 litre oil drum wedged under the moving conveyor return belt.

Above: The oil drum wedged under the conveyor belt.

Historically, fires in underground coal mines have led to significant human tragedy and loss. Any fire should be extinguished as quickly as possible. Mine operators should ensure that risk control measures to prevent the occurrence of fires, and the escalation and response to underground fires, are implemented and remain effective. Inspection regimes, housekeeping standards and emergency response procedures should be routinely examined to ensure minimum standards are met or exceeded.

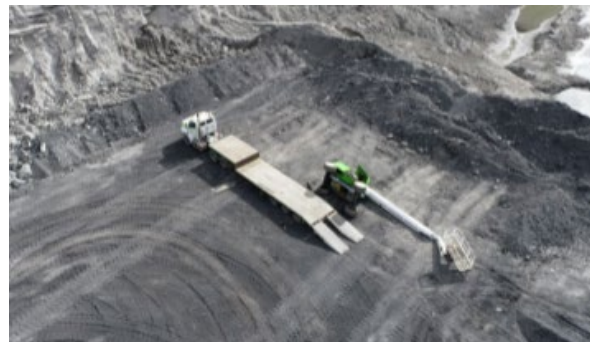
An elevated work platform was being driven toward the ramps of a low loader when it slipped off the edge of the deck. The operator who was in the basket of the platform at the time was thrown from the basket and sustained a fractured vertebra.

*Above: The elevated work platform and loader.*

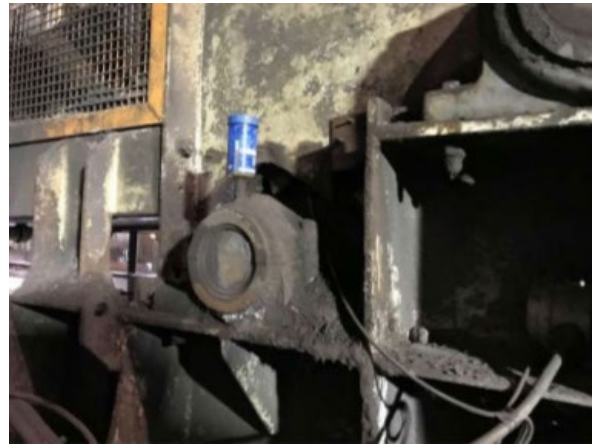
*Above: The unguarded snub pulley.*

Mine operators and workers must ensure that, before guarding around plant is removed for maintenance or cleaning purposes, all energy sources are isolated. Guarding must be restored to its secured position before the plant resumes operation.

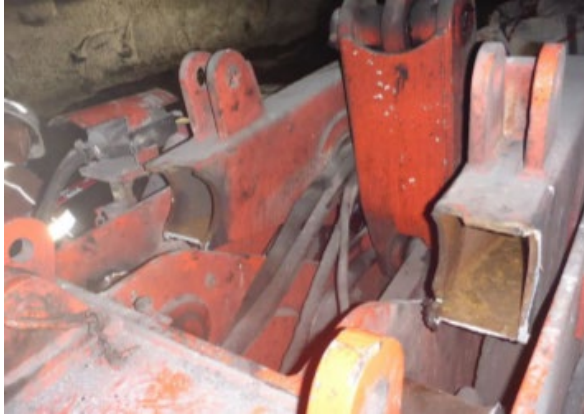
**DANGEROUS INCIDENT – STRUCTURAL FAILURE AT WELD POINT**

Above: Structural failure at weld point.

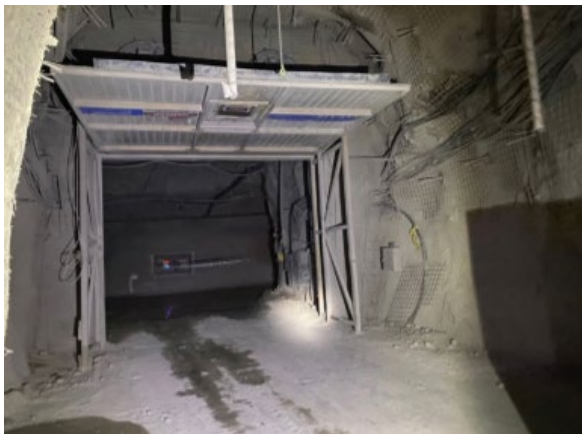
Above: The fully opened ventilation door.

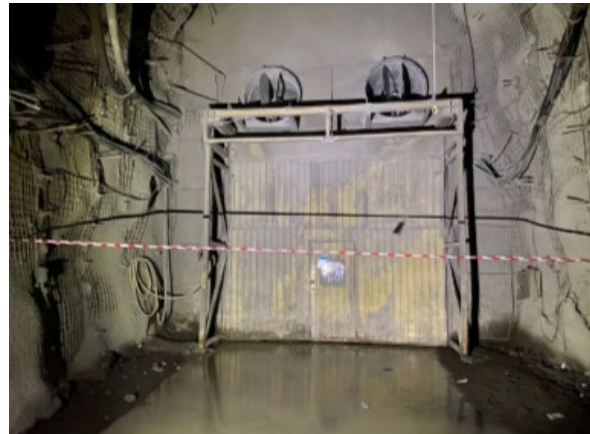
Above: The ventilation door in a closed position.
