INVESTIGATION INFORMATION RELEASE

Worker's leg fractured during strata support work in a coal mine drift

Incident date: 18 July 2022

Location: Appin East Mine

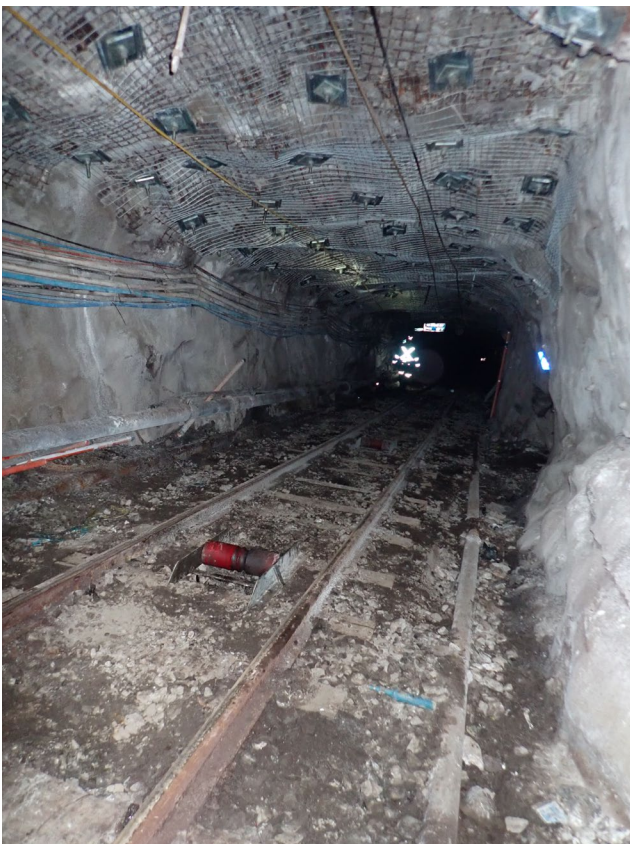
Figure 1 The drift of Appin East Mine

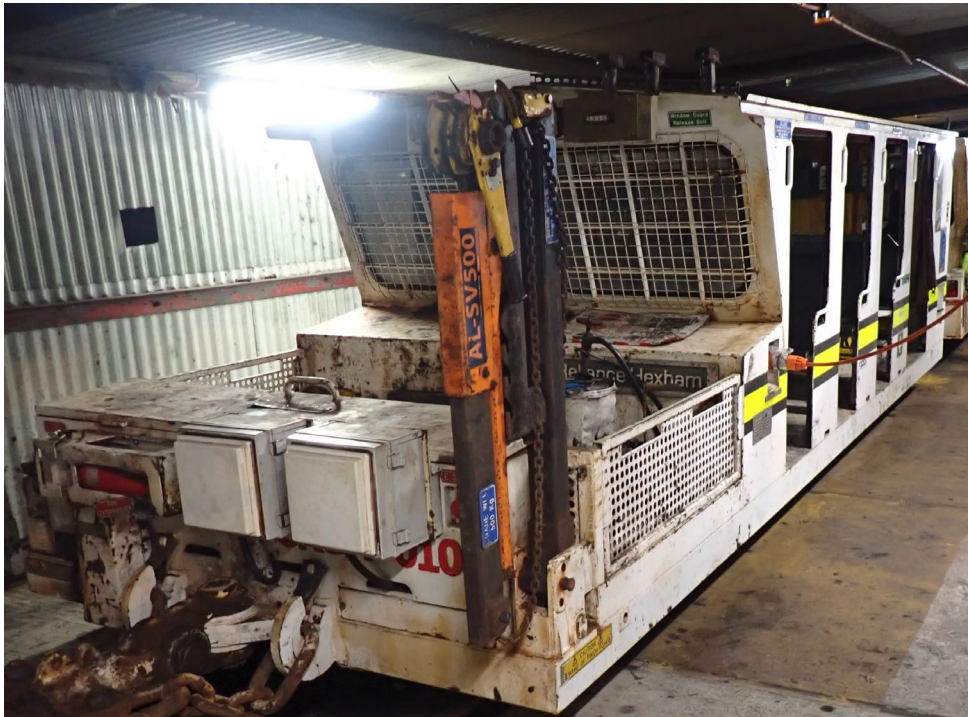
Figure 2 The control car and personnel car at Appin East Mine
