**Compliance audit program**  
Castle Mountain Zeolites  
**Castle Mountain Enterprises Pty Ltd**

*March 2023*

Title: Compliance audit program: Castle Mountain Zeolites, Castle Mountain Enterprises Pty Ltd

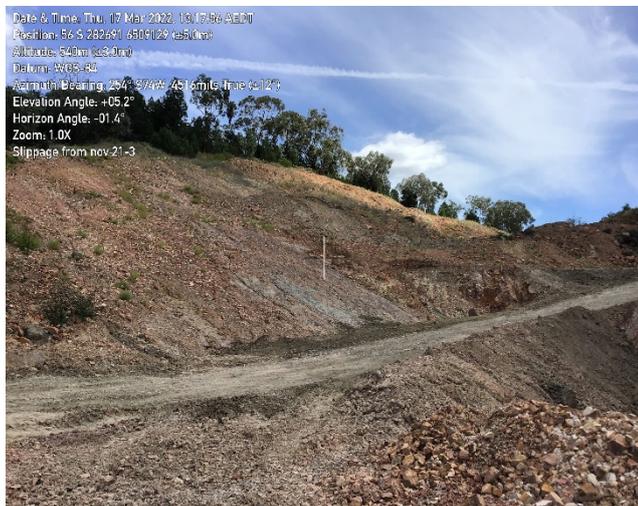
Figure 1 Slippage area Nov 2021\_1

It was observed during the audit that the area where the wall slippage occurred was quite substantial and as a result had caused the works to be shut down due to safety concerns. Additionally, a smaller area that slipped during wet weather in December 2021 was observed (Figure 1, Figure 2 and Figure 3). The slippage area was chocked to stabilise the area as part of the mine safety notice (Figure 4). In between the November and December slippage areas, an area of formed land ready for rehabilitation was observed (Figure 5).

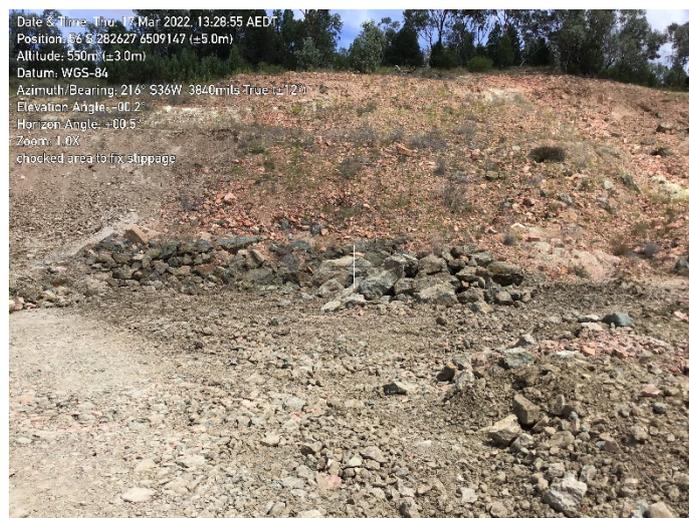
Figure 4 Chocked area to stabilise slippage

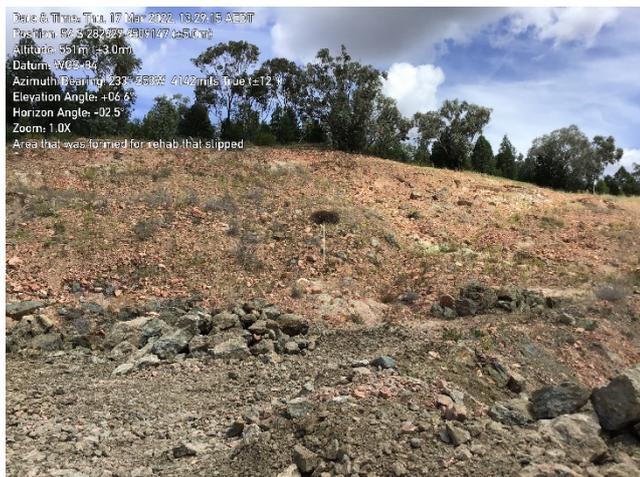
Figure 5 Area that was formed for rehab works that slipped Figure 6 Recent blasting area at time of audit

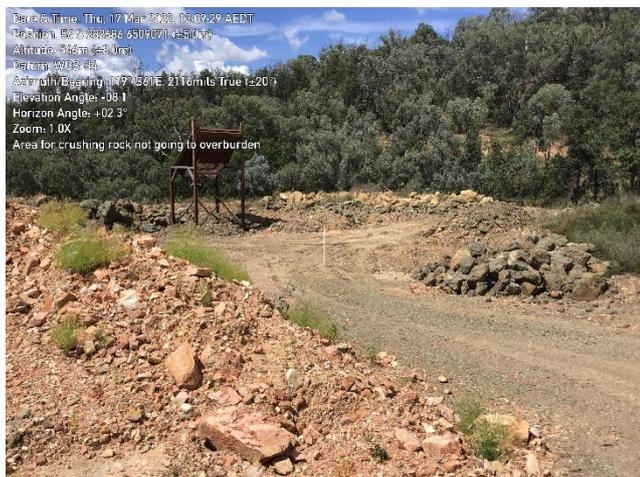
Figure 7 Area for rock crushing not going to overburden

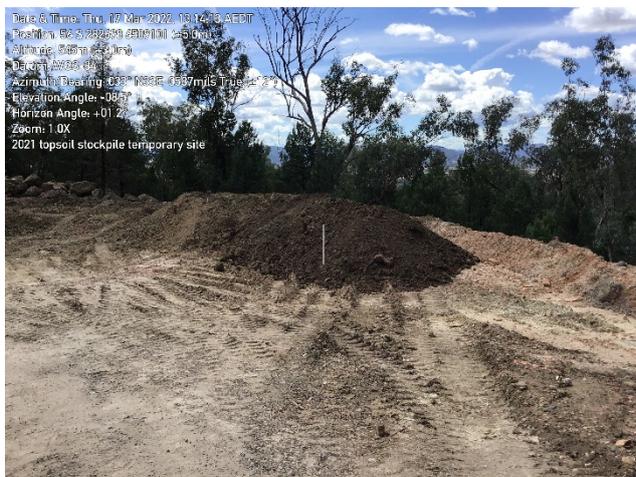
Figure 8 Temporary topsoil staging area est.2021

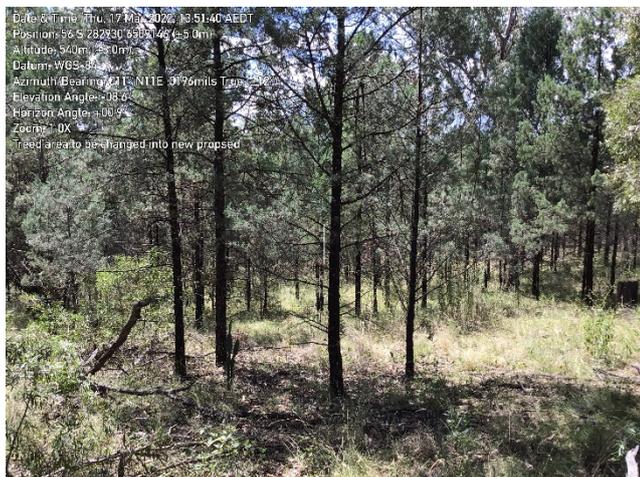
Figure 9 Treed area to be changed into proposed roadway

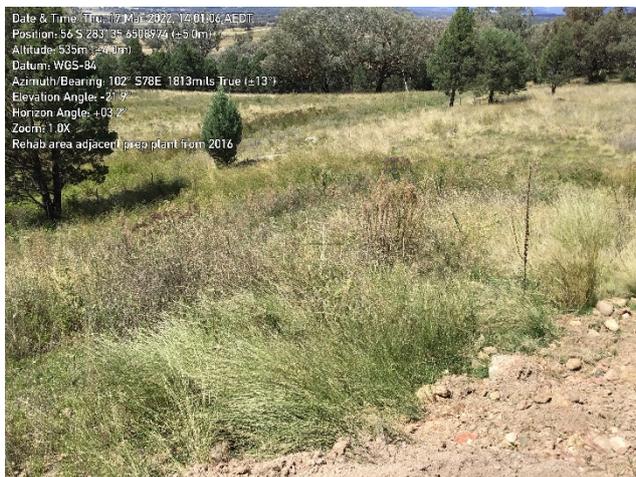
A small patch of 2016 rehabilitation area was inspected during the audit. It was noted that monitoring of this area was not included in reporting of rehabilitation in either the 2020 or 2021 AEMRs. Figure 10 and Figure 11 showed the area with good growth and some weeds. It was observed there was a highly disturbed area on top of a bund from feral pigs. The disturbance if left would continue to erode and lead to further disturbance along the bunded area. Castle Mountain staff advised that the areas were repaired when found and it would be repaired in the next few weeks at the time of the audit.

Figure 10 2016 rehabilitation area adjacent prep plant

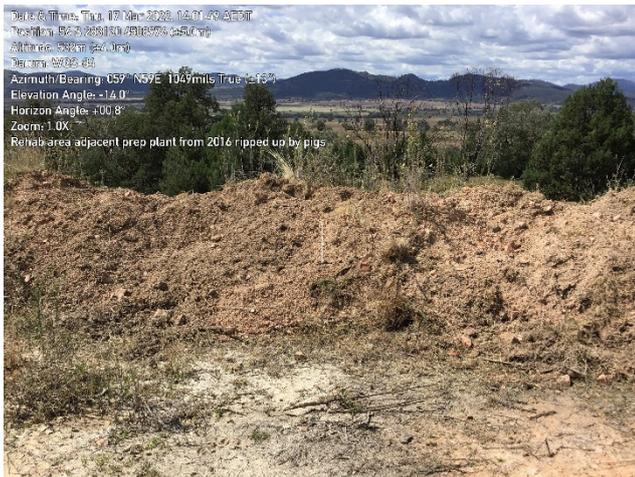
Figure 11 2016 rehabilitation area ripped up by pigs
