Compliance audit program

Wallerawang Quarry

Walker Quarries Pty Ltd

March 2023

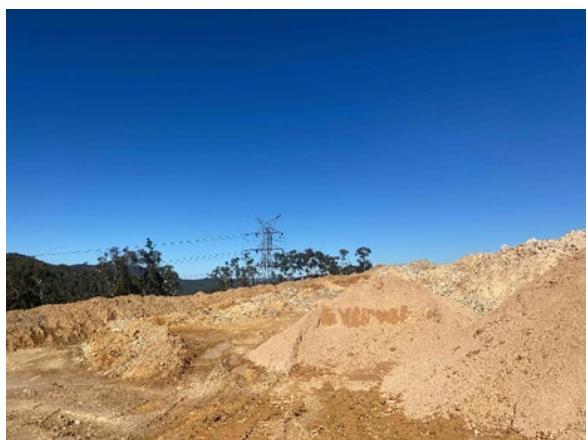
Figure 1 New transmission lines

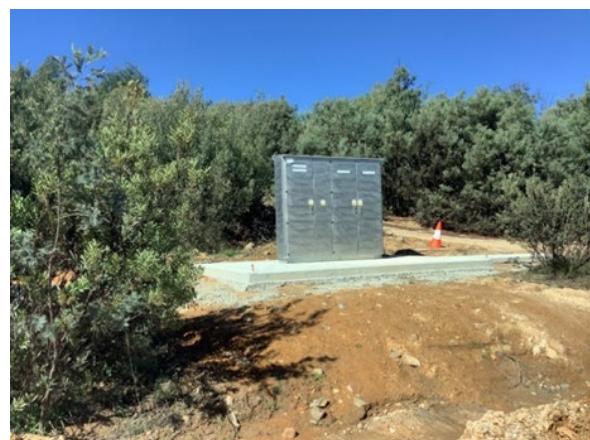
Figure 2 Recently installed 400kV substation

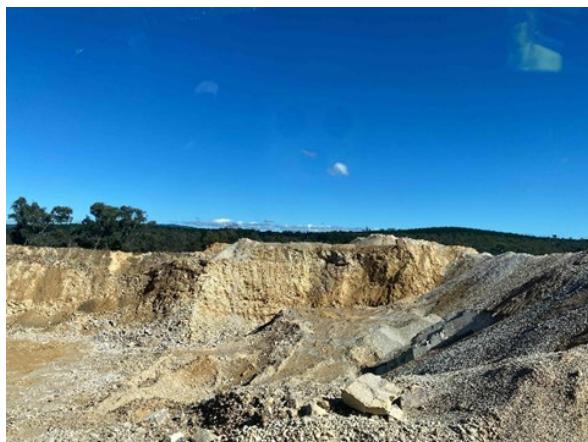
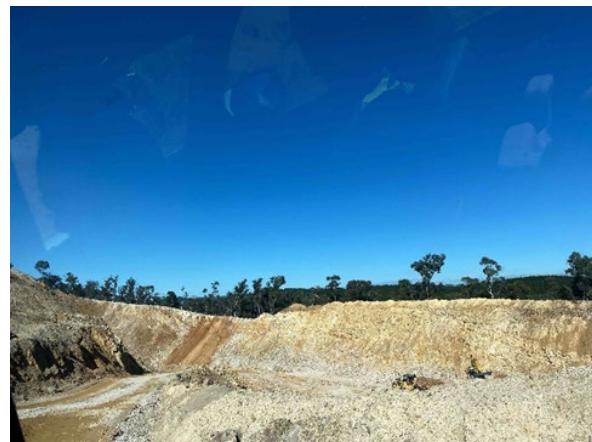
- Exploration activities – MOP section 2.3.1 identified that no exploration activities would be carried out within ML 1633 during the term of the MOP.
- Construction – MOP section 2.3.2 outlined the installation of a new 11kV transmission line from the Great Western Highway to a 400 kV substation to be located adjacent to the quarry office building. Evidence of the new transmission line and substation were observed while on site (see Figure 1 and Figure 2).
- Construction – MOP section 2.3.2 noted that bund walls would be constructed around the northern and eastern perimeter of the extraction area to be developed over the MOP term. Bund walls around the extraction area were observed while on site (see Figures 3 and 4).

Figure 3 Bund walls around extraction area

Figure 4 Bund walls around extraction area

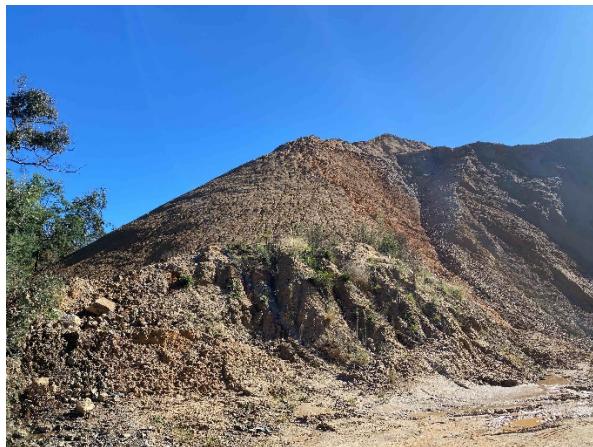
Soil stockpiles were inspected during the audit. It was noted that the available soil on site was limited and largely poor quality – approximately 100 mm depth.

Figure 5 Soil stockpile with vegetation establishing

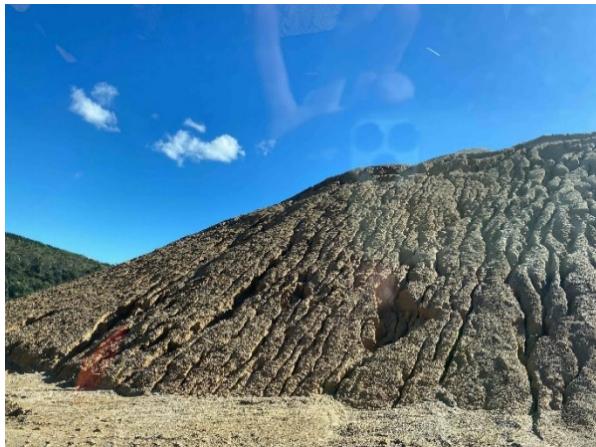
Figure 6 Erosion rilling evident on stockpile

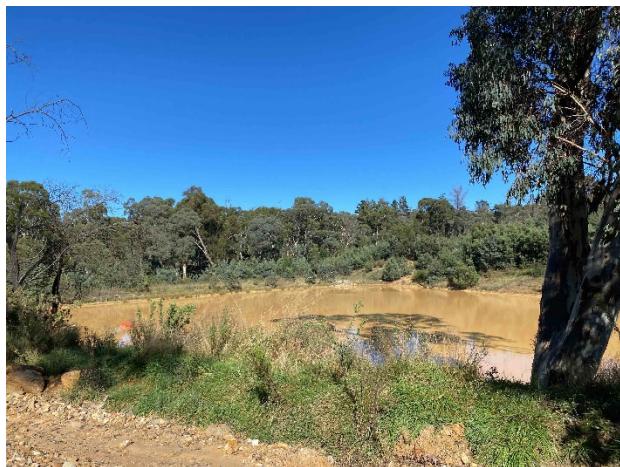
Figure 7 Sediment dam 1

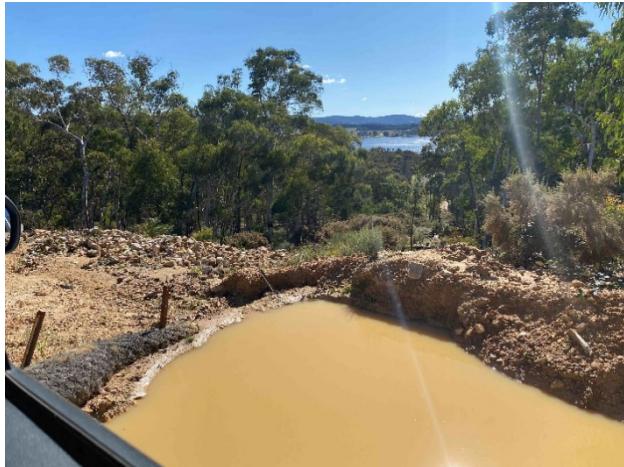
Figure 8 Spill drains along access tracks

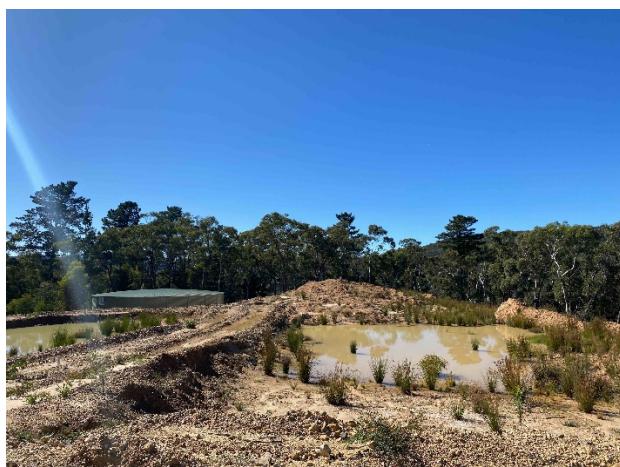
Figure 9 Sediment dam 2

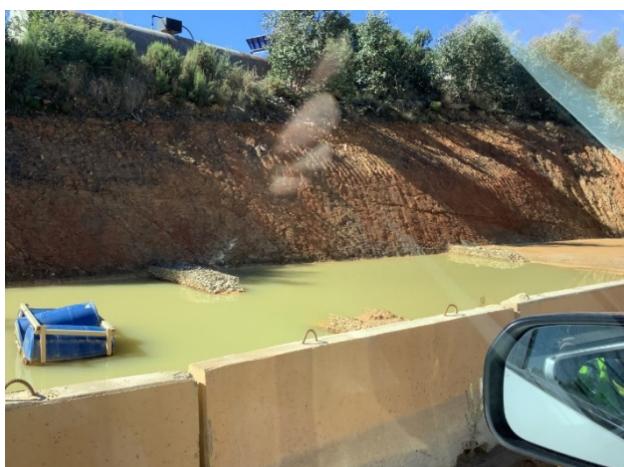
Figure 10 Silt pond

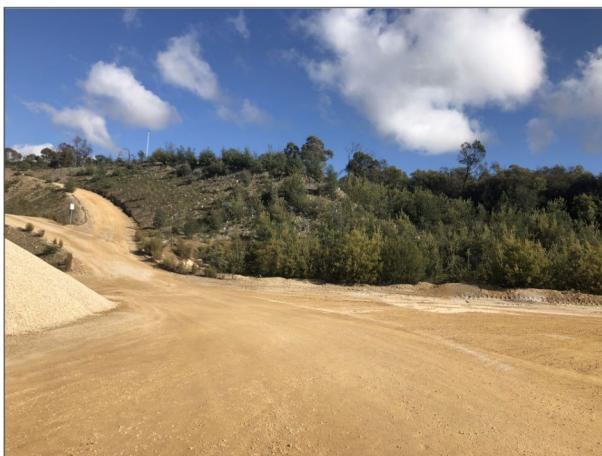
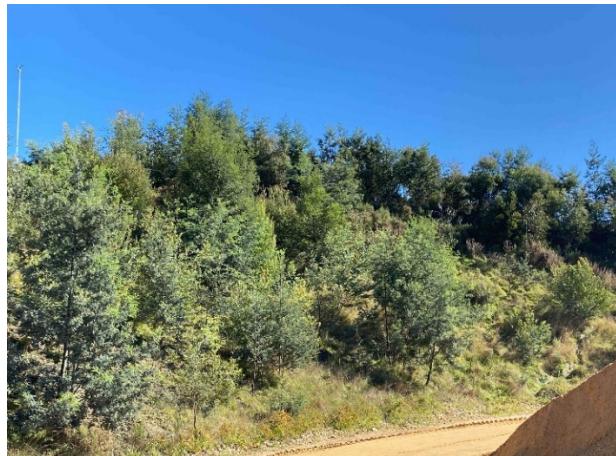
- vegetation established on the visual amenity bund, to the north of the western stockpile area was maintained (Figures 11 and 12). Walker Quarries noted that it took 3 attempts with spray grass before strike and 1000 tubestock were planted along the right hand side.

Figure 11 Vegetation on the visual amenity bund (plate 13 of Wallerawang Quarry annual review, September 2020)

Figure 12 Rehabilitation of bund west of western stockpile area

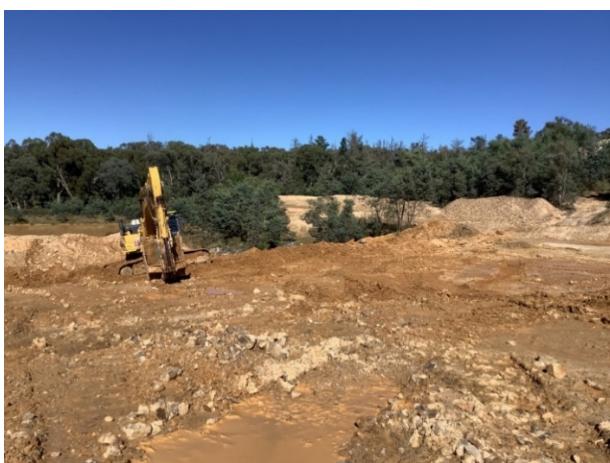
During a site visit on 3 May 2022, backfilling and compacting on the sediment basin 1 (SB1) was observed for the extension to the stockpile area. (see Figure 13)

Figure 13 Backfilling and compacting of sediment basin 1 (SB1)

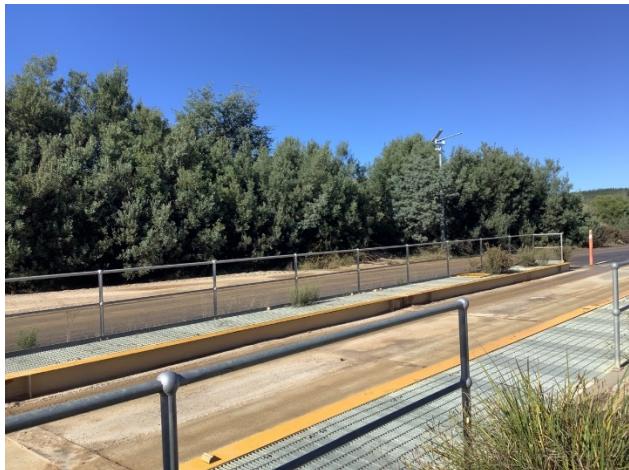
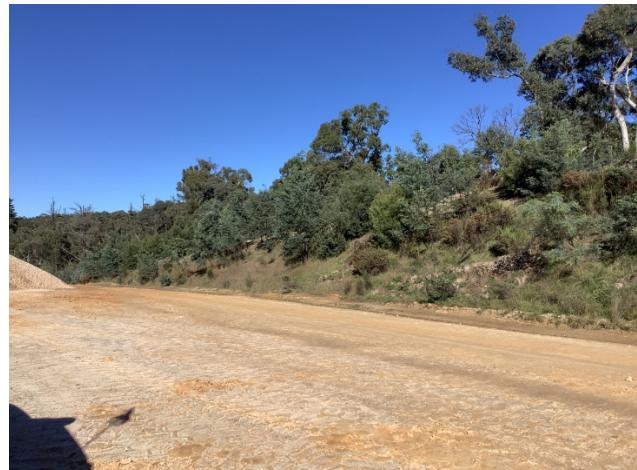
The annual environmental management reports during the audit period noted natural revegetation of the batters to the south of the weighbridge (along the haul road), east of the material stockpile area (MSA) and on the batter slopes of the silt cells and storage dams continued. These areas were observed during the site visit on 3 May 2022. (see Figure 14 and 15)

Figure 14 Natural revegetation of batters south of the weighbridge

Figure 15 Vegetation on batter slopes east of the main stockpile area (MSA)
