# Investigation information release

## Serious injury of a worker performing maintenance work on a mobile screen

**Event:** Serious injury of a worker while assisting with belt tracking of a mobile screen

# Investigation information release IIR23-07

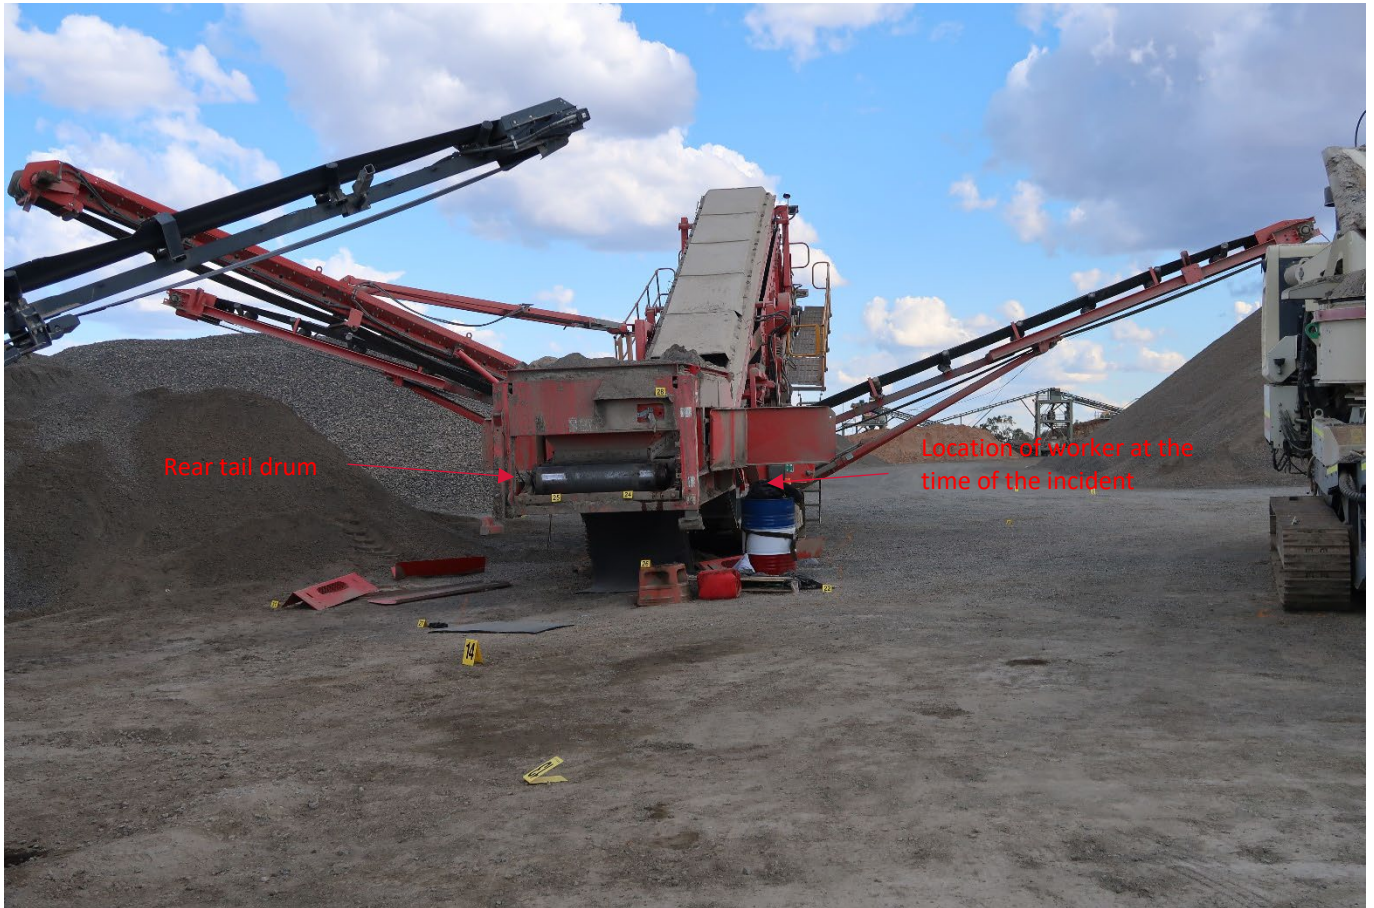
While undertaking the task, one of workers was in proximity of the right-hand side of the screen toward the rear of the item of plant. The screen was energised with its conveyor operating. The worker's arm became entangled in the rotating tail drum of the screen, pulling the worker into the drum up to his shoulder.

Figure 1: Mobile screen (screen 7) at the incident scene

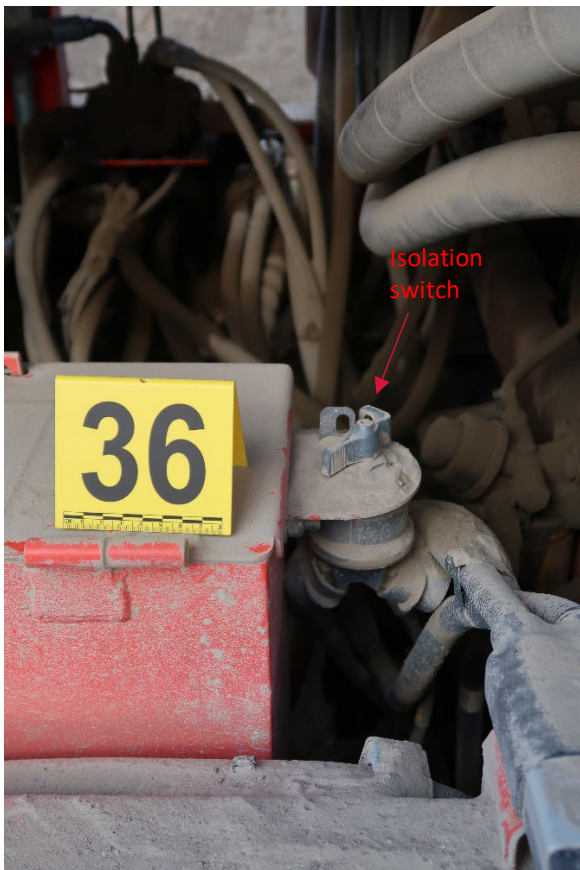
Figure 2: Screen 7's isolation switch as found by investigators attending the scene in the 'on' position

- implement a safe system of work that requires workers to isolate plant before attempting to remove, change or adjust components or perform maintenance
- provide workers with adequate instruction and training about how to identify and control risks to health and safety associated with performing maintenance on mobile plant, including mobile screens, that is commensurate with their experience and the risk
- ensure that any fixed conveyor guards and covers required to be removed during maintenance tasks are reinstalled prior to the plant being re-energised and operated
- ensure that isolation points and e-stops on mobile plant are functional, clearly marked and easily accessible.
