Compliance audit program

EL6699 Tallebung Tin Exploration Project

Stannum Pty Ltd

February 2024

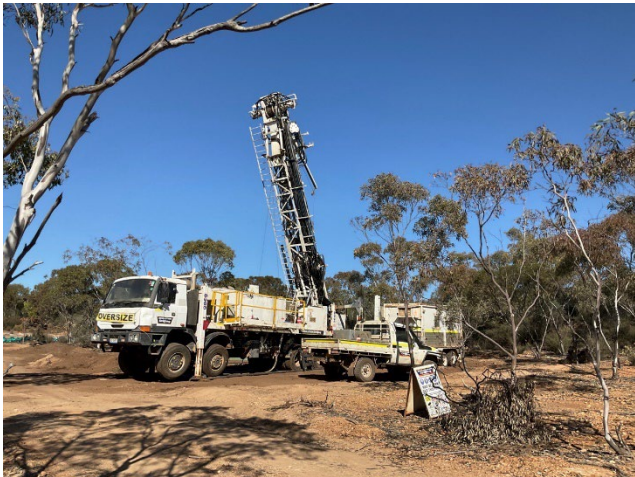
Figure 1 Diamond drill rig on hole TBD096

An assessment against the Exploration code of practice: Environmental management was completed for the exploration activities in progress on EL6699 as documented in the following sections. It was observed that both a diamond drilling program and a reverse circulation (RC) drilling program were in progress on the site. The RC drill rig finished hole TBRC066 and was moving to hole TBRC067. The diamond drill rig was drilling hole TBD006 (Figure 1).

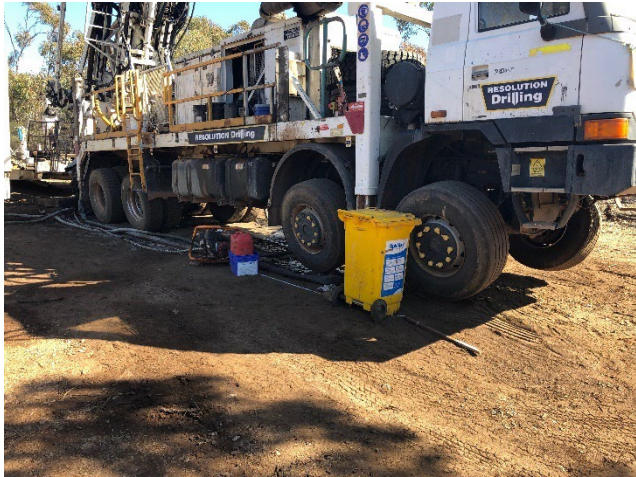
Figure 2 Spill kit, rig nappy, and secondary containment for pump fuel container at the diamond drilling site

A spill kit was observed at the diamond drill rig (Figure 2). A spill kit was reported to be available for the RC rig, but this was stored on the support vehicle for the rig move. A very small hydrocarbon stain (less than 50 cm diameter) was noted when the RC drill rig moved off site, but this was cleaned up immediately by the drillers when packing up the rig nappy.

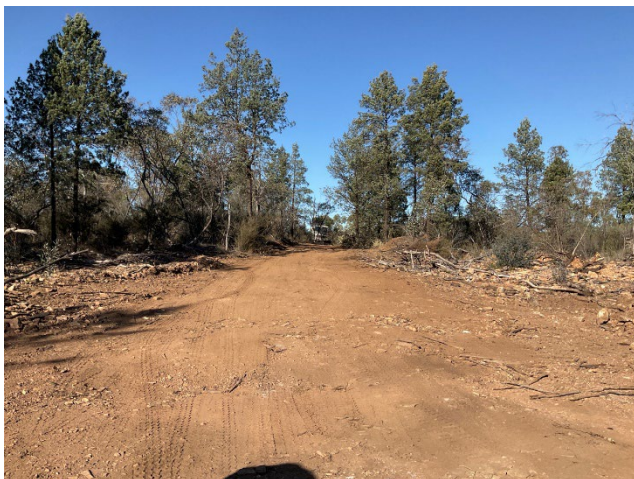
Figure 3 Short section of track pushed in to access drill pad TBRC66

It was observed there were numerous unsealed roads and tracks associated with the former tin mining operations. Generally, these tracks were used to access drill sites. Short lengths of track were pushed in to access some drill pads (Figure 3).

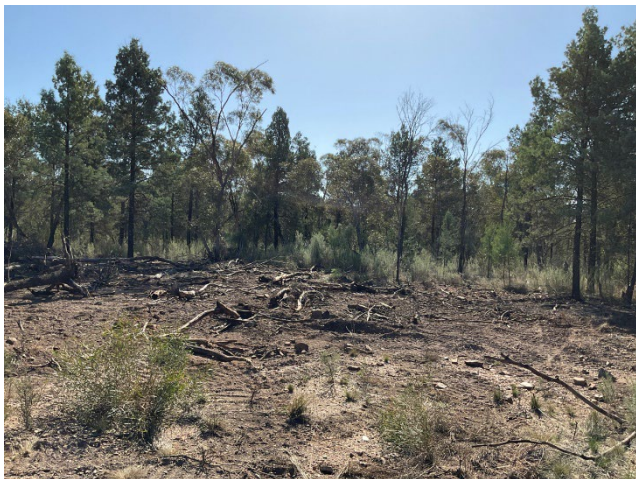
Figure 4 Rehabilitation of hole TBRC021 drilled in May 2022

Figure 4 shows the rehabilitation of completed hole TBRC021 that was drilled in May 2022.

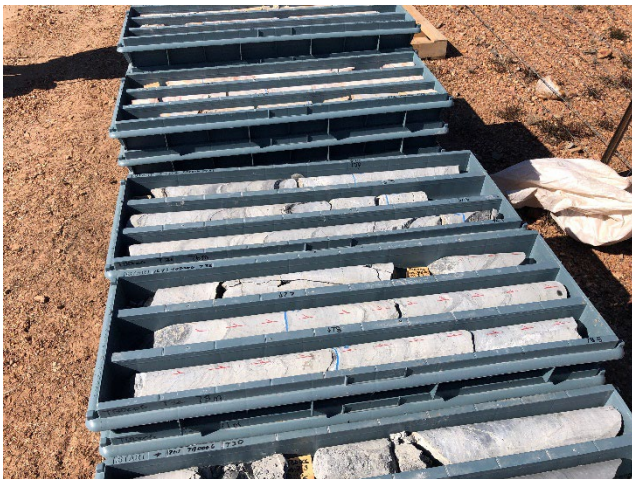
Figure 5 Core trays for the diamond drill hole TBD0006

Core from the diamond drilling in progress was available on site for inspection. It was observed that core was stored in plastic core trays, labelled with hole number, tray number, start and finish depths and downhole direction (Figure 5).
