Investigation information release

Worker injured when struck by a forklift attachment

Location: Cedar Point Quarry, Edenville NSW

Investigation information release IIR24-02

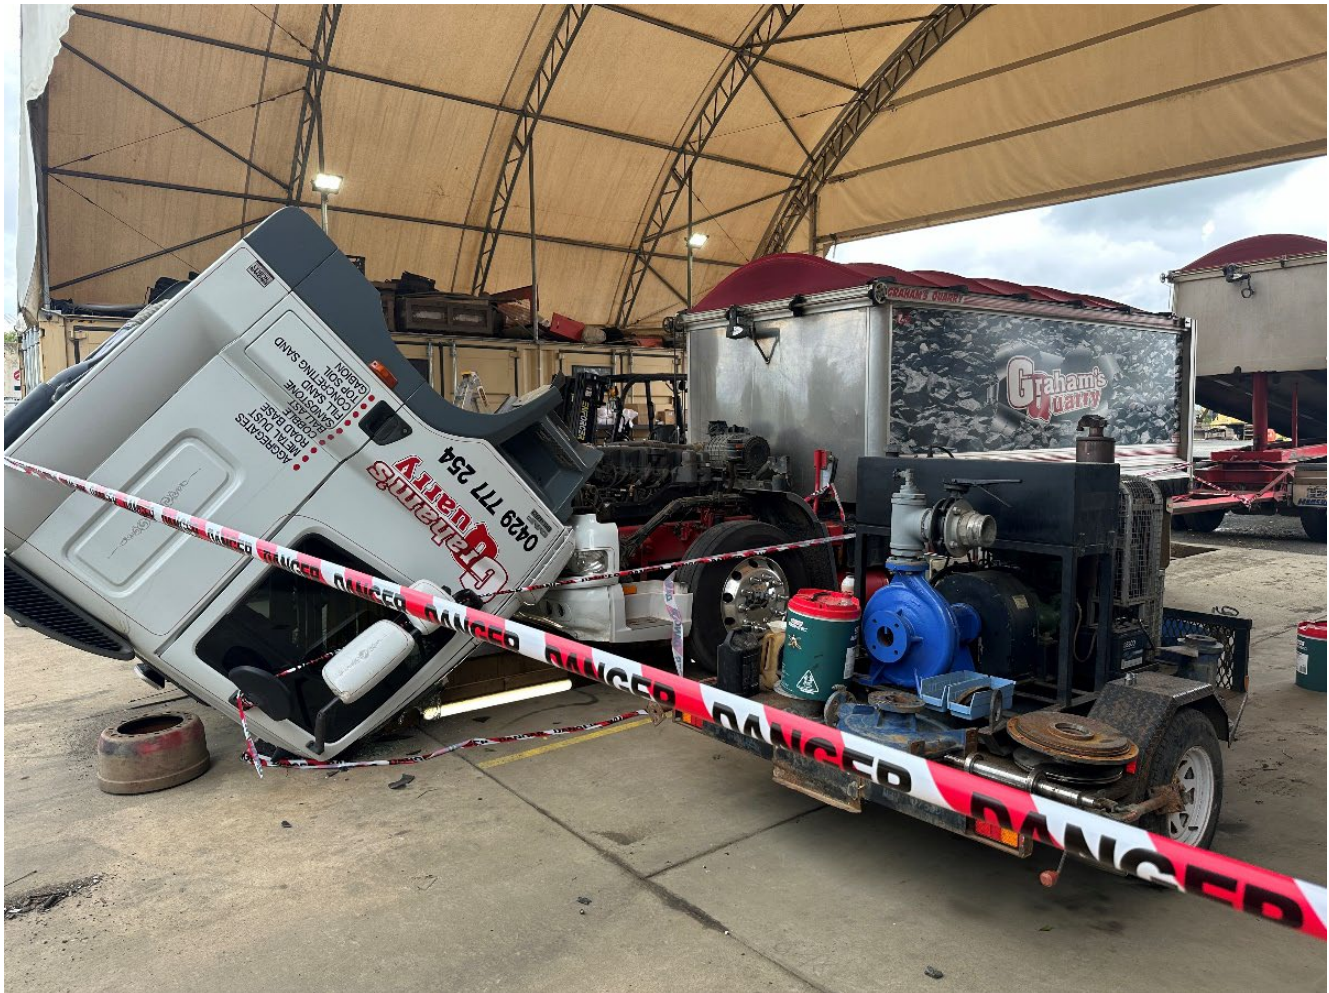
An apprentice mechanic was conducting an inspection of a tipper truck and dog trailer in the quarry's workshop on 1 March 2024. The hydraulic tilt lift cylinder detached from its mount as the worker tilted the cabin forward. This caused the front and top of the cabin to impact the ground.

Figure 1 Truck cabin in contact with ground

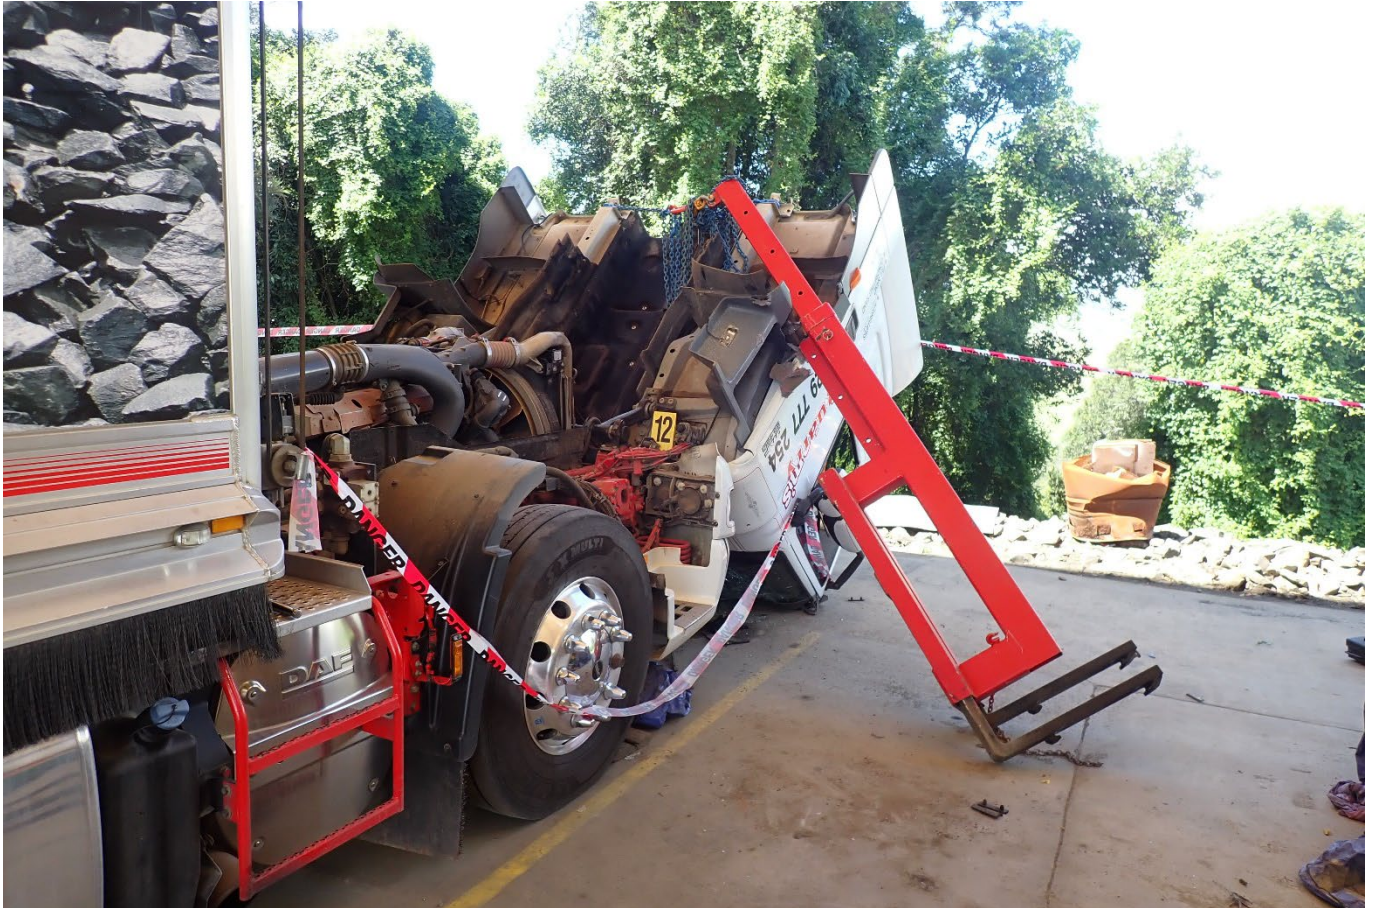
Chains were used to connect the jib to 2 connection points on the underside of the cabin. No specific assessment was undertaken to determine the effect that using the jib attachment would have on the forklift's rated load, or the lifting load of the truck cabin.

The safety officer raised the jib approximately 200 to 300 millimetres above its original raised position. The jib was approximately 2.5 metres above the ground at this point. The headboard detached from the body of the forklift. The forklift's tynes also detached from the headboard, causing the tynes and the forklift end of the jib to swing forward and down. The far end of the jib was suspended by the chains that remained attached to the underside of the truck's cabin.

The end of the jib that was connected to the forklift's tynes struck the mechanic's leg, causing him to move to the ground. The tynes remained engaged in the jib pockets and hit the ground in close proximity to the mechanic. The headboard from the forklift and the jib were suspended above the mechanic as he lay on the ground.

Figure 2 Position of tynes and jib following incident

- ensure fabricated forklift attachments are designed, assessed and certified by a competent person such as an engineer and are suitable for the load to be lifted or moved

- ensure forklifts and tynes are designed, rated and maintained to safely function with lifting jibs, when loaded to its maximum rated capacity
- ensure the stability and lifting capacity of forklifts, when fitted with rated and certified lifting jibs, are known and the load's centre of gravity relative to the forklift is factored into pre-lift risk management processes

- ensure that loads are controlled when lifted
- enforce suitable exclusion zones that appropriately account for the potential of suspended loads to drop, swing and topple

- ensure loads are not suspended near or over a person unless the plant is designed specifically for that purpose
- ensure that workers are provided with adequate information and training about calculating safe lifting loads, including education about the reduced load capacity when forklift attachments are used
