REHABILITATION INFORMATION RELEASE

DATE: 27 APRIL 2020

Completion of rehabilitation at Kempsey Clay Mine

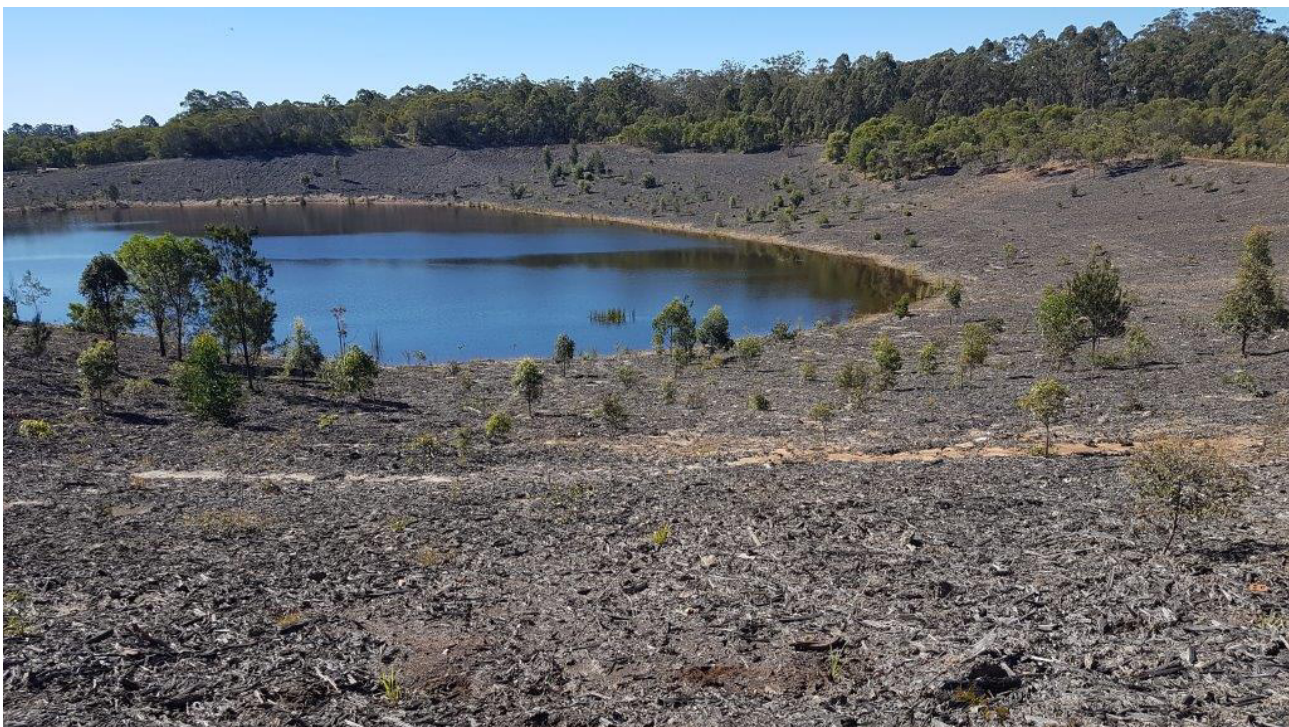
- all areas of the void batters were observed to be mulched and planted with native tube stock (tree and shrub species and riparian grasses and sedges at the waterline)
- there was no evidence of significant weed issues or erosion
- access roads had been ripped and revegetated where not required. The retained access track was in good repair.
- surface water catch drains and clean water diversions were in good condition and effective
- there was no evidence of hazardous material or contamination for any retained infrastructure outside of the asphalt batching plant area.

Figure 4 Native species around the final void

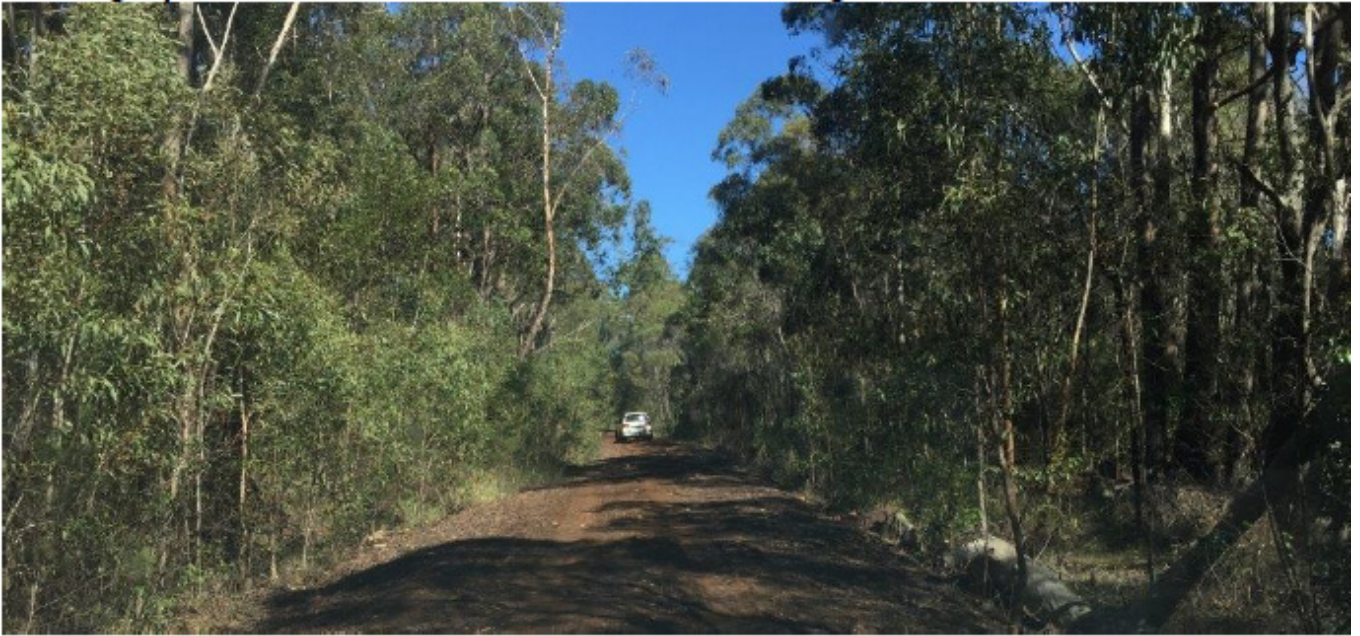
Figure 5 Access road remaining on the site

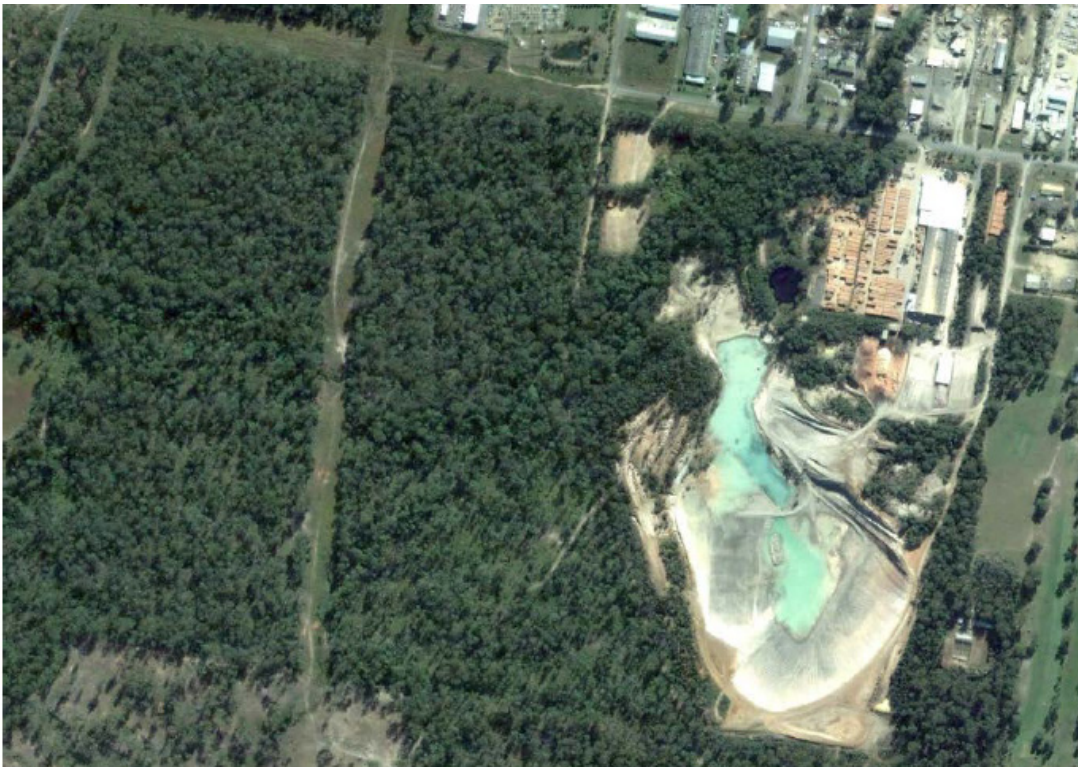
Figure 6 Woodland areas in 2005

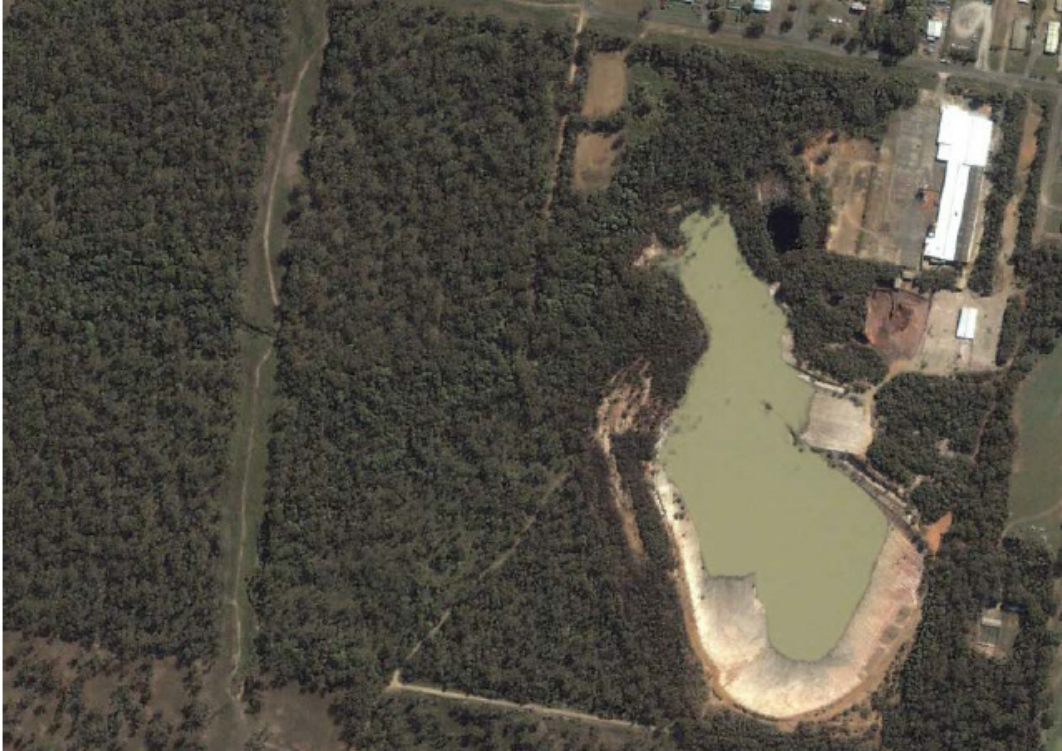
Figure 7 Woodland areas in 2013

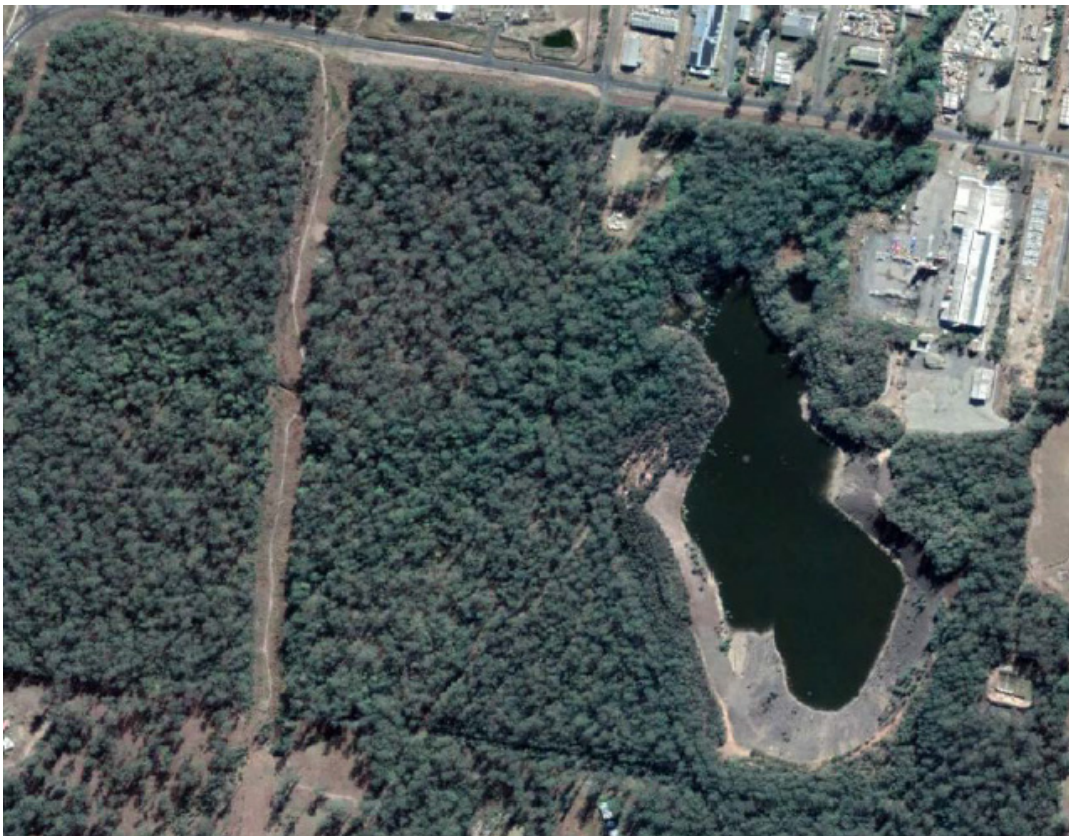
Figure 8 Woodland areas in 2019

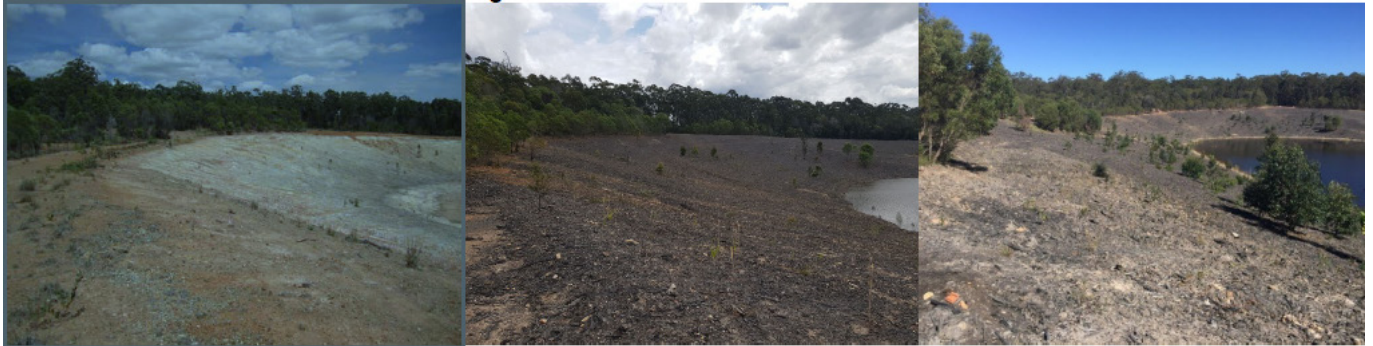
Figure 9 Rehabilitation progression – east face of final void from 2015 to 2019

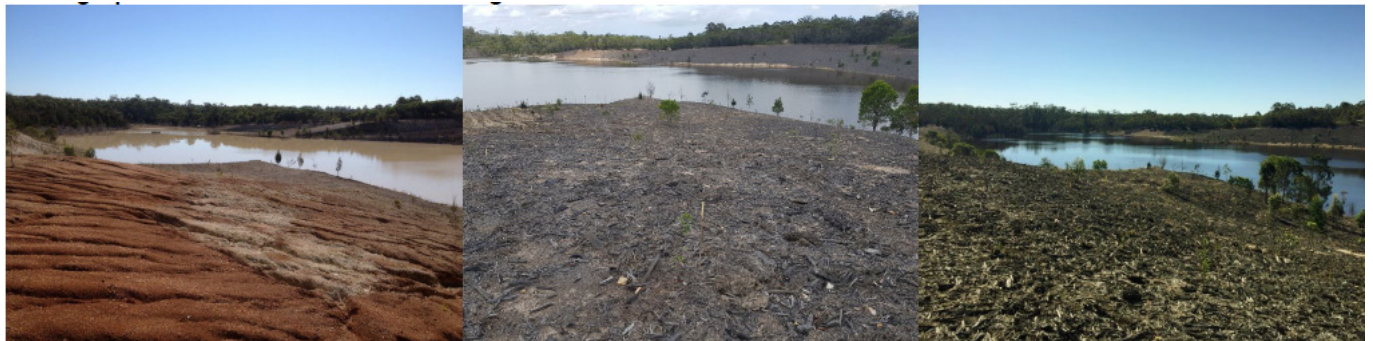
Figure 10 Rehabilitation progression – south west face of final void from 2014 to 2019

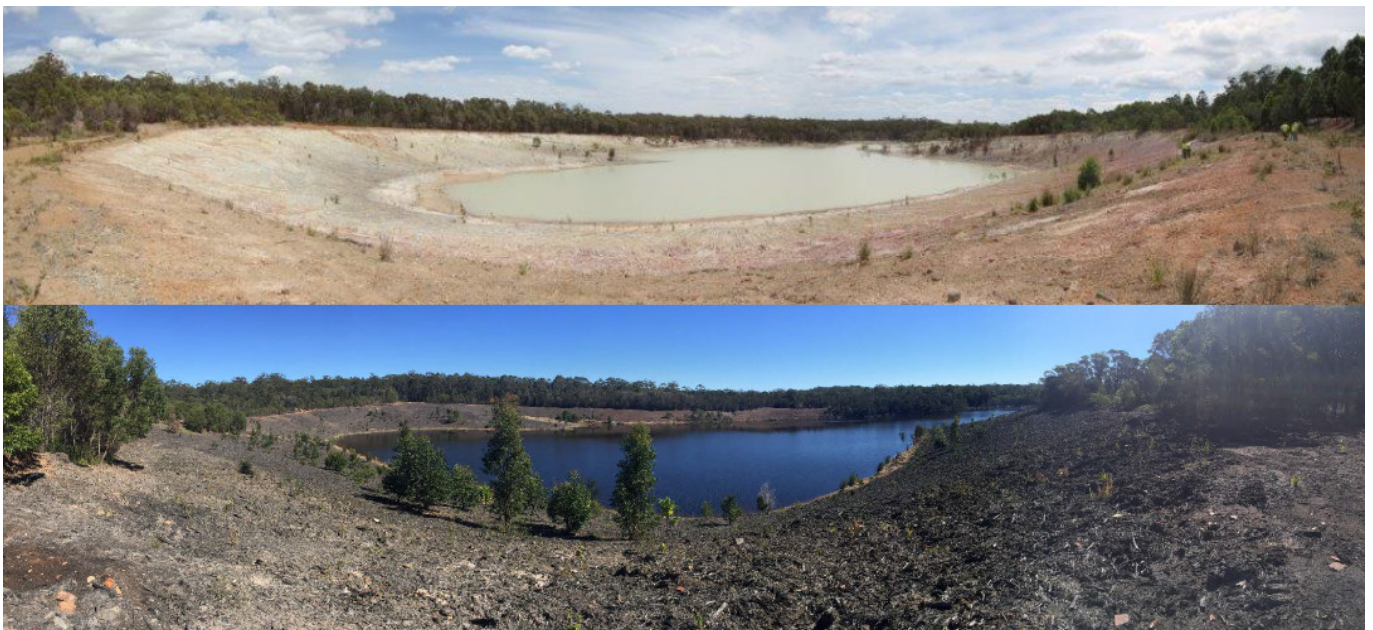
Figure 11 Rehabilitation progression – final void from 2015 to 2019
