SAFETY ALERT

Anti-friction washer ignites

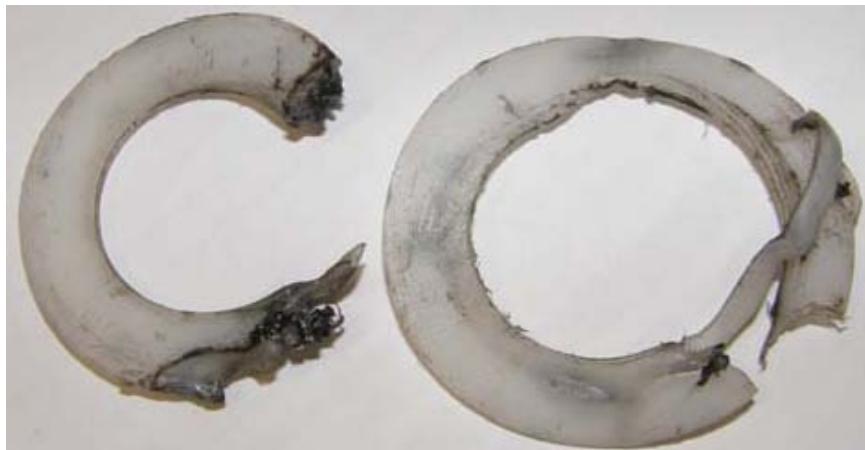
Both incidents occurred when the anti-friction washer broke down at temperatures of about 340 degrees Celsius, generating vapours with an auto-ignition point of 380 degrees Celsius.

On one occasion the heat was generated by the use of an incorrect spanner that applied direct pressure to the anti-friction washer, the steel dome ball and the steel volcano plate. On the other occasion the angle of the bolt resulted in point loading on the washer and the plate, causing a rapid wearing of the washer and resultant steel/steel friction.

The anti-friction washers in both cases were made of polyethylene. It was determined that sufficient heat to break the washer down and generate a vapour with an auto ignition point of 380 degrees could occur in many ways – over spinning, point loading and worn/incorrect spanners. The generation of temperatures in excess of 300 degrees could be reached in 10 – 20 seconds where steel/steel friction occurs.

Photo: A partially melted washer (left) and an ignited washer (right).

1. Review the composition of the anti-friction washer to minimise the risk of auto-ignition.
2. Determine the optimum bolt make-up (including domes, plates, etc) to reduce the likelihood of high temperatures and failure of the anti-friction washer between non-mating surfaces.
3. Provide information to end users on the effects of changing the bolt make-up on potential temperatures when over-spinning occurs.
4. Provide information to end users on the pre-tension that can be achieved with and without anti-friction washers.

1. Review all standard bolt assemblies in conjunction with the supplier to determine the appropriate assemblies for that mine to minimise the risk of heat generation by steel-on-steel friction.
2. Review the requirement for pre-tension of bolts under the mine's strata failure management system and ensure that it is attained with the lowest practical risk of auto-ignition.
3. Check that all spanners used in bolting are suitable for the task.

Note: The removal of the anti-friction washer without adequate assessment of the risks from the loss of pre-tension is inappropriate. It is expected that in many cases the benefits of pre-tension will point to the requirement for a change to an alternate anti-friction washer (eg teflon rather than polyethylene washer) with a lower auto-ignition risk.
