Serious injury

Event: Serious burns while refuelling mobile plant

Location: Mt Arthur Coal Mine, Muswellbrook NSW

Office use only	
RM8 reference	PUB17/516
Mine safety reference	IIR17-10
Published	23 August 2017

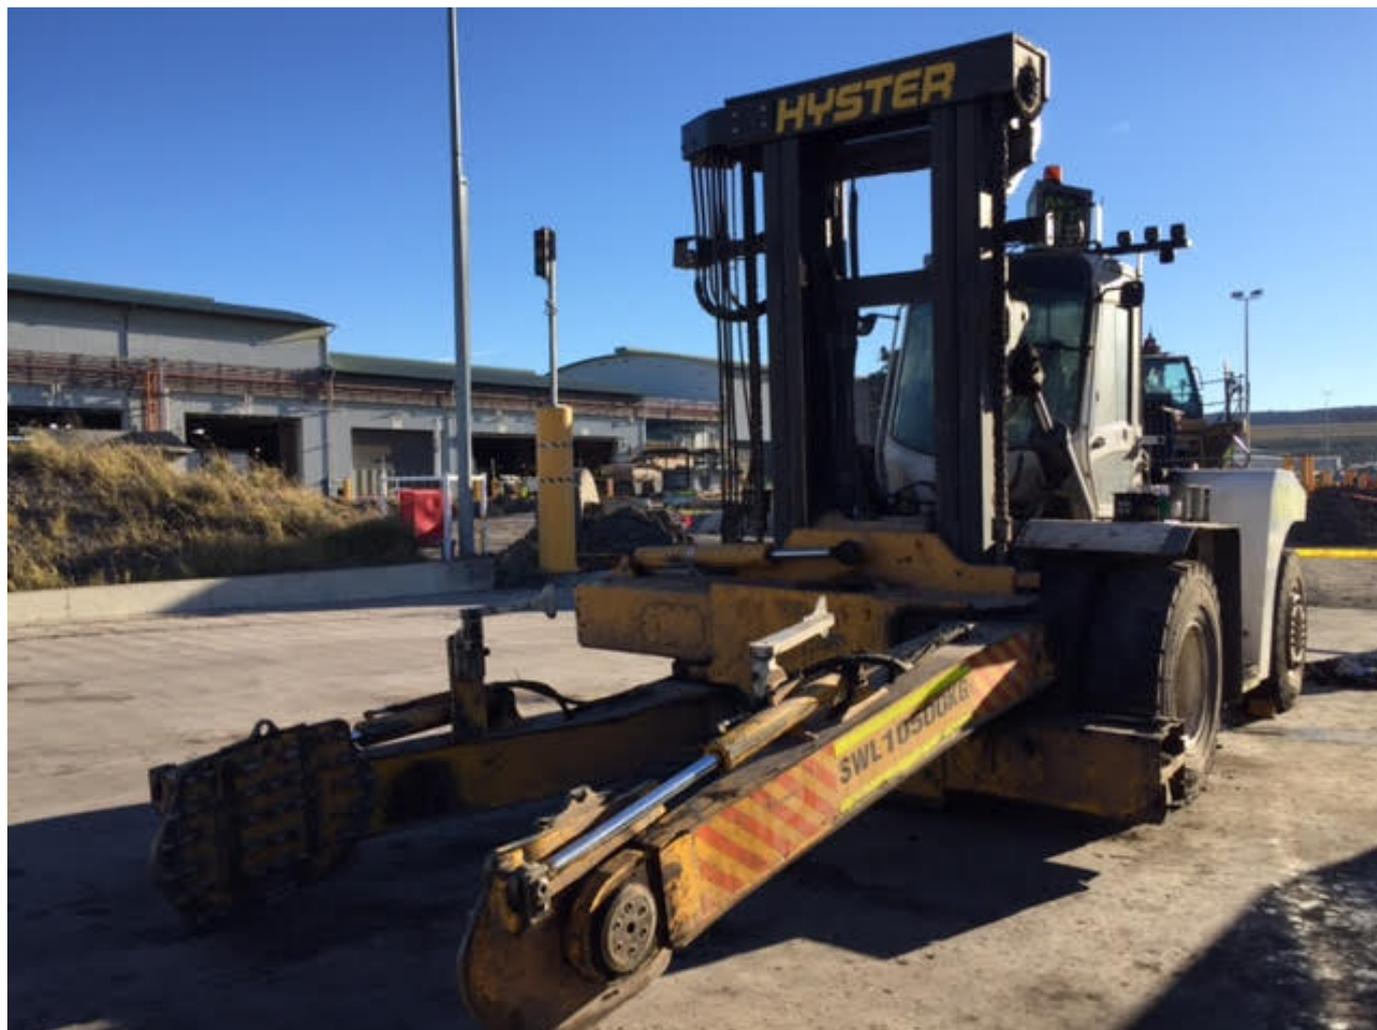
Photograph 1: The tyre handler at the refuelling bay.

During the morning, the worker drove the tyre handler, a large forklift with tyre handling attachment (Photograph 1) to the heavy vehicle fuel bay near the mine's workshop.

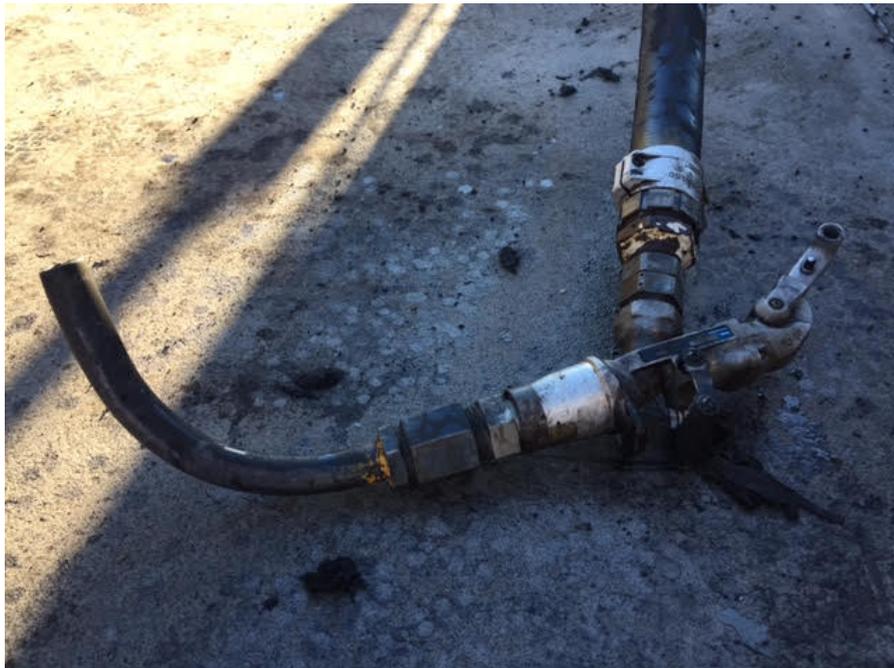
At the fuel bay, the worker attached a fuel splash filler nozzle adaptor to the 800 lt/m fuel line via a Banlaw quick connect fuel nozzle (see Photograph 2).

Photograph 2: Fuel splash filler nozzle adaptor attached to Banlaw quick connect fuel nozzle.

When attached the adaptor made a free-flowing nozzle that enabled plant to be refuelled without a quick connect coupling.

An examination of the fuel splash filler nozzle identified that it was not suitable for the refuelling task and enabled pressurised fuel to flow out of the nozzle in an uncontrolled manner. This uncontrolled pressure allowed the fuel to come into contact with potential ignition sources such as the tyre handler's hot engine, turbo, exhaust system and other electrical equipment.

The use of suitable fuel fittings is essential. Under no circumstances should unsuitable fuel fittings or adapters be used to modify refuelling systems. High pressure and high flow fuel systems should not be used for refuelling smaller plant and equipment that does not have the appropriate refuelling fittings.

Mine operators should ensure that the correct refuelling fittings are used and consider the provision of alternative methods of refuelling such as in field service trucks or low pressure pumping systems to refuel plant without quick connect fittings.
