WEEKLY INCIDENT SUMMARY

Week ending Friday 04 December 2020

Summarised incidents

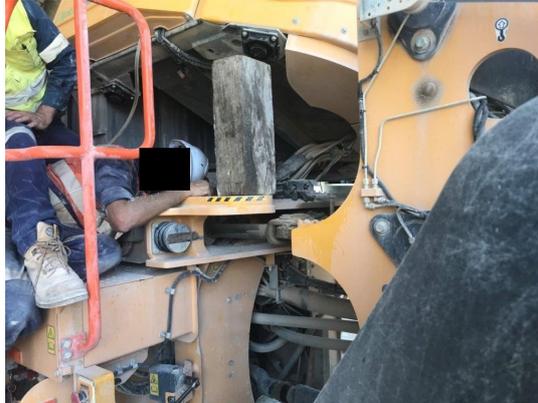
INCIDENT TYPE	SUMMARY	COMMENTS TO INDUSTRY
Dangerous incident IncNot0038755 Industrial minerals	A worker was trapped under the cab of a loader when the cab lowered onto him as he was working beneath it. The worker was trapped for about three minutes before he was released. Preliminary investigation found that the cab was unsupported at the time. No locking pin or chock was used to hold the raised cab in place. The worker sustained minor injuries.	This incident is under investigation and a full report will be published at a later date. Under no circumstances should an operator work beneath an unsupported cab. OEM recommended chocks and locking pins should be used to secure the raised cab in place.

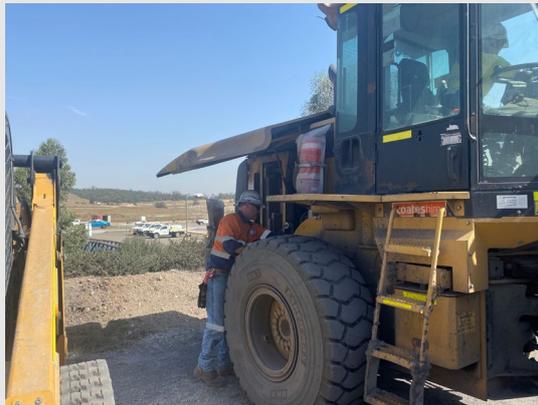
Dangerous incident
IncNot0038773
Coal processing
plant

An operator was checking the oil on a loader while positioned between the counterweight and the rear wheel. Another operator entered the loader and started the vehicle. The worker removed himself from the area and was uninjured.

Prior to undertaking any tasks around heavy machinery it is imperative that the machine is isolated.

Operators should follow procedures and ensure there is nobody in the vicinity of the machine before starting it. Visual checks and sounding the horn before starting the vehicle are basic controls that should be followed.

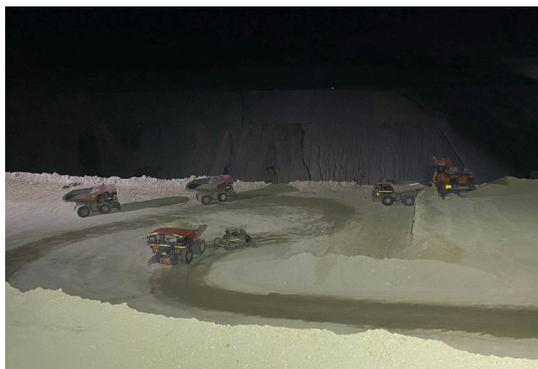
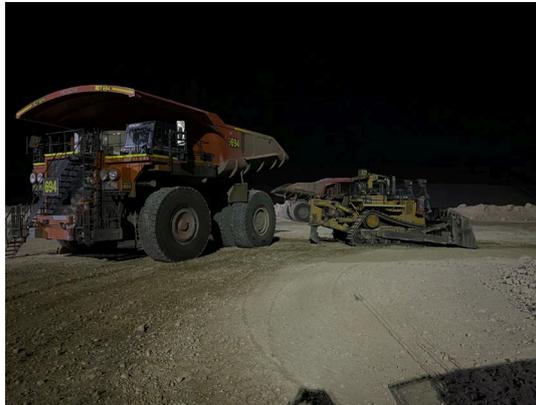
Dangerous incident
IncNot0038778
Open cut coal

As an overloaded dump truck was travelling across the working area, a dozer doing floor clean-up changed the direction of travel and reversed into the driver side rear tyre (POS-3). No one was injured.

Mine operators must have protocols and procedures to ensure positive communications are established between vehicle operators in collision zones.

Consideration should be given to proximity detection and collision avoidance technologies.

Supervisors must ensure that vehicle operators comply with the protocols and procedures.

Ensure that any equipment mounted inside the cab, such as a fan, does not impede operator vision.
