INVESTIGATION INFORMATION RELEASE

Rehabilitation at the former Nymboida Clay Mine

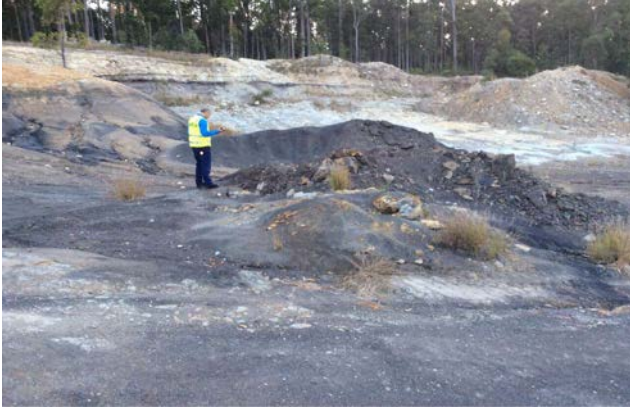
Figure 1 Before – the unrehabilitated pit has steep, unstable faces and waste rock stockpiles remaining on the pit floor

- The quarry face was actively eroding (refer to figure 1).
- Many areas were unrehabilitated, with poor surface water and sediment controls, presenting further risks of sedimentation impacts (refer to figure 3).
- Sediment dams built outside of the lease boundary had the potential to discharge turbid water offsite toward an adjacent public road and nearby watercourse (refer to figure 5).

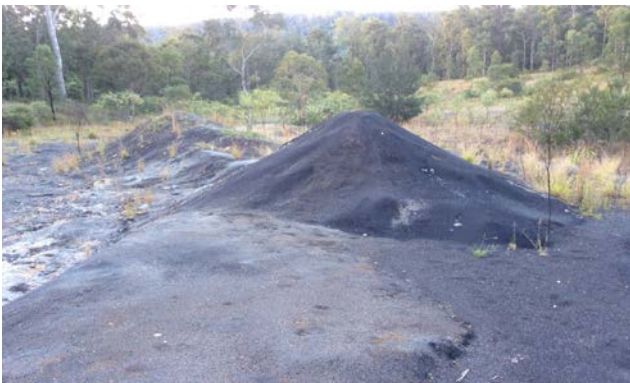
Figure 3 Before – disturbed areas in the pit floor, including waste material stockpiles, were the source of potential offsite pollution during storm events due to sediment laden run-off

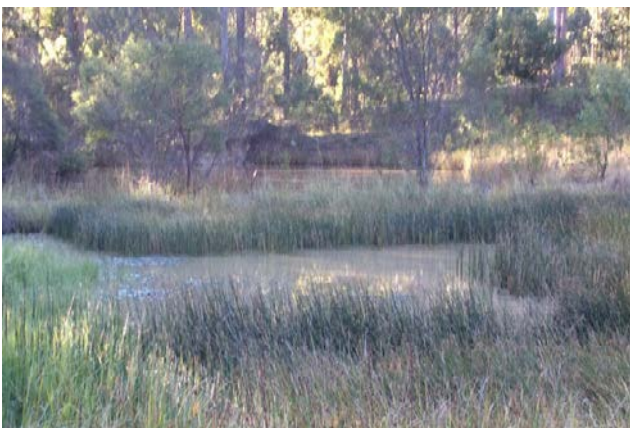
Figure 5 Before - poor dam water quality due to sediment laden run off from disturbed areas and waste material stockpiles

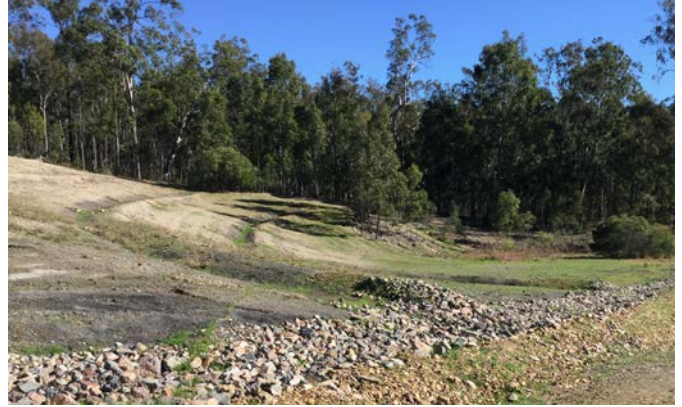
Figure 2 After – the pit is reprofiled to safe and stable slopes. Swales control run off and limit erosion

- earthworks to reprofile the quarry face and removing material stockpiles
- building rock line water diversion drains and swales to control surface waterflow, minimising erosion and sediment transport to retained dams
- revegetation works including planting native tree and shrub tube stock and seeding areas prone to erosion with fast-growing grasses
- rehabilitation monitoring including water quality, erosion monitoring and vegetation monitoring to demonstrate achievement of rehabilitation outcomes in the agreed rehabilitation management plan.

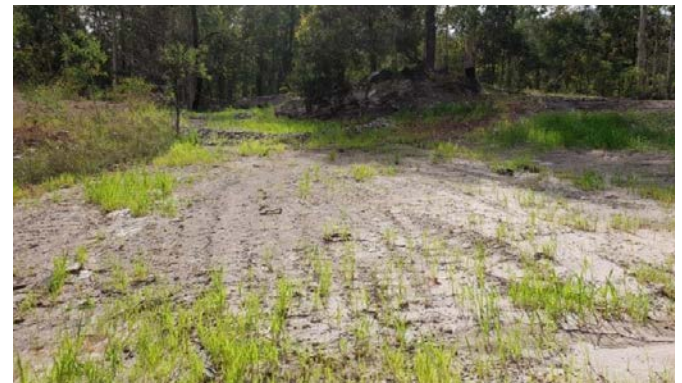
Figure 4 After - waste material stockpiles have been removed and areas seeded to minimise erosion. Rock check dams installed (in the background) slow down flows and capture coarse sediment before run-off collects in the dams

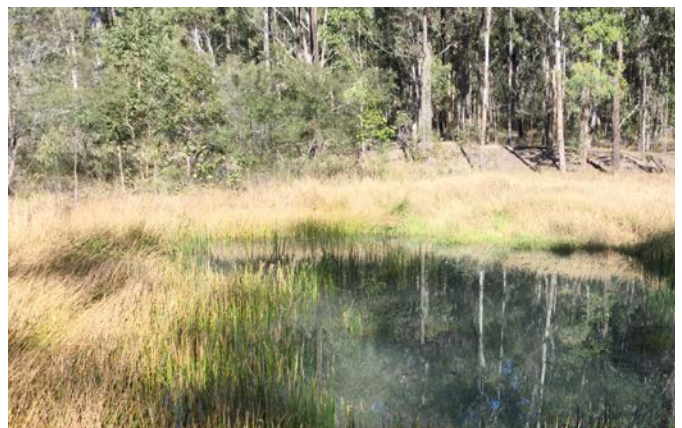
Figure 6 After - stabilisation of disturbed areas has resulted in improved water quality in the retained dams, providing a resource for the travelling stock reserve
