MINE SAFETY INVESTIGATION UNIT

INFORMATION RELEASE

Date	16 March 2013
Event	Fatal head injuries – transport in a shaft sinking kibble
Location	CSA Mine Cobar, NSW

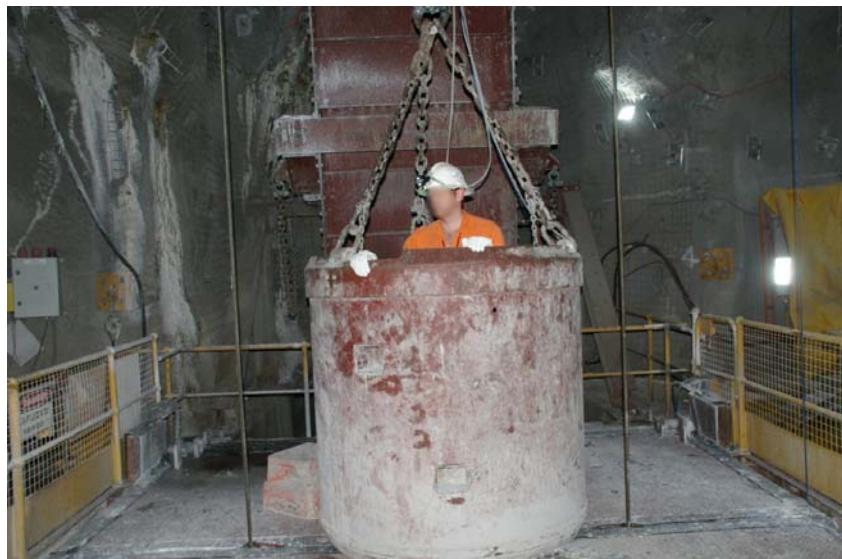
The kibble was suspended by a single head rope and had no guide ropes thereby allowing freedom of lateral movement and rotation. The clearance between the kibble and the kibble well was relatively small where it passed through the two stage decks. This created a hazardous nip-point when people were raised in the kibble.

Preliminary accounts suggest the supervisor put his head over the side of the rising kibble and sustained crush injuries when his head hit the underside of the top deck.

The kibble used in the project

The principal control measure used on this job to prevent this type of injury appeared to be that people travelling in the kibble must ensure body parts did not extend beyond the confines of the conveyance. This incident highlights the inadequacy of such procedural controls on their own. More effective controls, such as elimination of the hazard, substituting, isolating, or implementing engineering controls are required wherever reasonably practicable.¹

While man-riding in kibbles is an established practice in shaft sinking, this incident suggests the use of a purpose-built, man-riding conveyance should be considered wherever practicable. If the use of such conveyances is not reasonably practicable then other control measures of equivalent or greater safety need to be used.

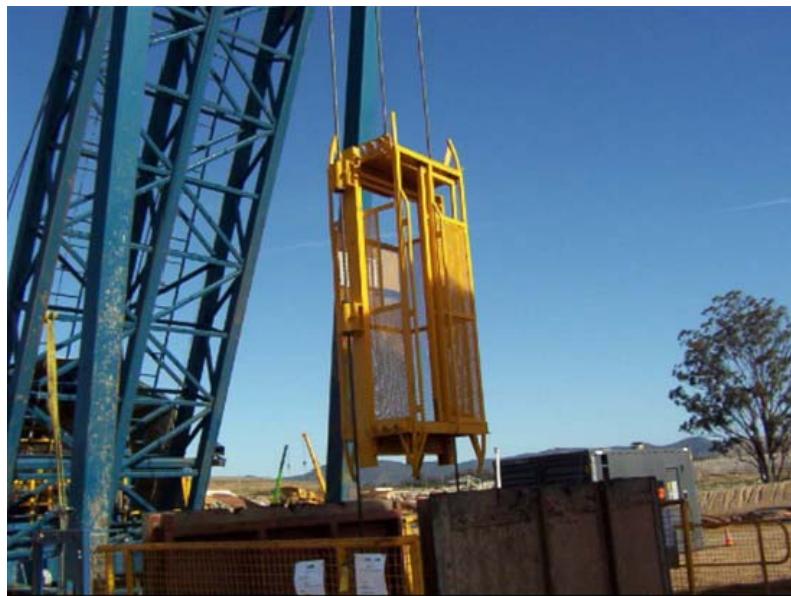
An example of a man riding cage
