# MINE SAFETY INVESTIGATION UNIT

INFORMATION RELEASE

## Fatality

<b>Date</b>	16 March 2013
<b>Event</b>	Fatal head injuries – transport in a shaft sinking kibble
<b>Location</b>	CSA Mine Cobar, NSW

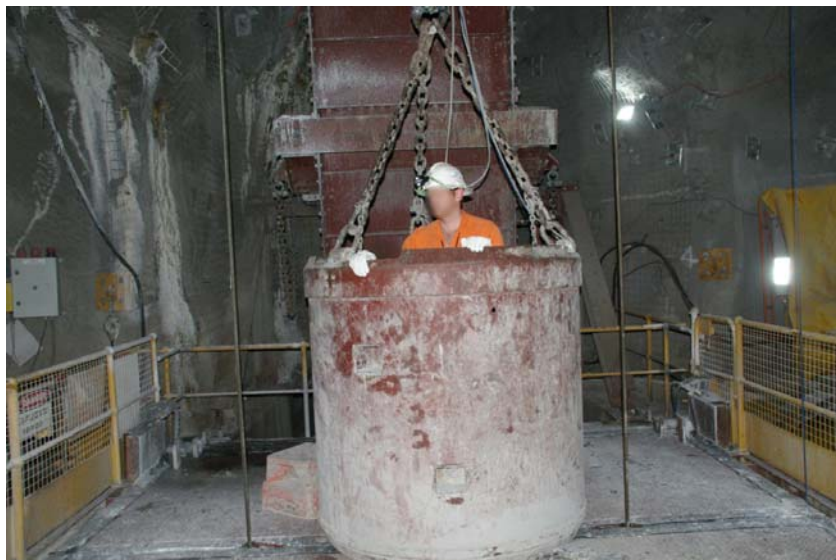
The kibble was suspended by a single head rope and had no guide ropes thereby allowing freedom of lateral movement and rotation. The clearance between the kibble and the kibble well was relatively small where it passed through the two stage decks. This created a hazardous nip-point when people were raised in the kibble.

Preliminary accounts suggest the supervisor put his head over the side of the rising kibble and sustained crush injuries when his head hit the underside of the top deck.

**The kibble used in the project**

The principal control measure used on this job to prevent this type of injury appeared to be that people travelling in the kibble must ensure body parts did not extend beyond the confines of the conveyance. This incident highlights the inadequacy of such procedural controls on their own. More effective controls, such as elimination of the hazard, substituting, isolating, or implementing engineering controls are required wherever reasonably practicable.<sup>1</sup>

While man-riding in kibbles is an established practice in shaft sinking, this incident suggests the use of a purpose-built, man-riding conveyance should be considered wherever practicable. If the use of such conveyances is not reasonably practicable then other control measures of equivalent or greater safety need to be used.

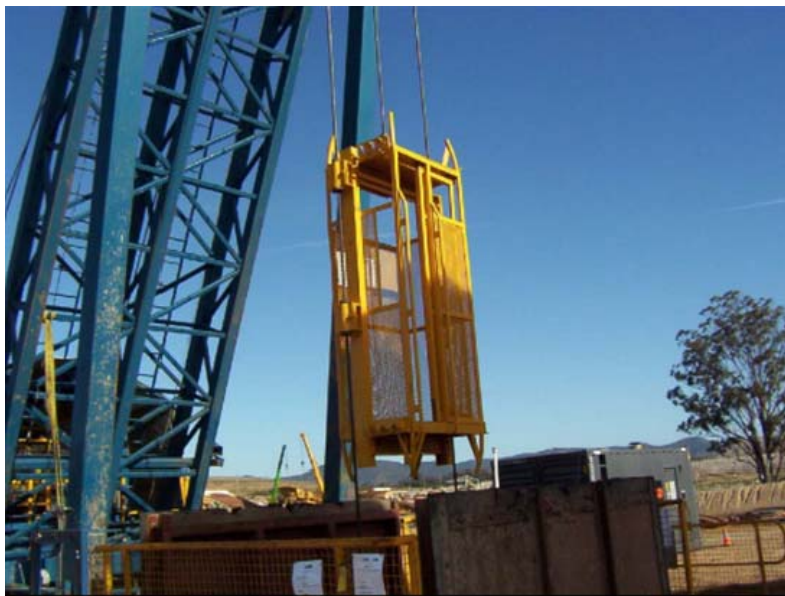
**An example of a man riding cage**

The draft guideline draws attention to a number of design considerations for kibbles and equipment, including the risk of injury from falling objects, and structural considerations where a kibble is used for man riding.
